Annual Inspection

Mudford Parish Council

Mudford Play Ground

Inspected: 26-August-2024 - 14:26 by Lyn Williams (RPII Annual Inspector)

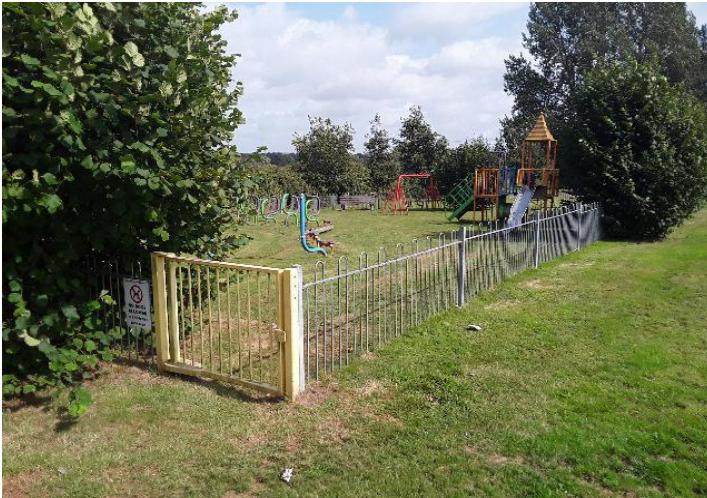
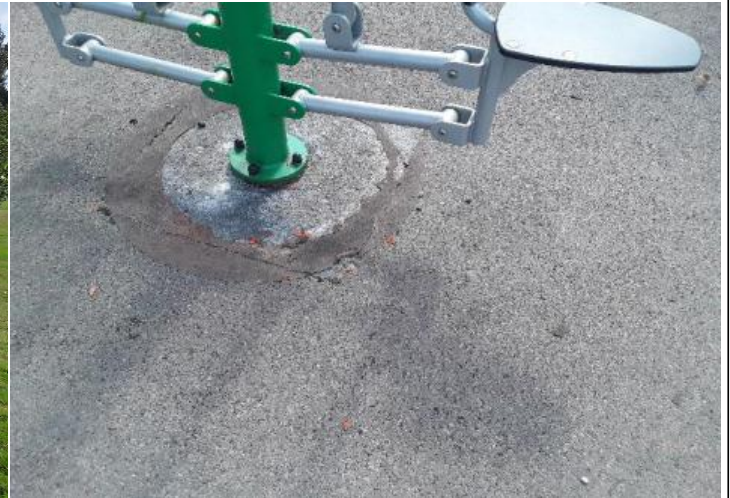
Item: Ancillary Items - Site General
Manufacturer: Owner/Operator

Finding: The graphics around the fitness equipment is breaking up

Action: Remove the loose material and consider re painting the graphics

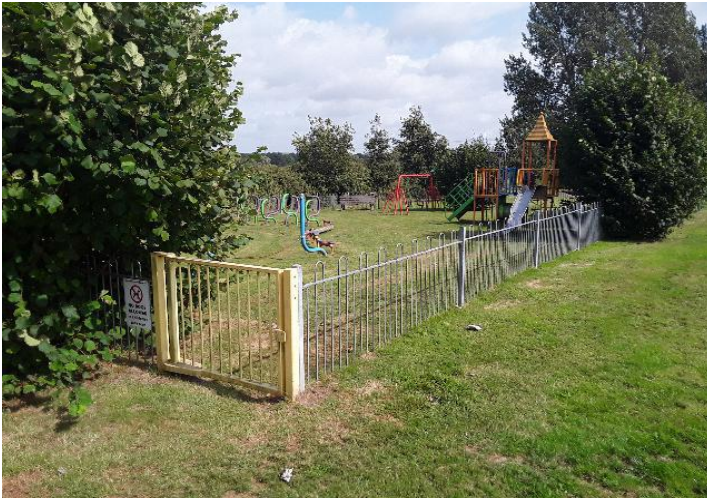
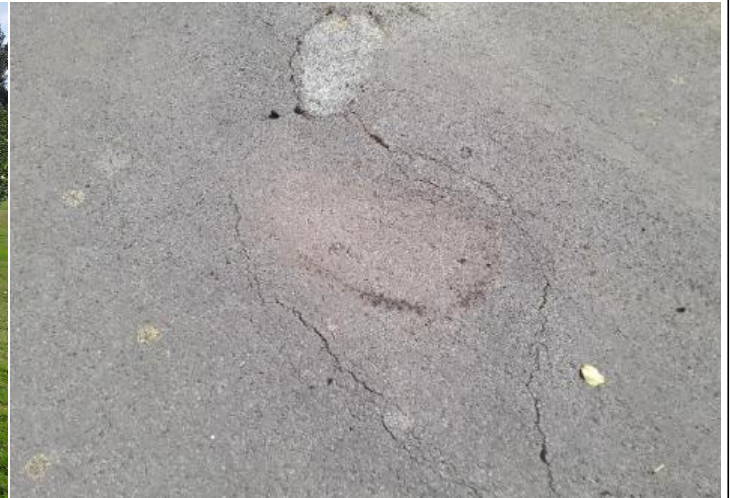
Item: Ancillary Items - Site General
Manufacturer: Owner/Operator

Finding: The tarmac surface has subsided in some areas

Action: Monitor for any further deterioration and repair as required

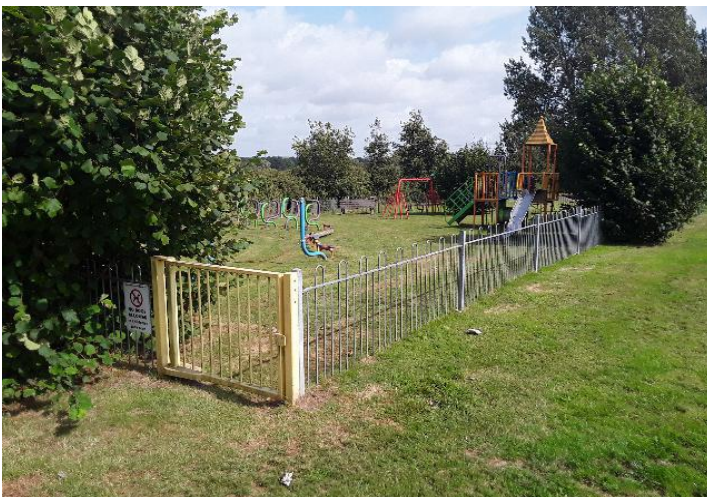
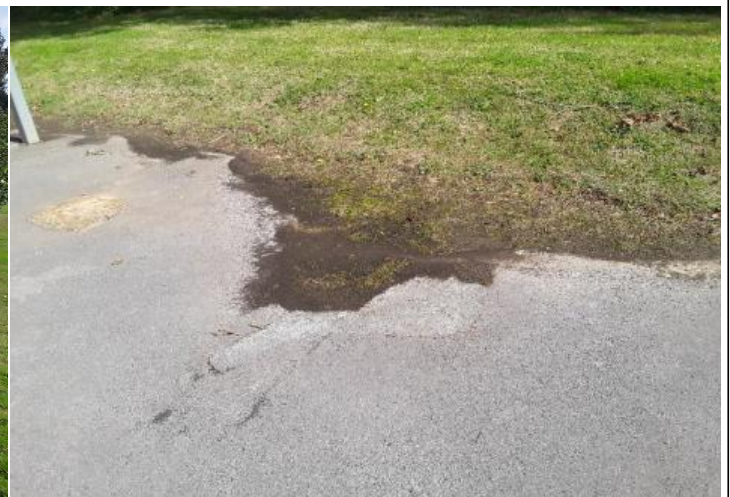
Item: Ancillary Items - Site General
Manufacturer: Owner/Operator

Finding: There is algae, silt or moss growth on the tarmac surface resulting in slippery conditions

Action: Clean and treat appropriately

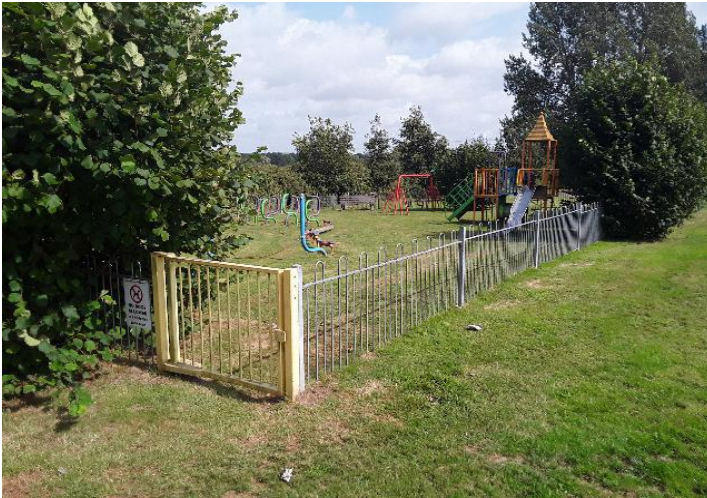
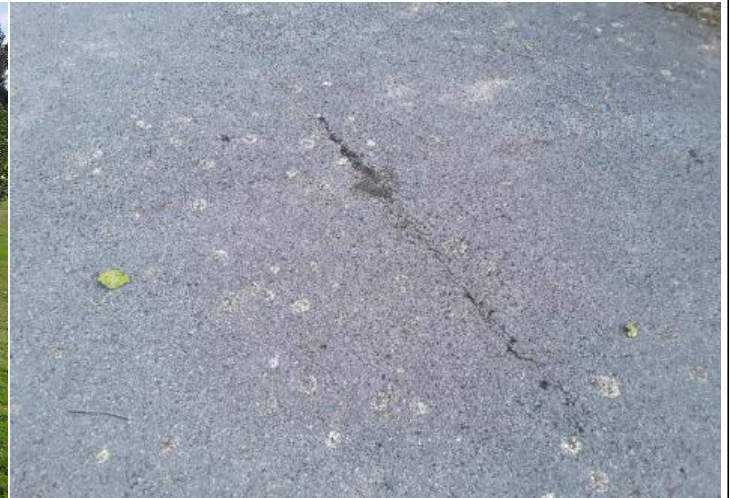
Item: Ancillary Items - Site General
Manufacturer: Owner/Operator

Finding: There are minor stress fractures in the tarmac surface

Action: Monitor and repair if required

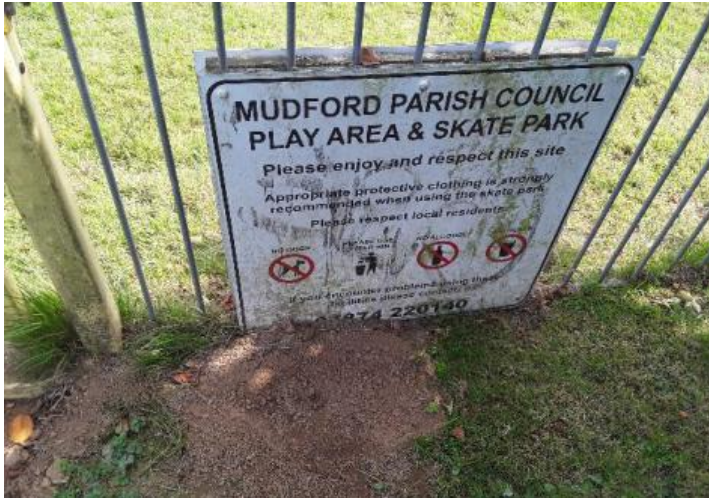
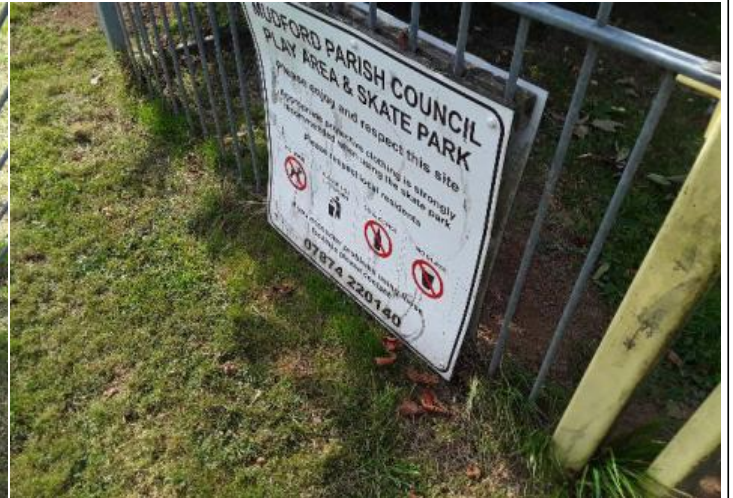
Item: Ancillary Items - Sign
Risk Level: L - Low Risk
Manufacturer: Owner/Operator
Surface: N/A

Finding: The signage is damaged

Action: Replace signage

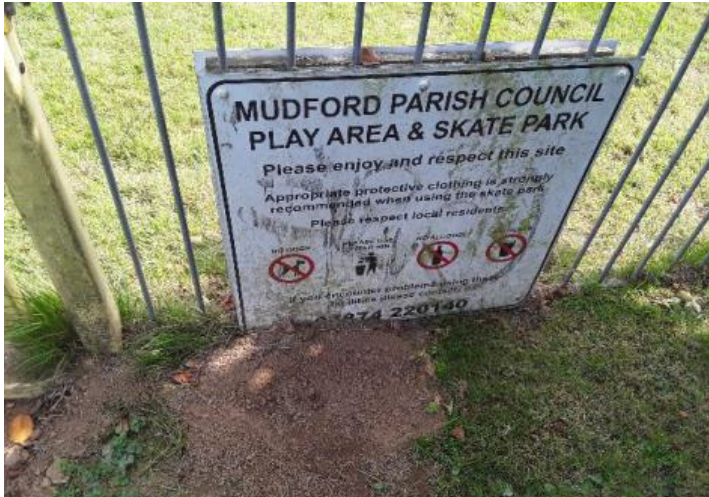
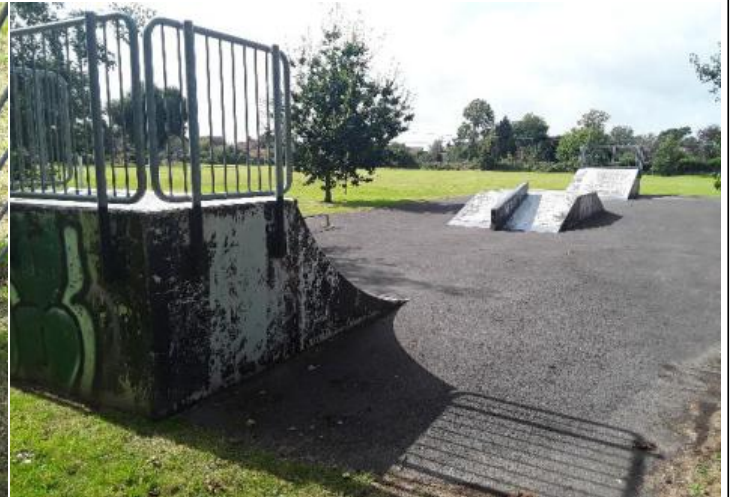
Item: Ancillary Items - Sign
Risk Level: V - Very Low Risk
Manufacturer: Owner/Operator
Surface: N/A

Finding: Signage of the wheeled sports area should be provided as recommended in BS EN 14974; this will include, but not exclusively, the use of the area, a recommendation to wear protective equipment, emergency contact details etc

Action: Provide signage as recommended by BS EN 14974 for wheeled sports areas

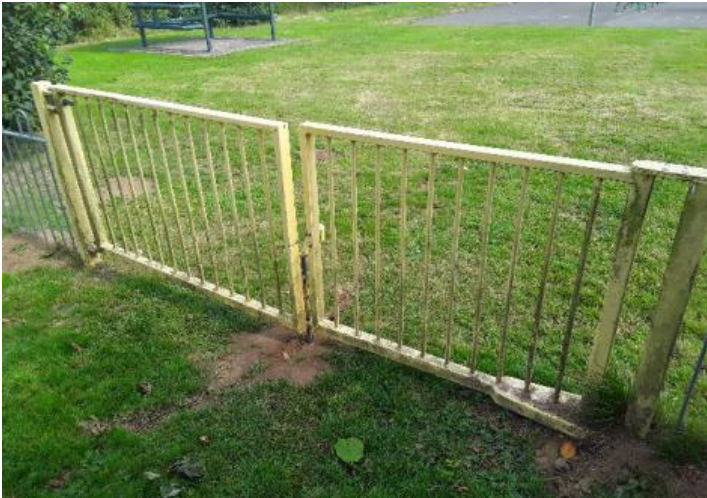
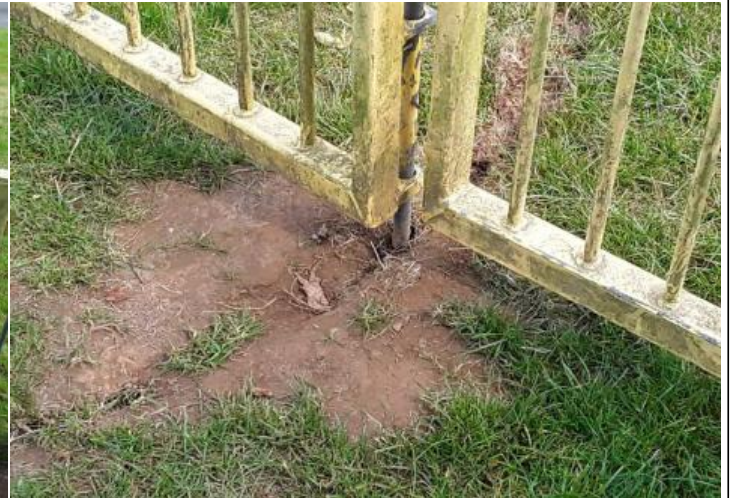
Item: Gates - Gate - Combination
Manufacturer: Easy Gate Ltd

Finding: The gate has no drop bolt sleeves fitted and the drop bolt has damaged the surface

Action: Provide drop bolt sleeves and reinstate the surrounding surface

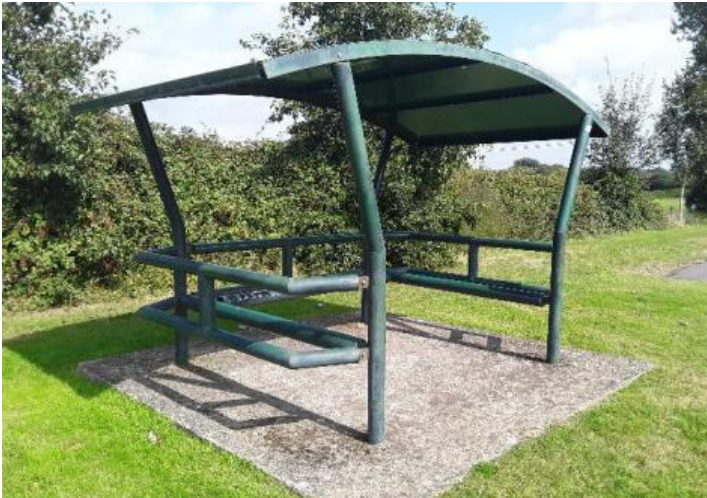
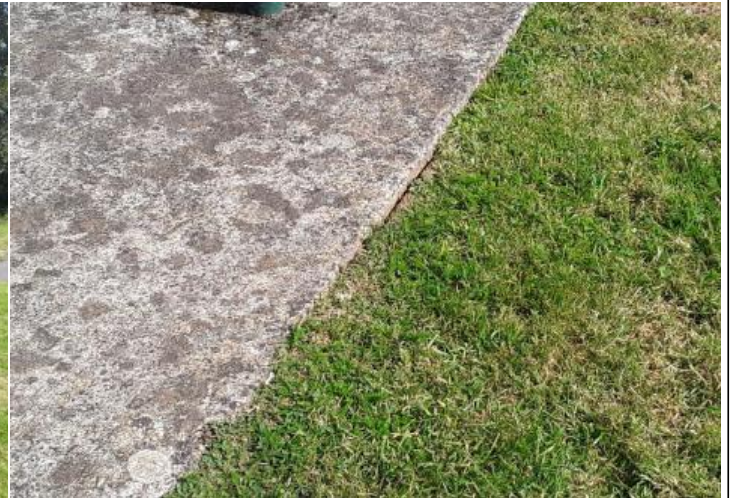
Item: Ancillary Items - Teenage Shelter
Manufacturer: Not Identified

Finding: There are trip hazards present over the concrete base

Action: Remove trip hazard

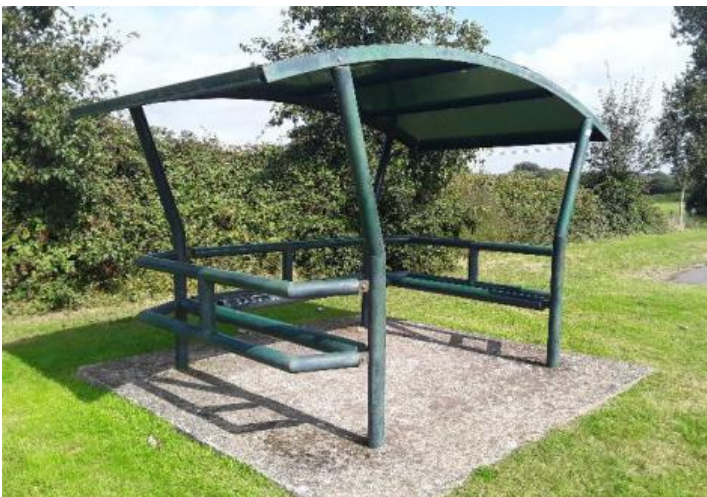
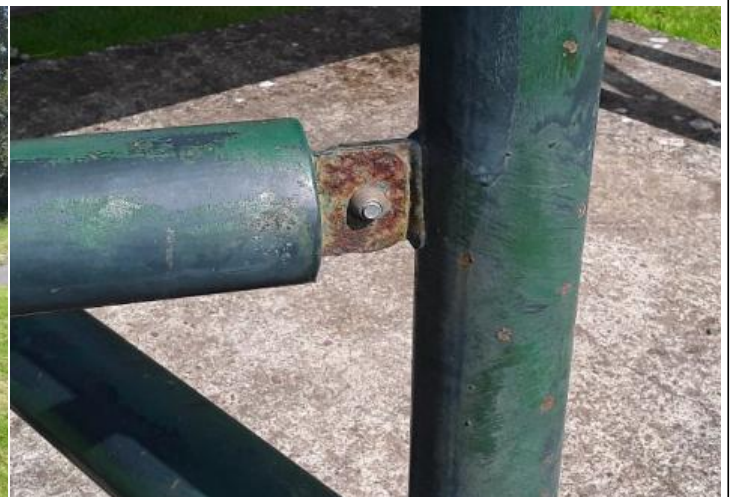
Item: Ancillary Items - Teenage Shelter
Manufacturer: Not Identified

Finding: There is surface corrosion / rust present on the item

Action: Consider treating the item

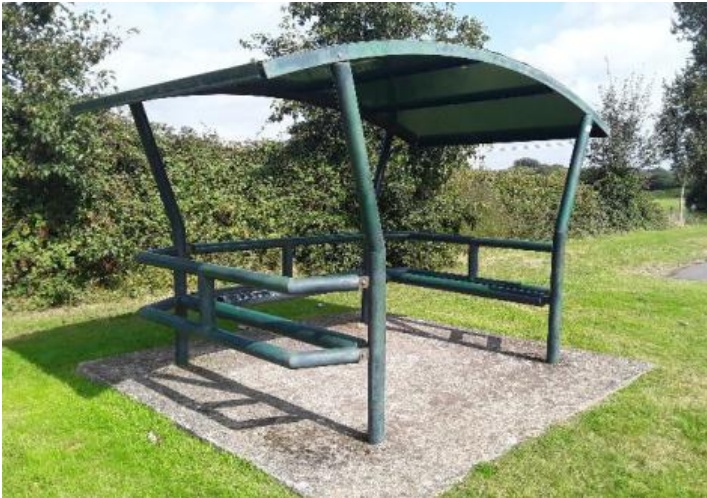
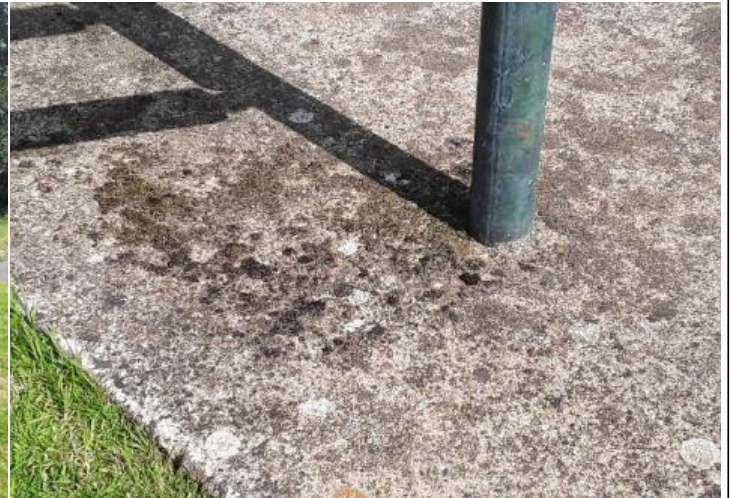
Item: Ancillary Items - Teenage Shelter
Manufacturer: Not Identified

Finding: There is algae, silt or moss growth on the surface resulting in slippery conditions

Action: Clean and treat appropriately

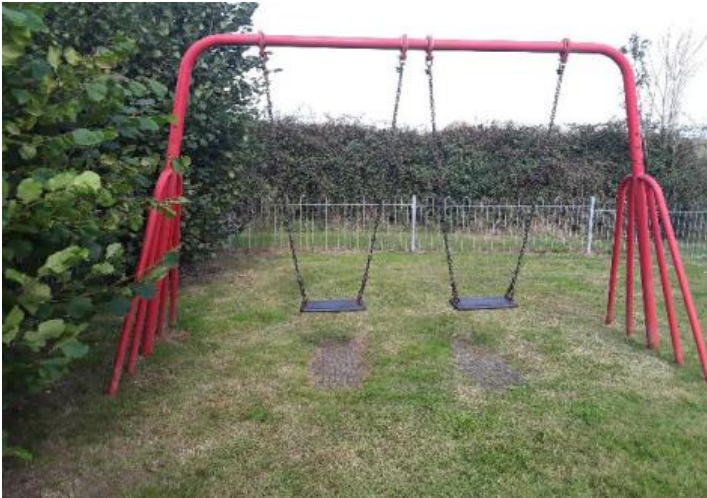
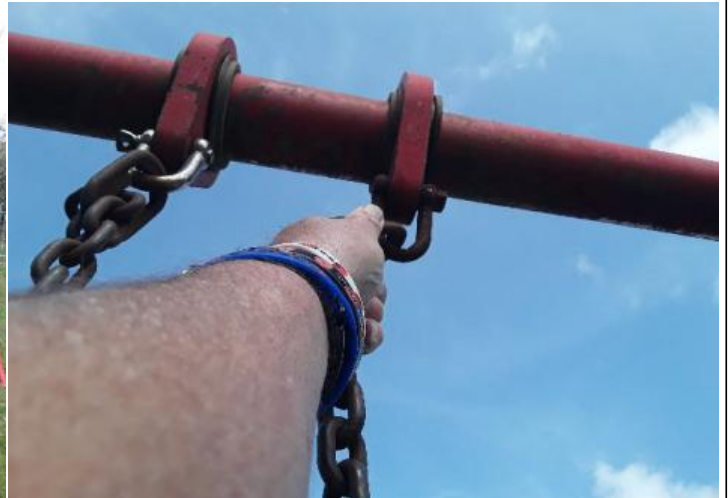
Item: Swings - 1 Bay 2 Seat (Flat)
Manufacturer: Wicksteed Playgrounds

Finding: There is some wear to the shackles

Action: Monitor for any further deterioration and replace when 40% worn

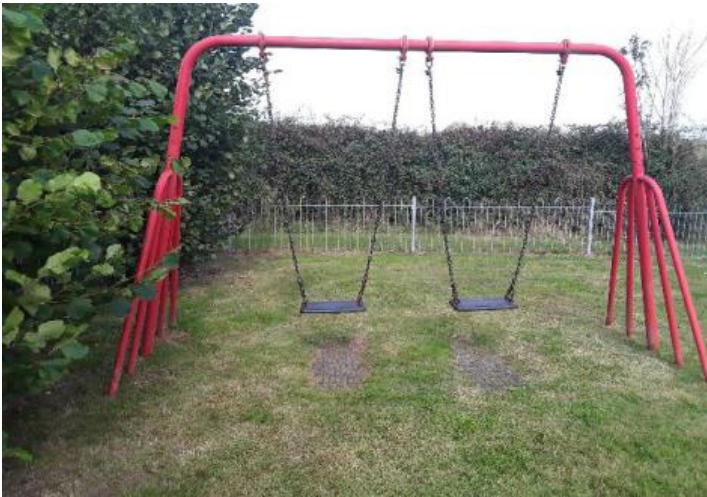
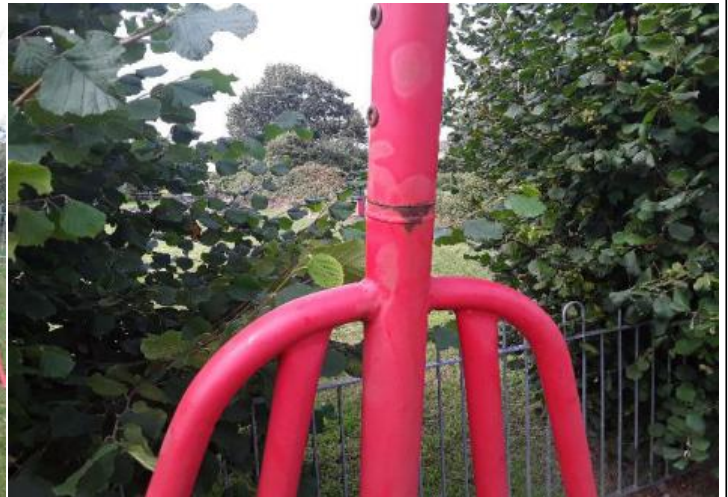
Item: Swings - 1 Bay 2 Seat (Flat)
Manufacturer: Wicksteed Playgrounds

Finding: There is surface corrosion / rust present on the item

Action: Consider treating the item

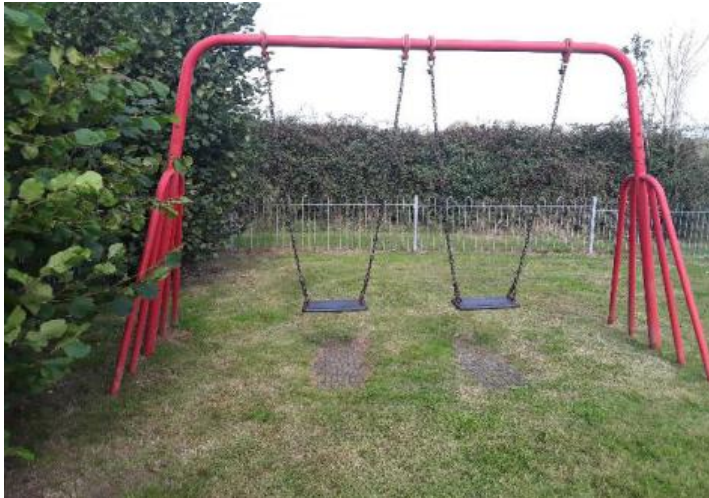
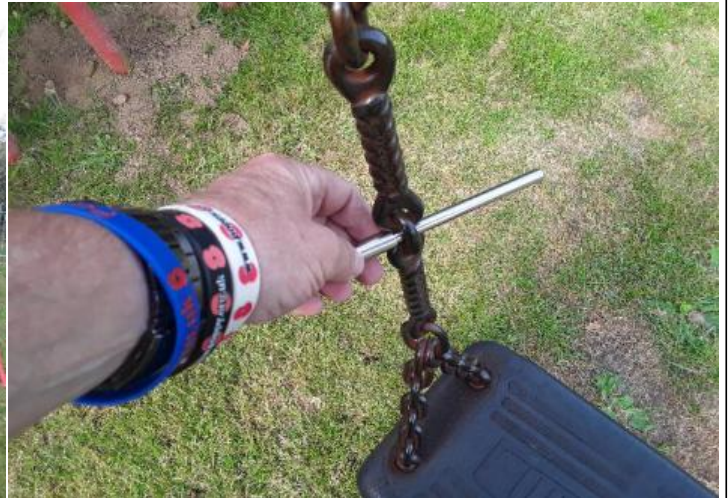
Item: Swings - 1 Bay 2 Seat (Flat)
Manufacturer: Wicksteed Playgrounds

Finding: The chain openings are in excess of the 8.6mm as recommended by BS EN 1176 **Action:** Monitor - No remedial work recommended

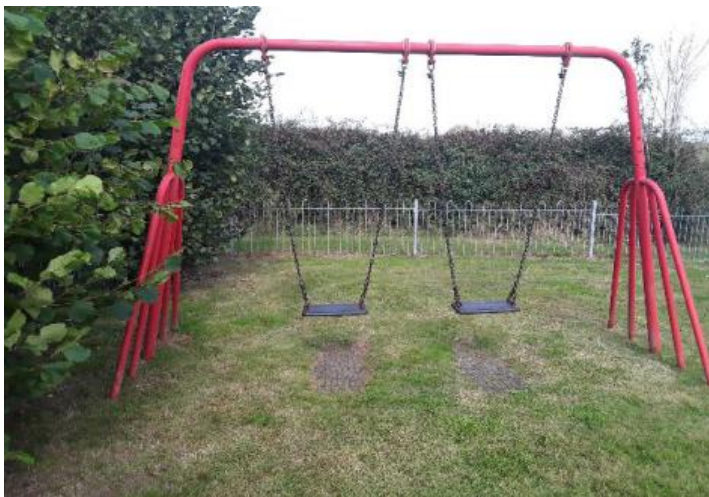
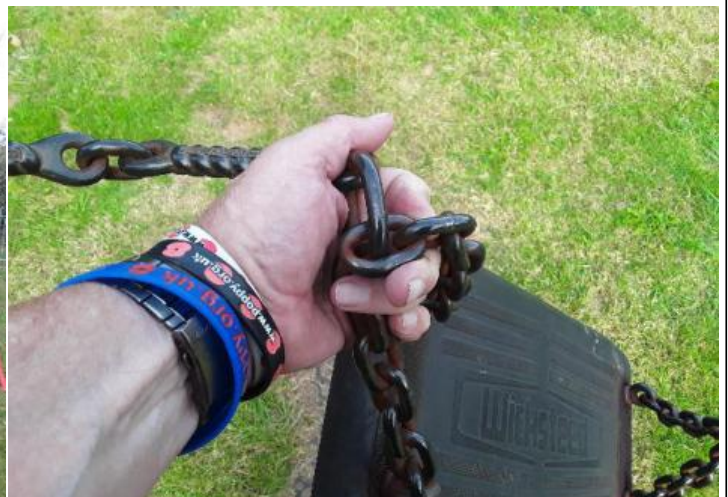
Item: Swings - 1 Bay 2 Seat (Flat)
Manufacturer: Wicksteed Playgrounds

Finding: There is some notable evidence of chain wear **Action:** Monitor for any further deterioration and replace when 40% worn

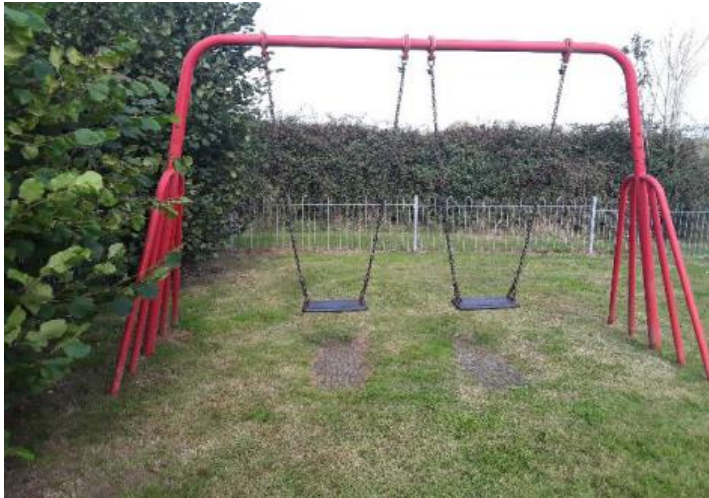
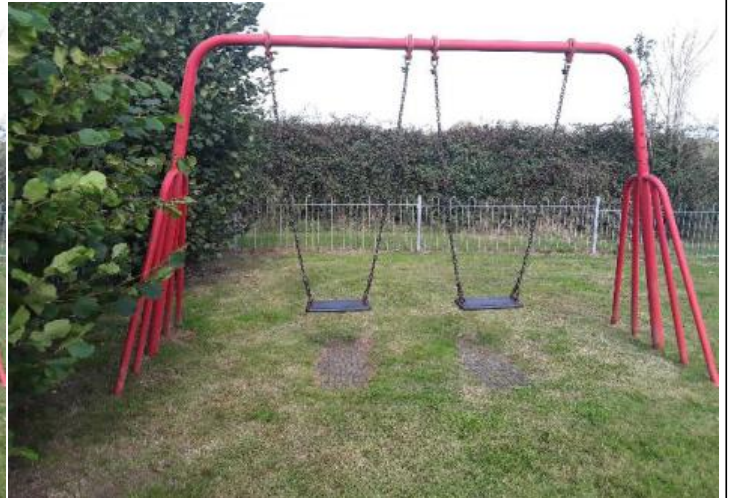
Item: Swings - 1 Bay 2 Seat (Flat)
Manufacturer: Wicksteed Playgrounds

Finding: The seats are too close to each other as defined in BS EN 1176 Part 2; this is a low risk failure and no remedial action is required
Action: Monitor - No remedial work recommended

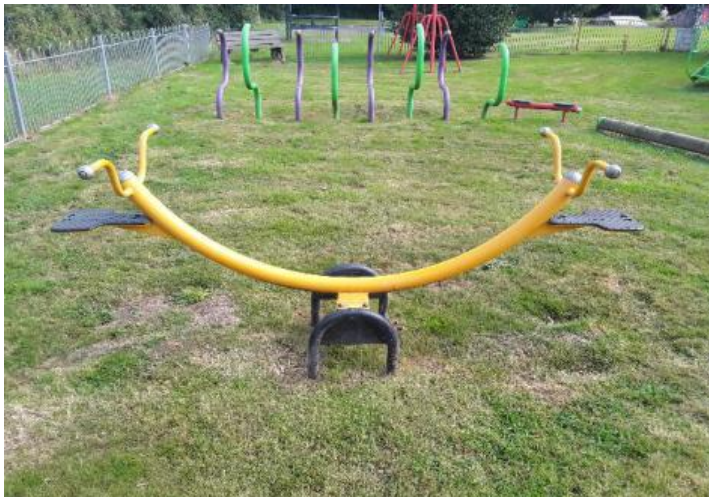
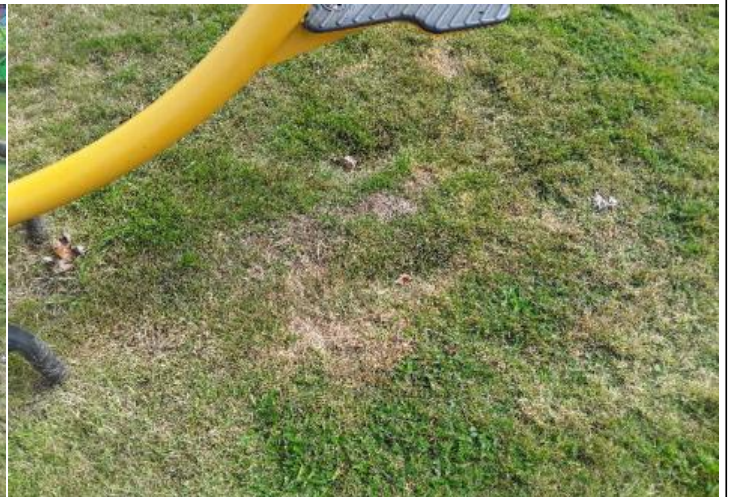
Item: Rocking Equipment - See Saw
Manufacturer: Wicksteed Playgrounds

Finding: The surface has subsided creating trip hazards
Action: Repair as required to provide a uniform surface

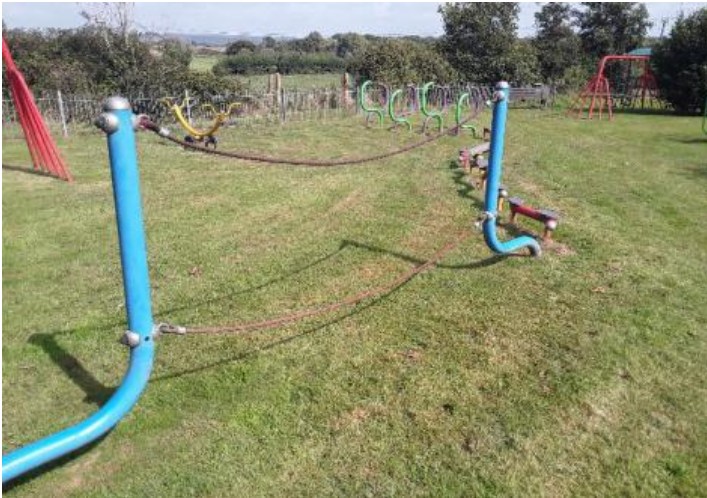
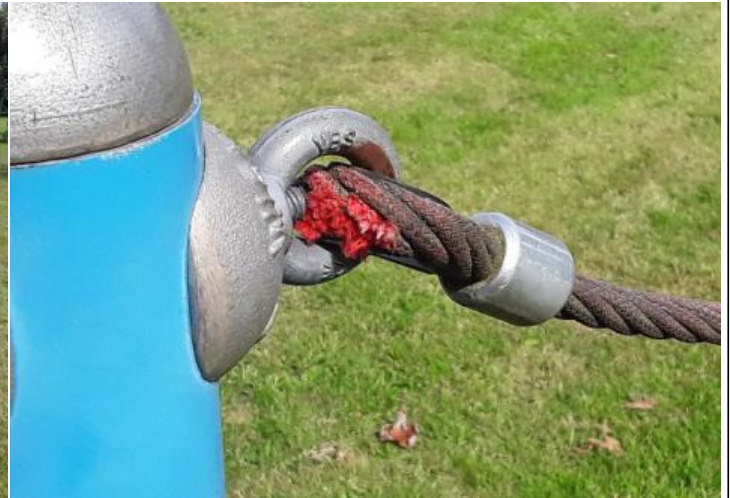
Item: Activity Equipment - Activity Trail
Manufacturer: Wicksteed Playgrounds

Finding: The rope has worn and wire strands are exposed **Action:** Replace rope or net

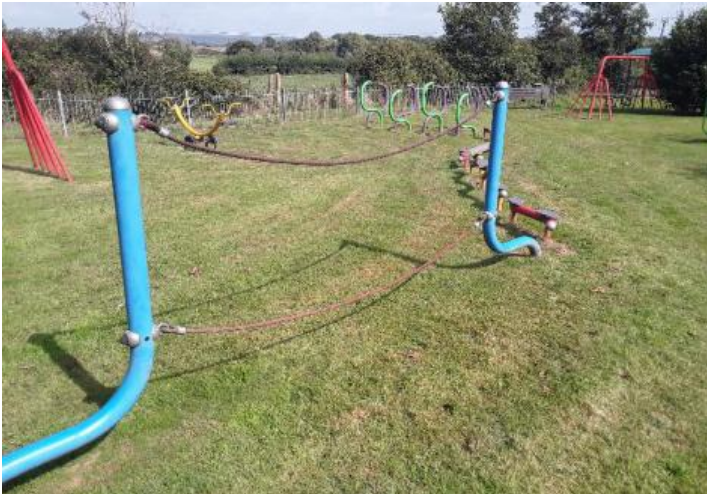
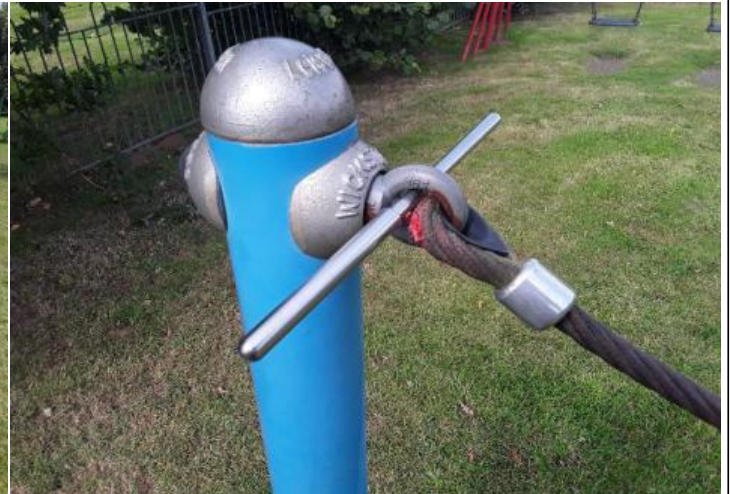
Item: Activity Equipment - Activity Trail
Manufacturer: Wicksteed Playgrounds

Finding: The connecting links are in excess of 8.6mm and less than 12mm and fail the requirements of BS EN 1176 Part 1; clause 4.2.13, Chains **Action:** Monitor use and replace with compliant links at the next maintenance cycle

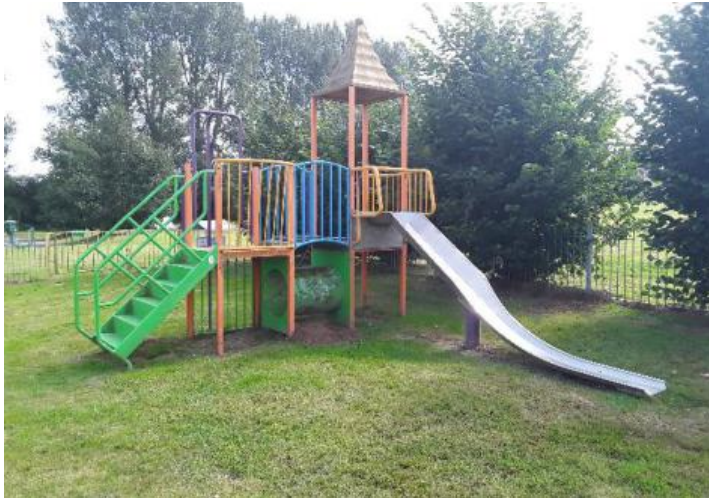
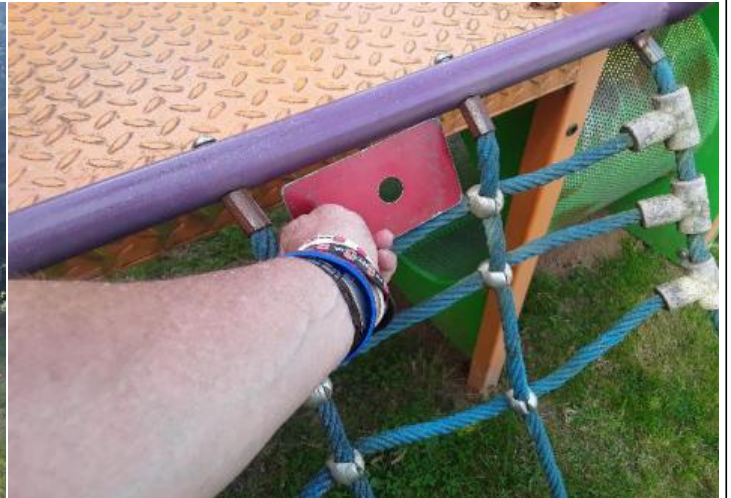
Item: Activity Equipment - Multi Play (Junior)
Manufacturer: Wicksteed Playgrounds

Finding: The item fails to meet the requirements of BS EN 1176 Part 1 4.2.7.2 for head and neck entrapment in the rope openings

Action: Monitor - No remedial work recommended

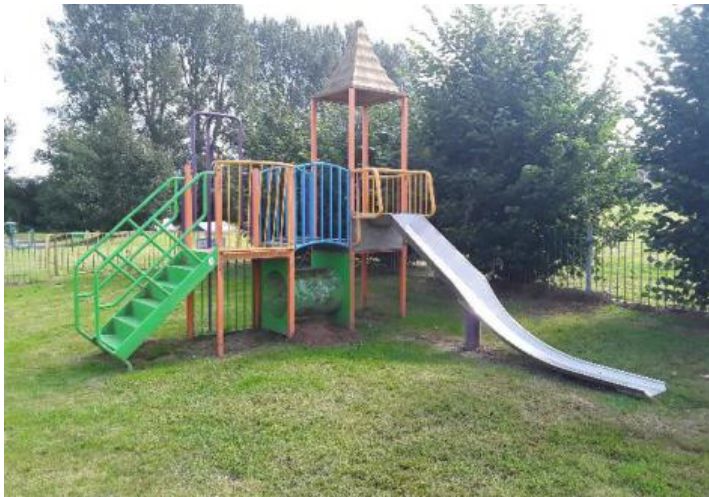
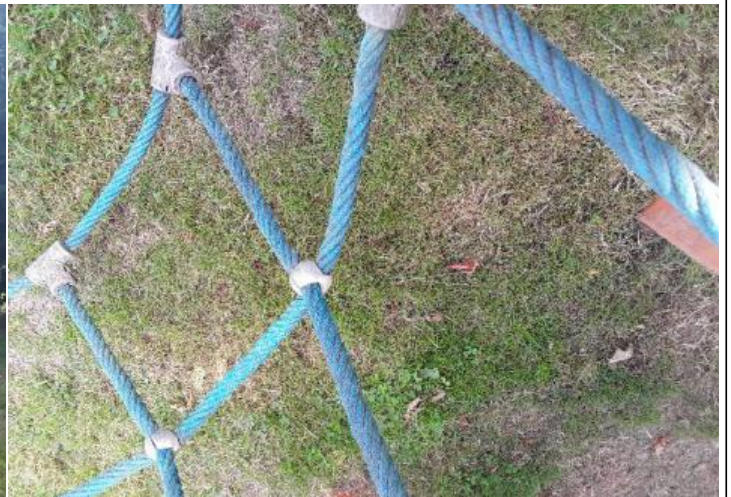
Item: Activity Equipment - Multi Play (Junior)
Manufacturer: Wicksteed Playgrounds

Finding: The ropes/nets are worn/damaged in places

Action: Monitor for any further deterioration and repair or replace as required

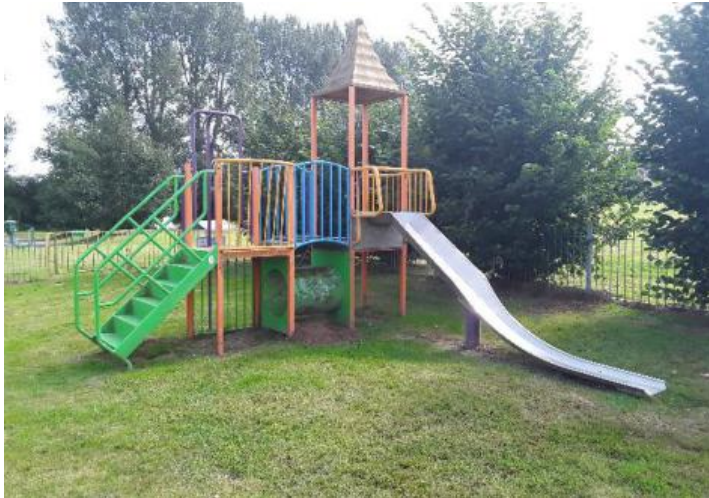
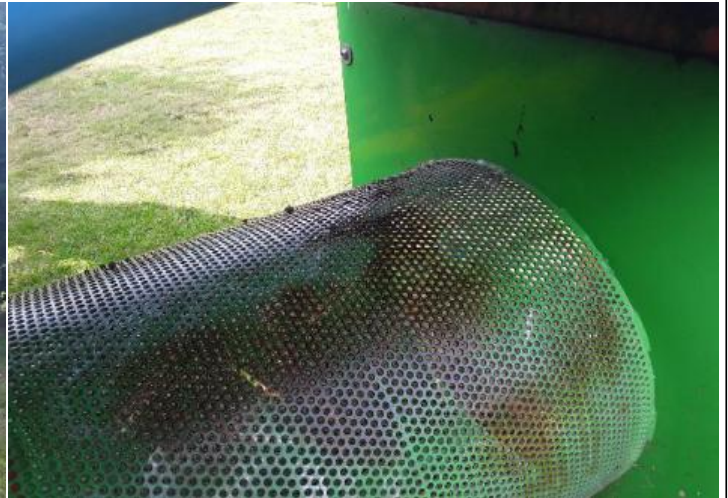
Item: Activity Equipment - Multi Play (Junior)
Manufacturer: Wicksteed Playgrounds

Finding: There is surface corrosion / rust present on the item

Action: Consider treating the item

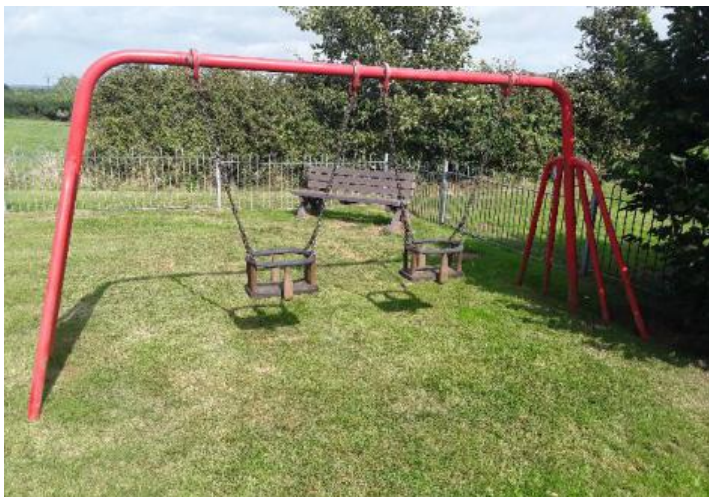
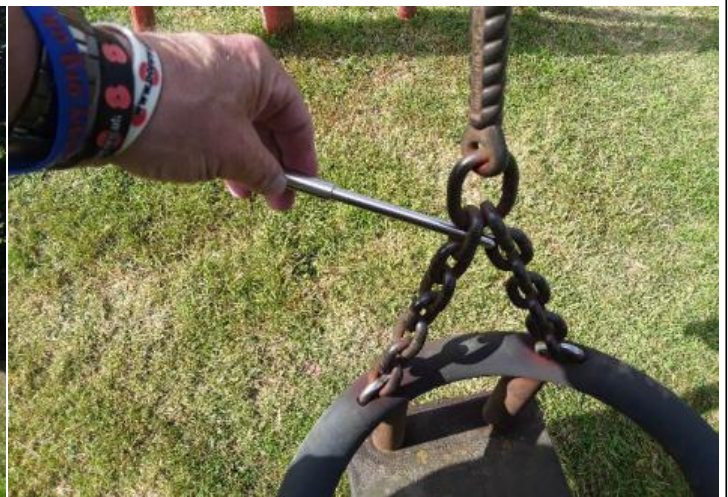
Item: Swings - 1 Bay 2 Seat (Cradle)
Manufacturer: Wicksteed Playgrounds

Finding: The chain openings are in excess of the 8.6mm as recommended by BS EN 1176

Action: Monitor - No remedial work recommended

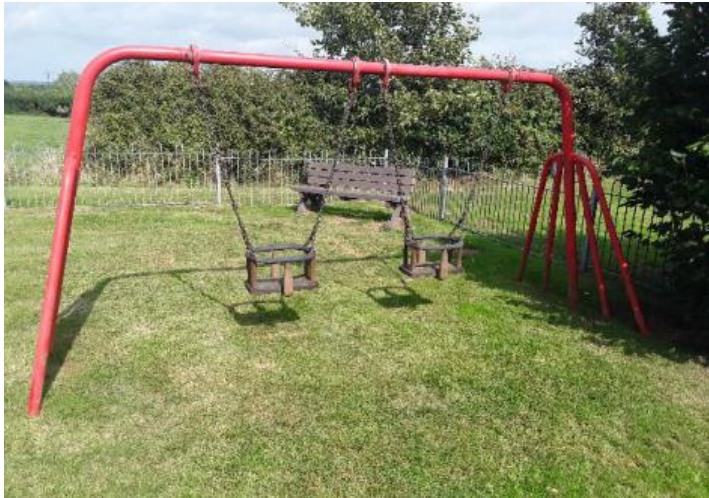
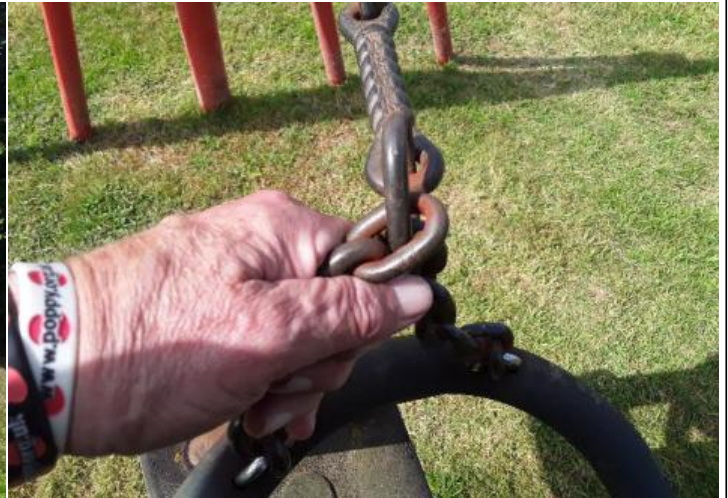
Item: Swings - 1 Bay 2 Seat (Cradle)
Manufacturer: Wicksteed Playgrounds

Finding: There is some notable evidence of chain wear

Action: Monitor for any further deterioration and replace when 40% worn

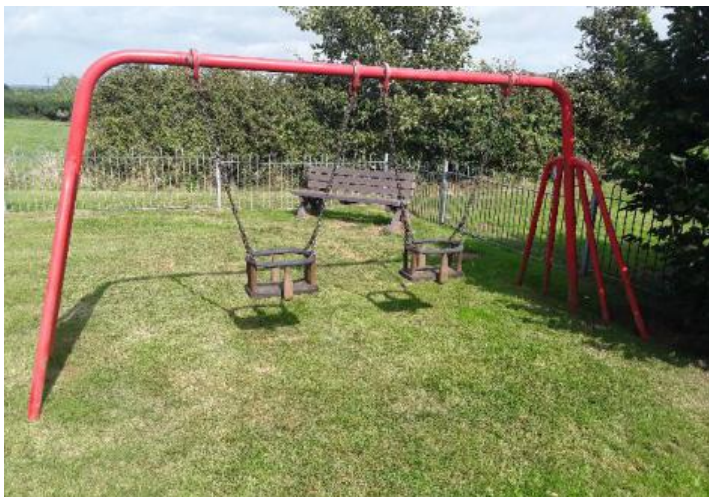
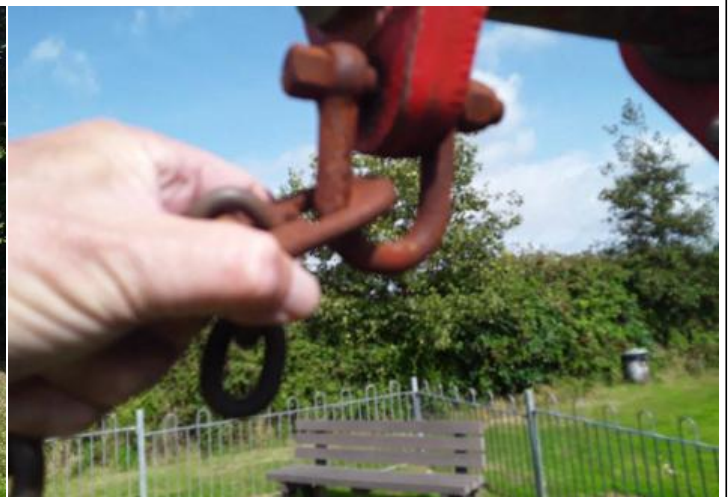
Item: Swings - 1 Bay 2 Seat (Cradle)
Manufacturer: Wicksteed Playgrounds

Finding: There is some wear to the shackles

Action: Monitor for any further deterioration and replace when 40% worn

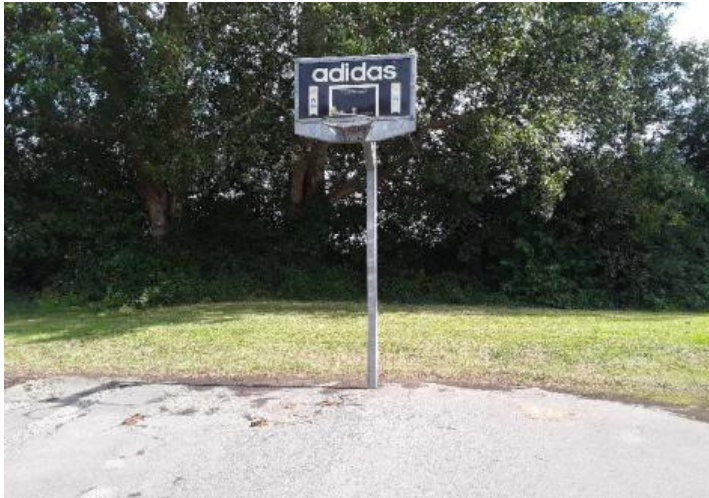
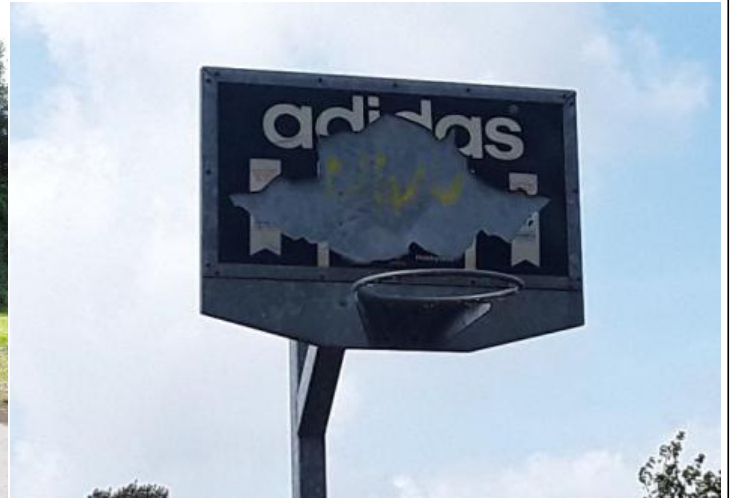
Item: Multi Use Games Area - Basketball Post
Manufacturer: Not Identified

Finding: The backboard is damaged

Action: Repair or replace the damaged backboard as required

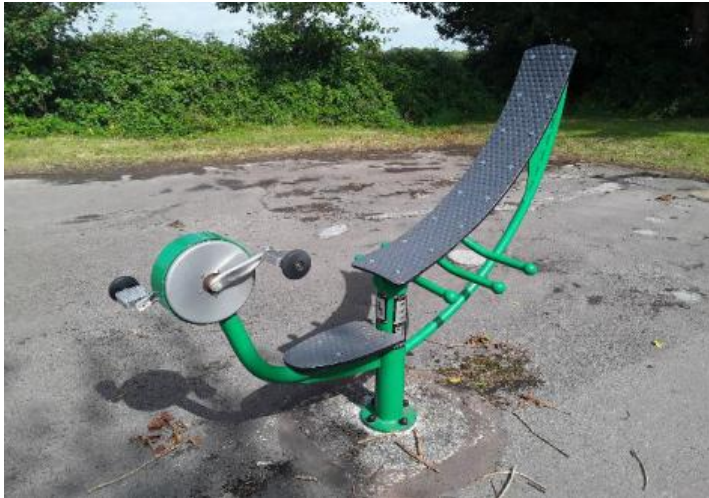
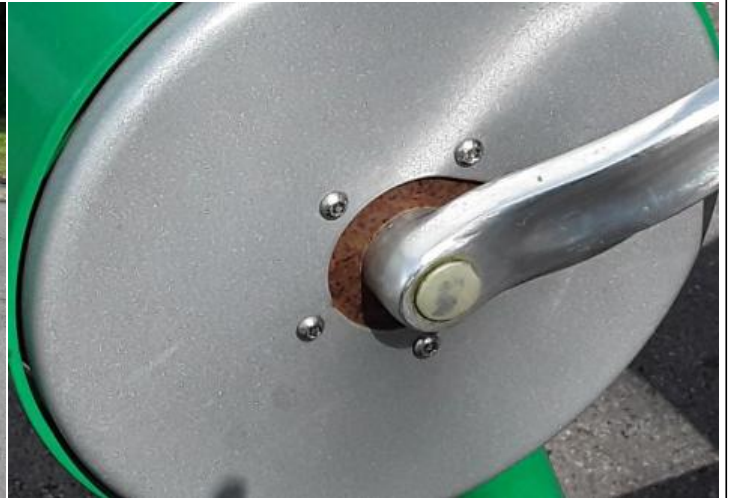
Item: Outdoor Fitness Equipment - Cycle
Manufacturer: Hags

Finding: There is surface corrosion / rust present on the item

Action: Consider treating the item

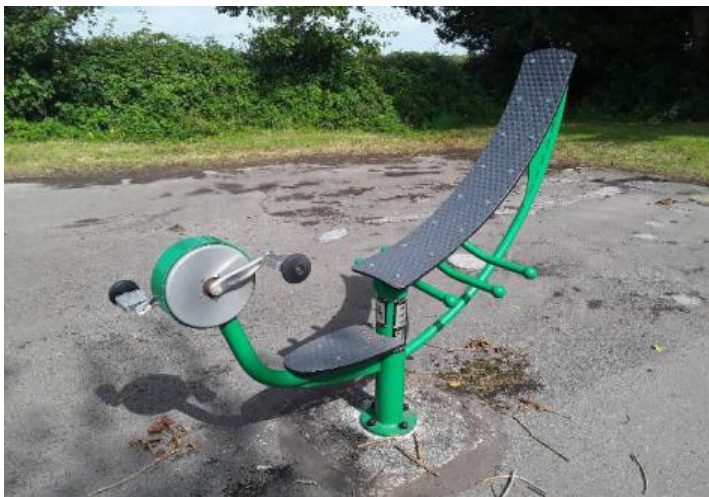
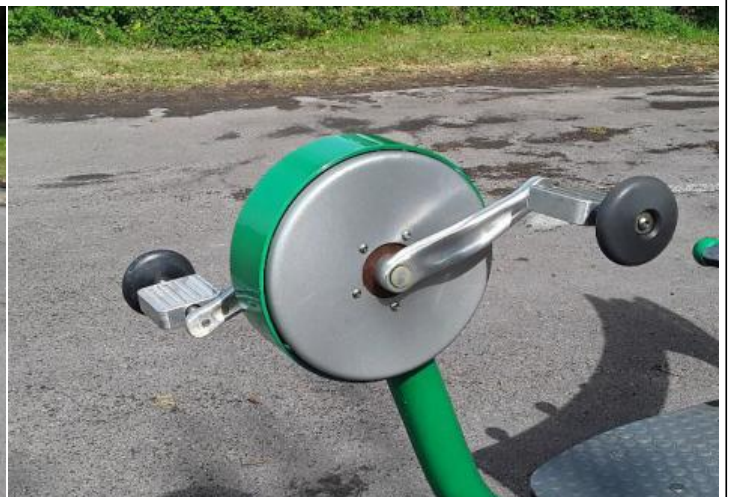
Item: Outdoor Fitness Equipment - Cycle
Manufacturer: Hags

Finding: The bearing is showing signs of wear

Action: Monitor for any further deterioration and replace as required

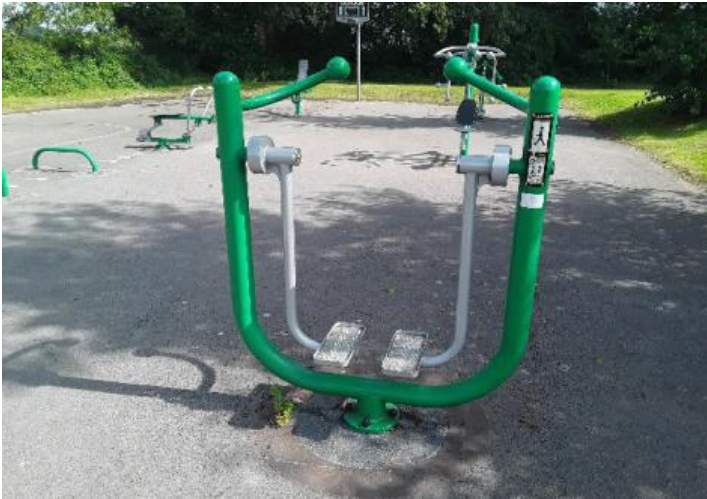
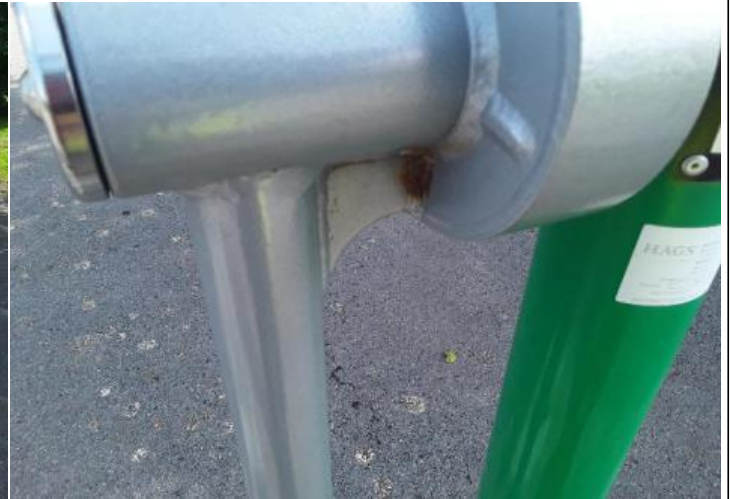
Item: Outdoor Fitness Equipment - Health Walker
Manufacturer: Hags

Finding: There is surface corrosion / rust present on the item

Action: Consider treating the item

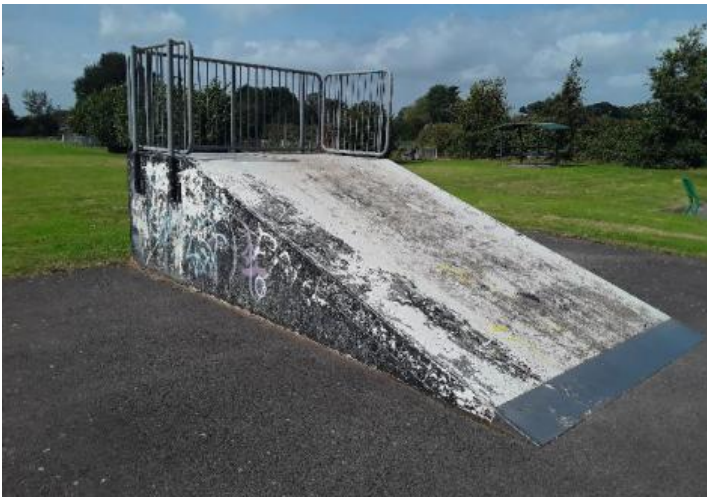
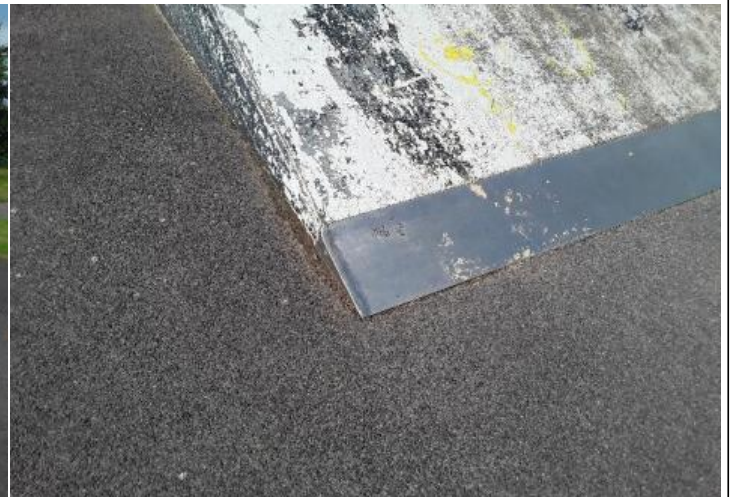
Item: Wheeled Sports - Flat Bank
Manufacturer: Not Identified

Finding: The kicker plate protrudes more than 5mm above the surrounding surface level, BS EN 14974 - 6.1.4 recommends a maximum of 5mm

Action: Adjust height to ensure a maximum of 5mm change in level

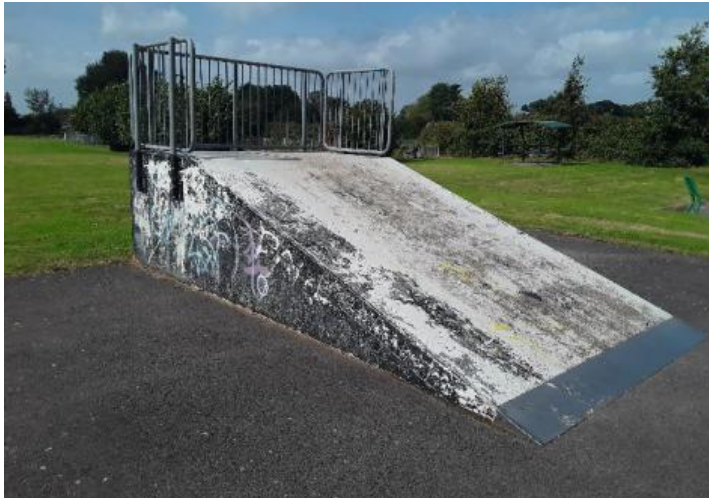
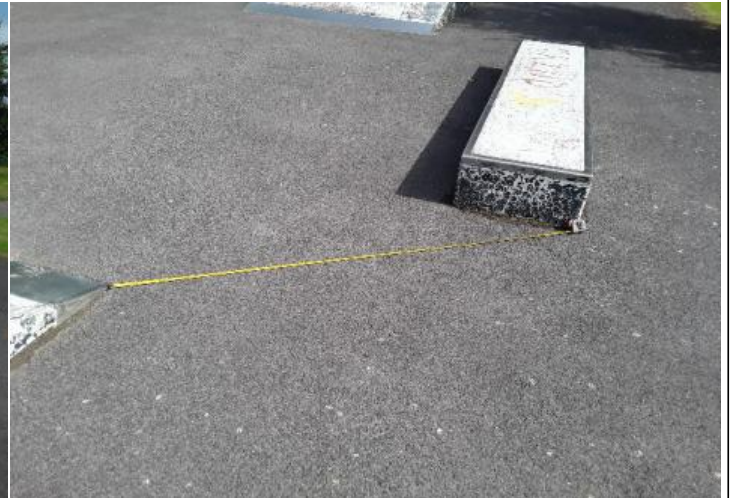
Item: Wheeled Sports - Flat Bank
Manufacturer: Not Identified

Finding: The item has insufficient safety zone allowed as required by BS EN 14974. This should consist of a bound uniform material and extend at least 2.0 metres on most items (1.50m for ledges, curbs and rails installed adjacent to each other)

Action: Monitor - No remedial work recommended
