Annual Inspection

Mudford Parish Council

Mudford Play Ground

Inspected: 26-August-2024 - 14:26 by Lyn Williams (RPII Annual Inspector)

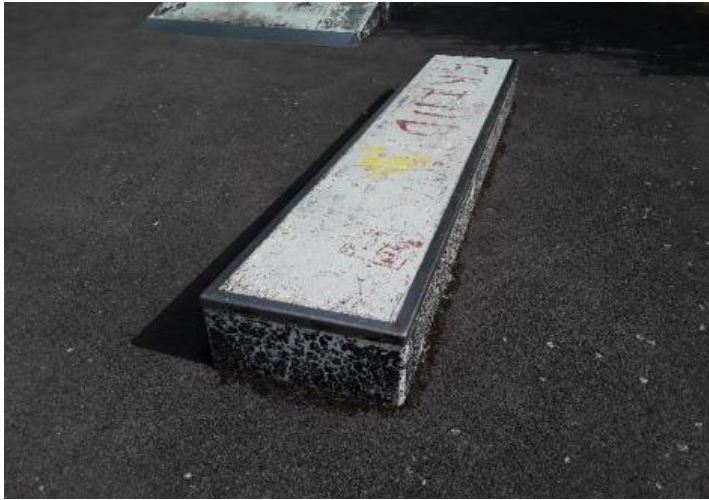
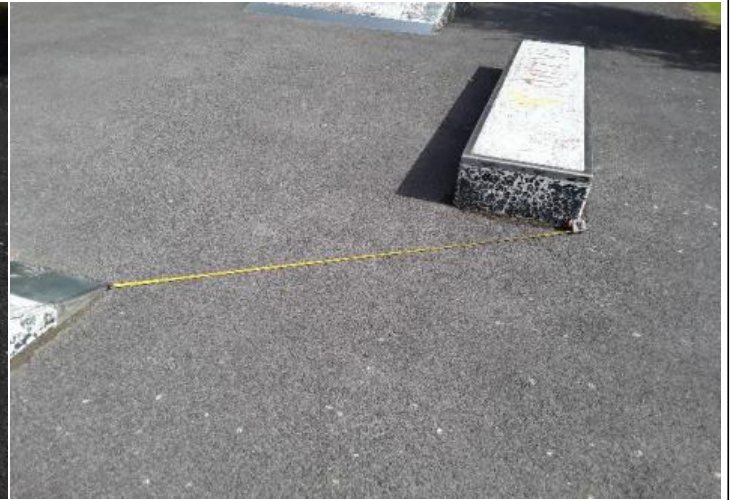
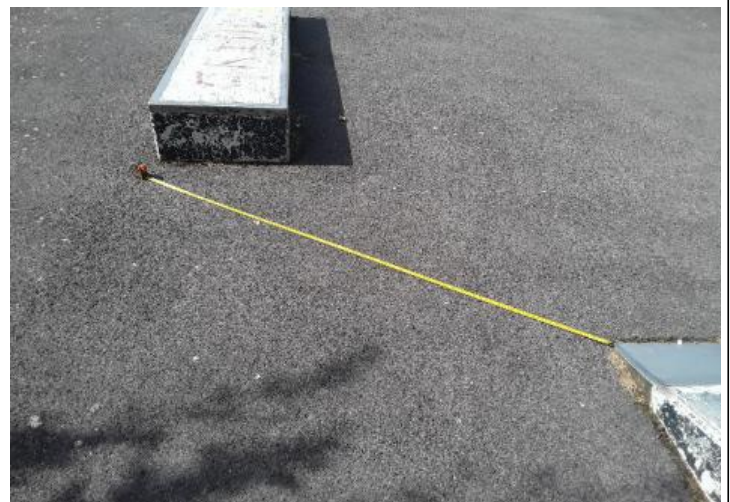
Item: Wheeled Sports - Grind Box
Manufacturer: Not Identified

Finding: The item has insufficient safety zone allowed as required by BS EN 14974. This should consist of a bound uniform material and extend at least 2.0 metres on most items (1.50m for ledges, curbs and rails installed adjacent to each other)

Action: Monitor - No remedial work recommended

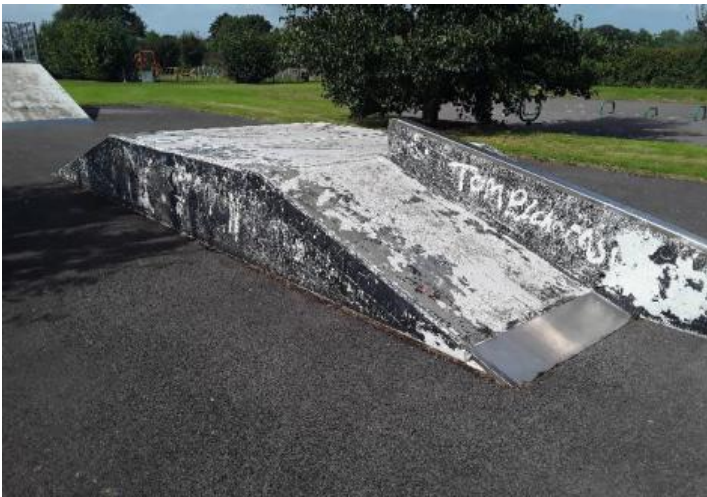
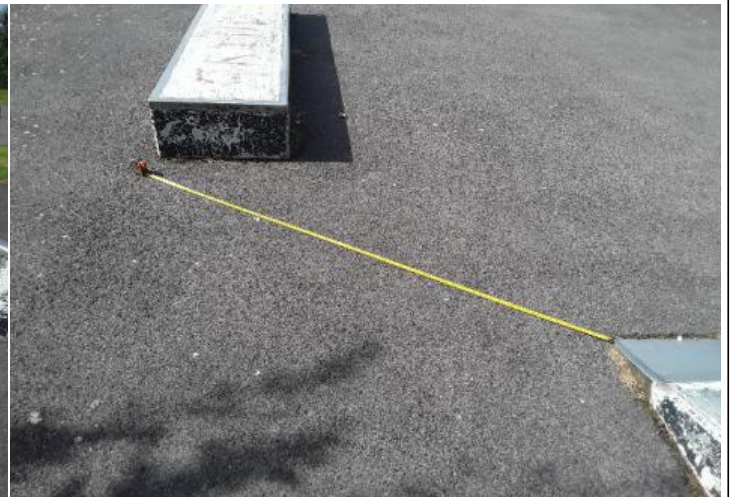
Item: Wheeled Sports - Fun Box
Manufacturer: Not Identified

Finding: The item has insufficient safety zone allowed as required by BS EN 14974. This should consist of a bound uniform material and extend at least 2.0 metres on most items (1.50m for ledges, curbs and rails installed adjacent to each other)

Action: Monitor - No remedial work recommended

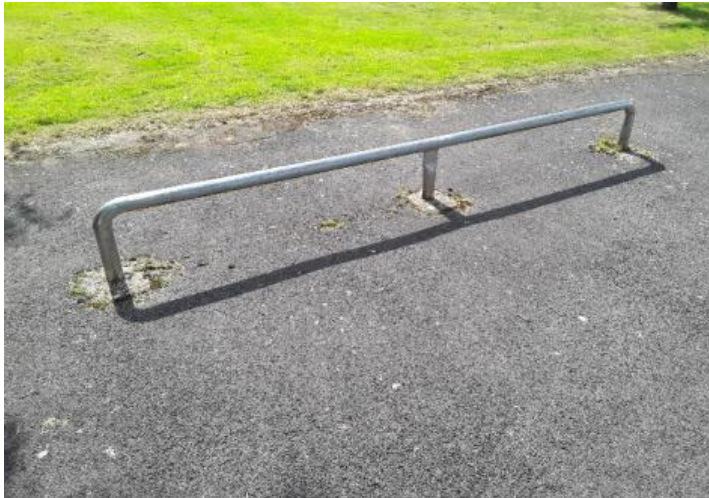
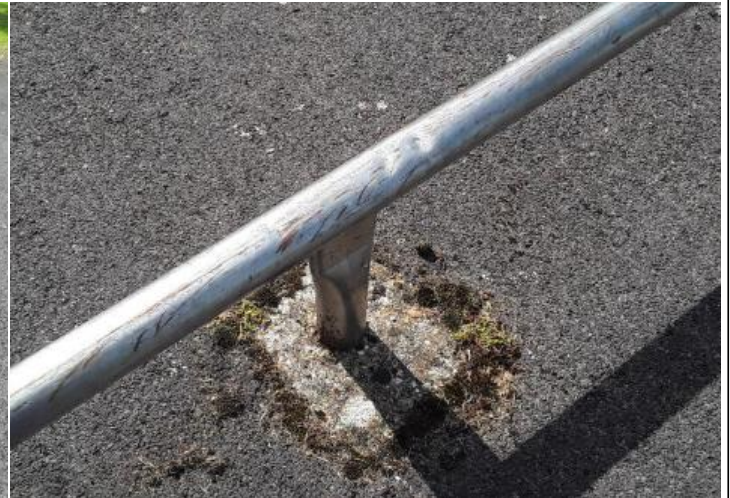
Item: Wheeled Sports - Grind Rail
Manufacturer: Not Identified

Finding: There is minor damage to the grind rail

Action: Monitor and repair if required

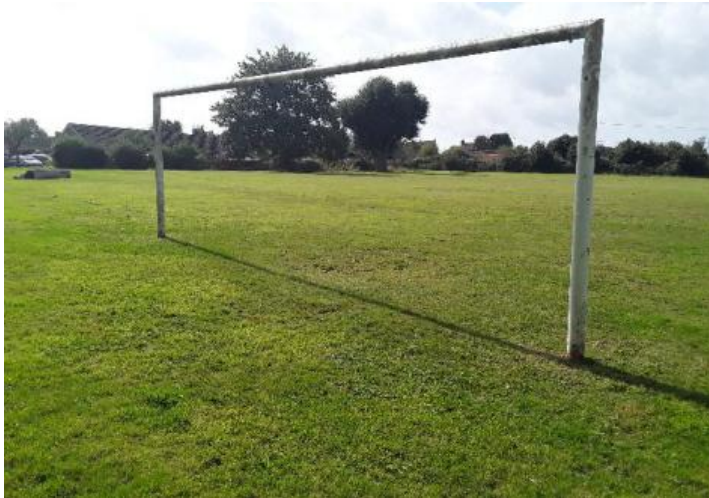
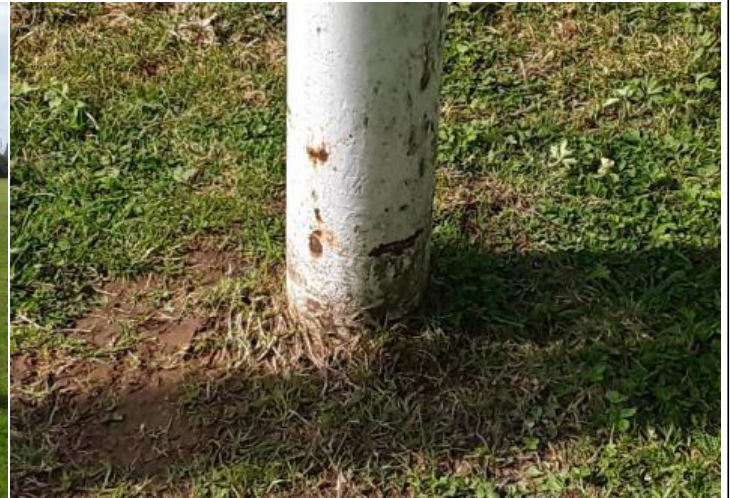
Item: Multi Use Games Area - Football Goal
Manufacturer: Not Identified

Finding: There is surface corrosion / rust present on the item

Action: Consider treating the item
