the **play inspection** company

Annual Inspection

Mudford Parish Council

Mudford Play Ground

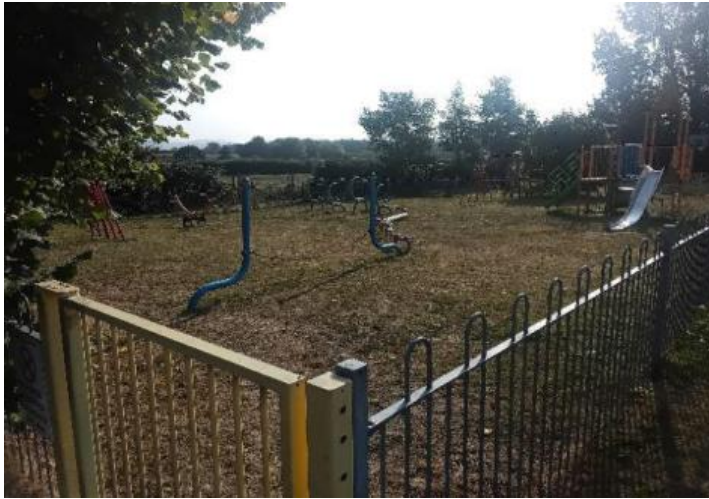
Item: Ancillary Items - Site General
Manufacturer: Owner/Operator

Signage of the wheeled sports area should be provided as recommended in BS EN 14974; this will include, but not exclusively, the use of the area, a recommendation to wear protective equipment, emergency contact details etc - Provide signage as recommended by BS EN 14974 for wheeled sports areas

Finding: Signage of the wheeled sports area should be provided as recommended in BS EN 14974; this will include, but not exclusively, the use of the area, a recommendation to wear protective equipment, emergency contact details etc

Action: Provide signage as recommended by BS EN 14974 for wheeled sports areas

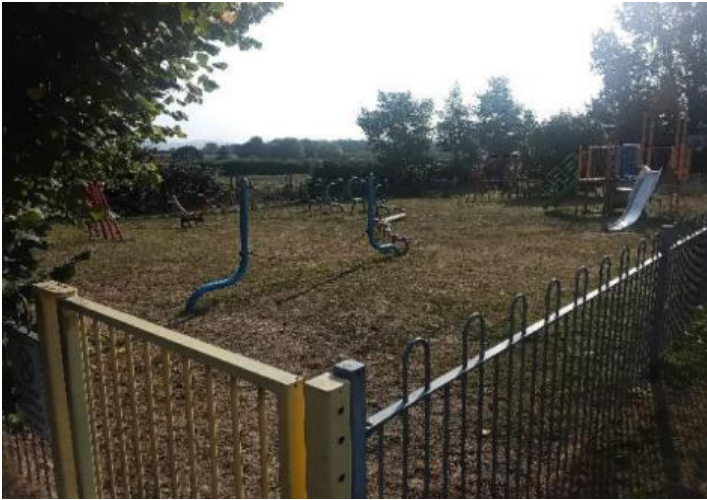
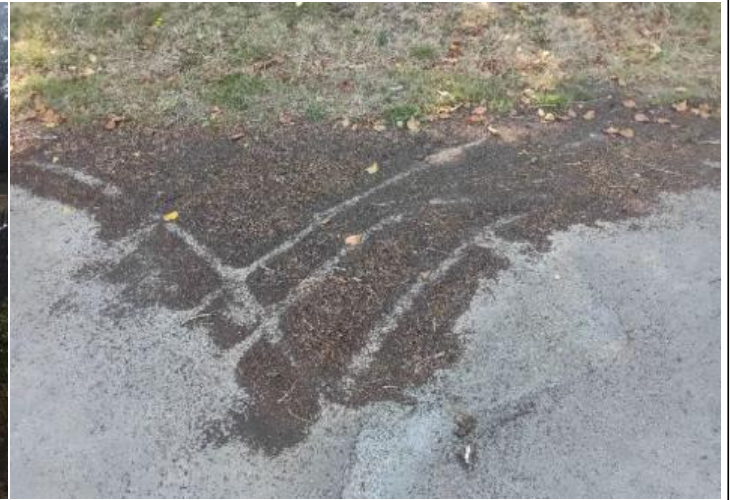
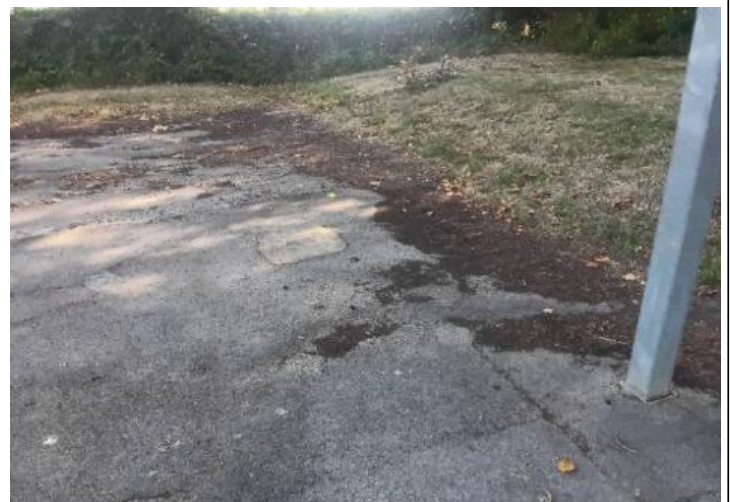
Item: Ancillary Items - Site General
Manufacturer: Owner/Operator

There is algae, silt or moss growth on the surface resulting in slippery conditions - Clean and treat appropriately

Finding: There is algae, silt or moss growth on the surface resulting in slippery conditions

Action: Clean and treat appropriately

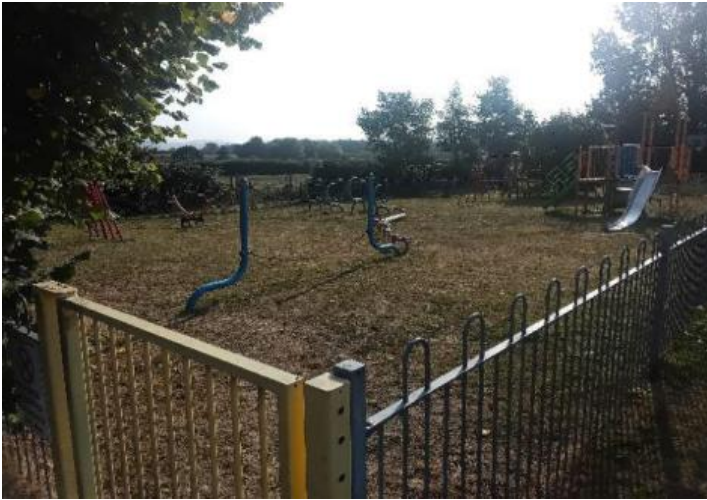
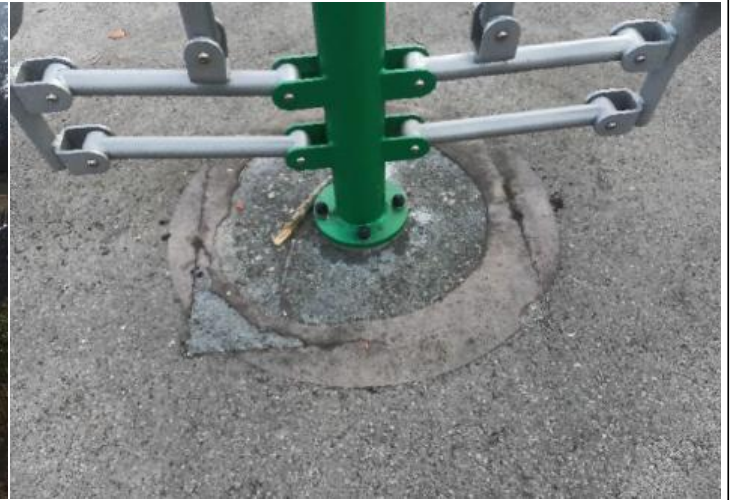
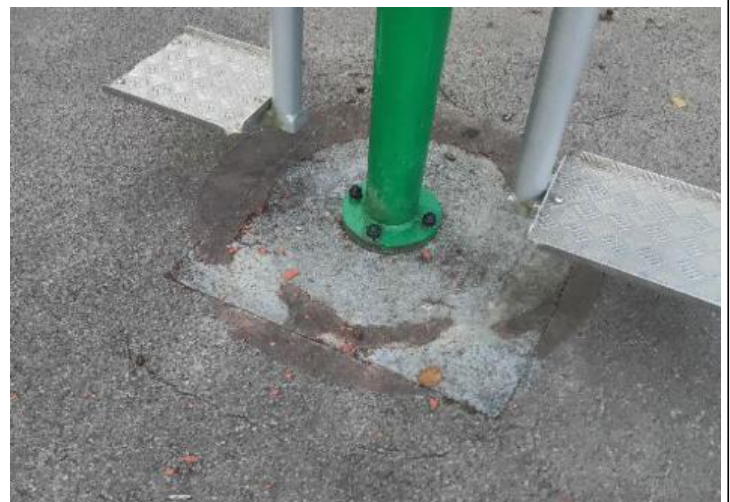
Item: Ancillary Items - Site General
Manufacturer: Owner/Operator

The graphics around the fitness equipment is breaking up - Remove the loose material and consider re painting the graphics

Finding: The graphics around the fitness equipment is breaking up

Action: Remove the loose material and consider re painting the graphics

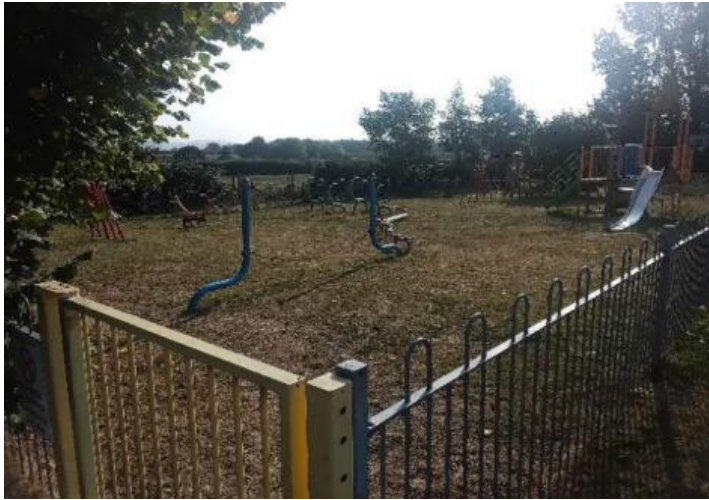
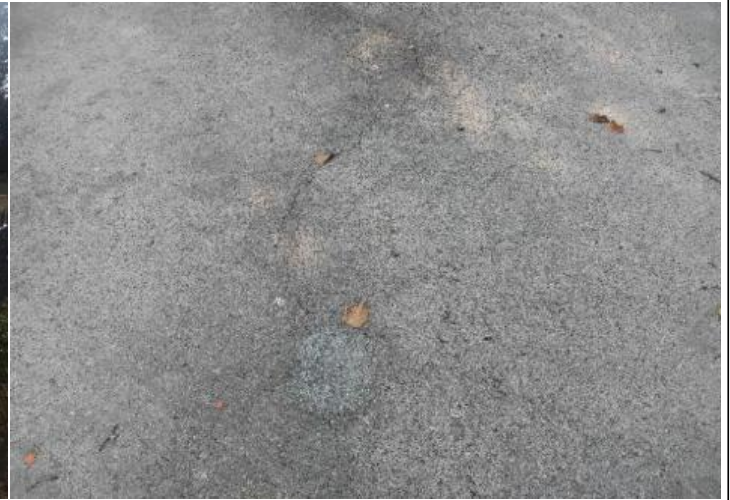
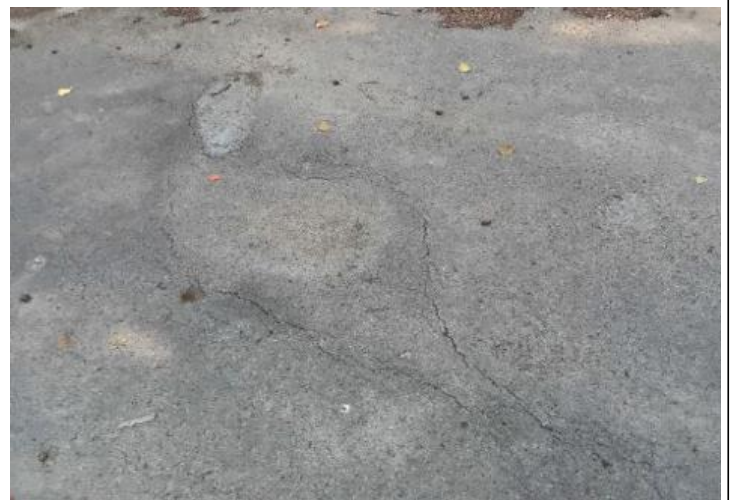
Item: Ancillary Items - Site General
Manufacturer: Owner/Operator

The bitumen surface is worn or damaged - Monitor for any further deterioration and repair as required

Finding: The bitumen surface is worn or damaged

Action: Monitor for any further deterioration and repair as required

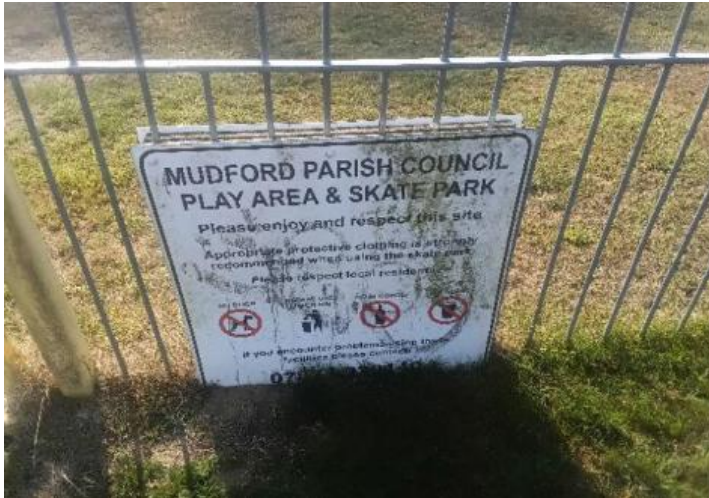
Item: Ancillary Items - Sign
Manufacturer: Not Identified

BS EN 1176 Part 7 recommends that signage shall include the site name / address - Provide additional information

Finding: BS EN 1176 Part 7 recommends that signage shall include the site name / address
Action: Provide additional information

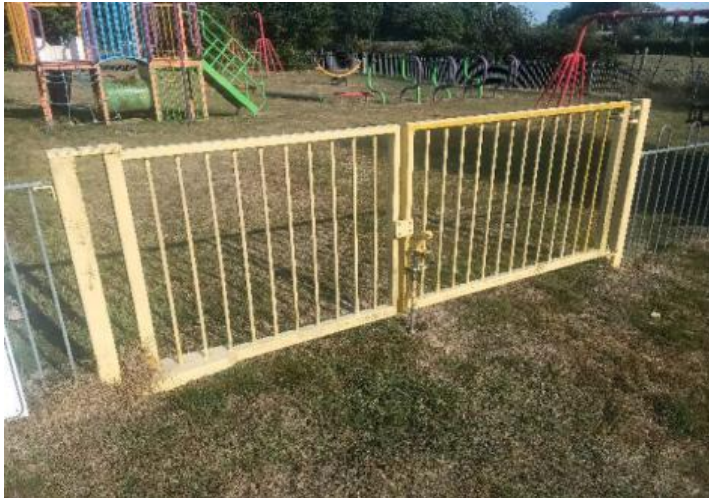
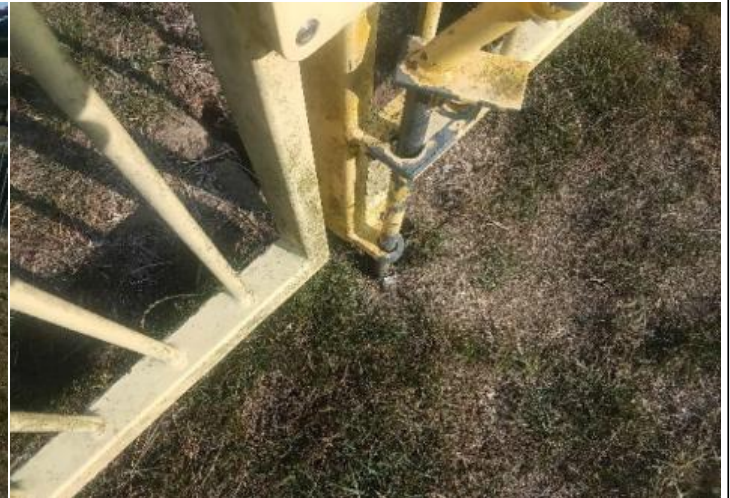
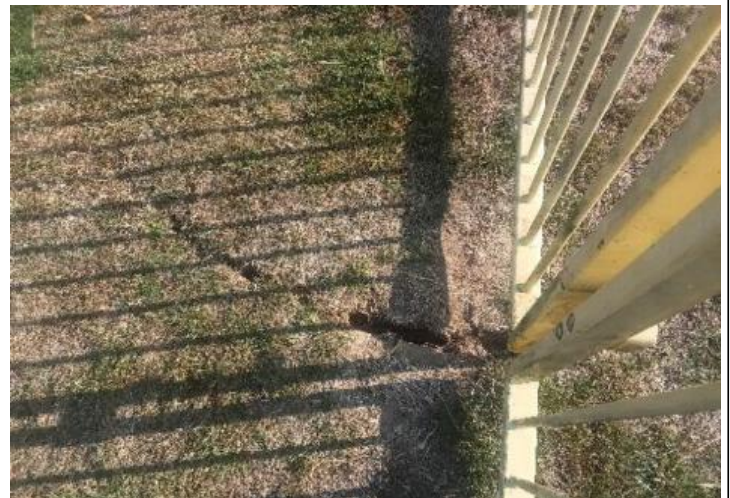
Item: Gates - Gate - Combination
Manufacturer: I.A.E. Fencing

The gate has no drop bolt sleeves fitted and the drop bolt has damaged the surface - Provide drop bolt sleeves and reinstate the surrounding surface

Finding: The gate has no drop bolt sleeves fitted and the drop bolt has damaged the surface

Action: Provide drop bolt sleeves and reinstate the surrounding surface

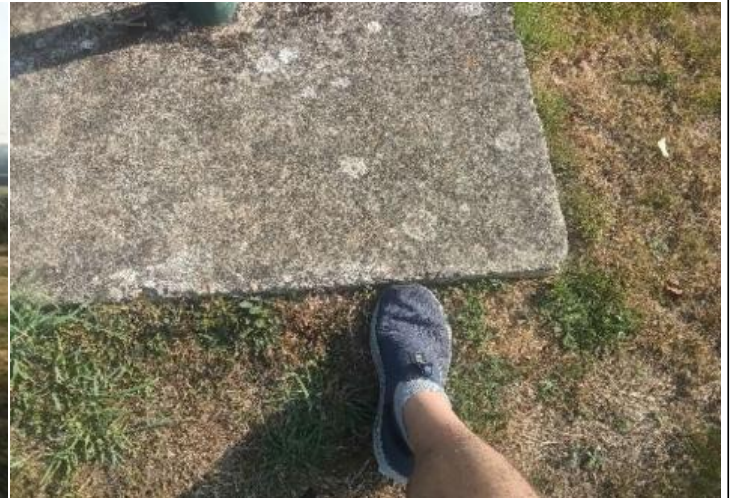
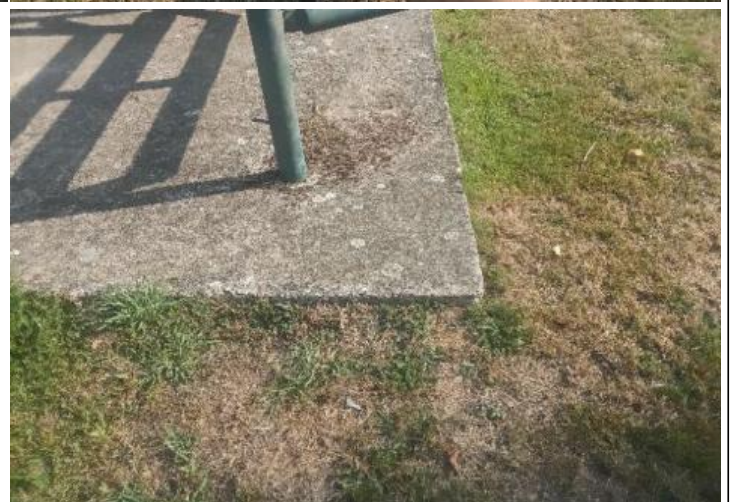
Item: Ancillary Items - Teenage Shelter
Manufacturer: Not Identified

There are trip hazards at the edges of the surface - Remove trip hazard

Finding: There are trip hazards at the edges of the surface **Action:** Remove trip hazard

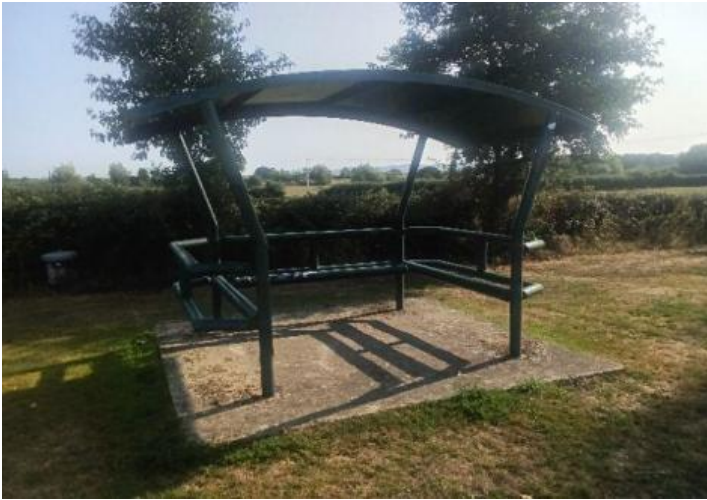
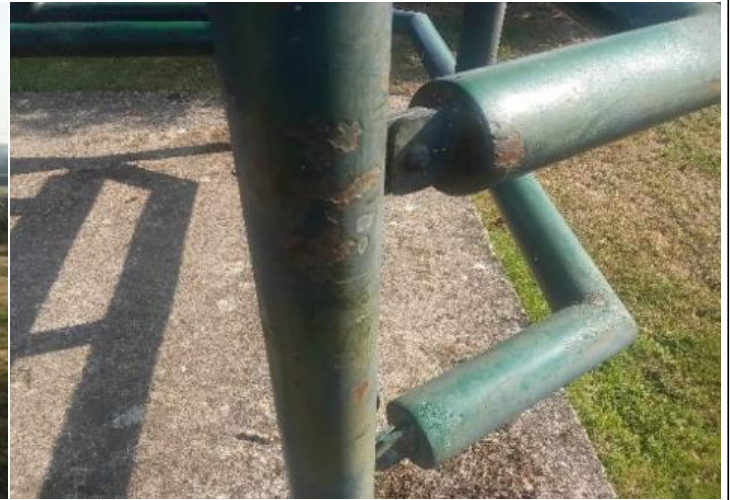
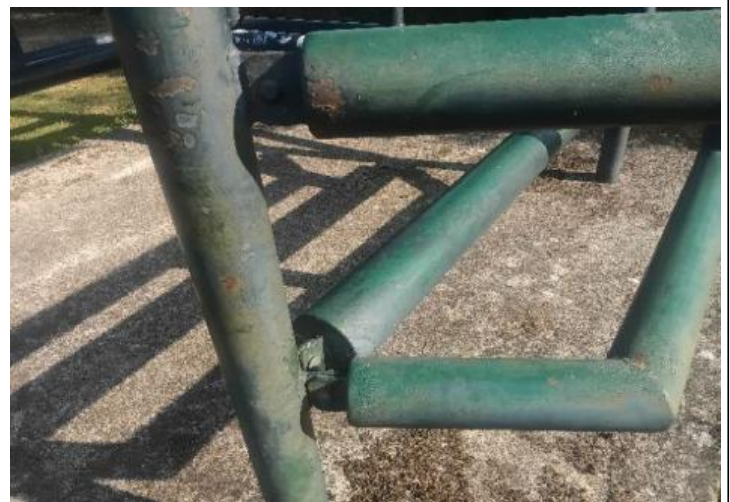
Item: Ancillary Items - Teenage Shelter
Manufacturer: Not Identified

Finding: The paintwork on this item has been damaged or worn exposing the metal underneath which is rusting / corroding

Action: Treat affected areas and repaint

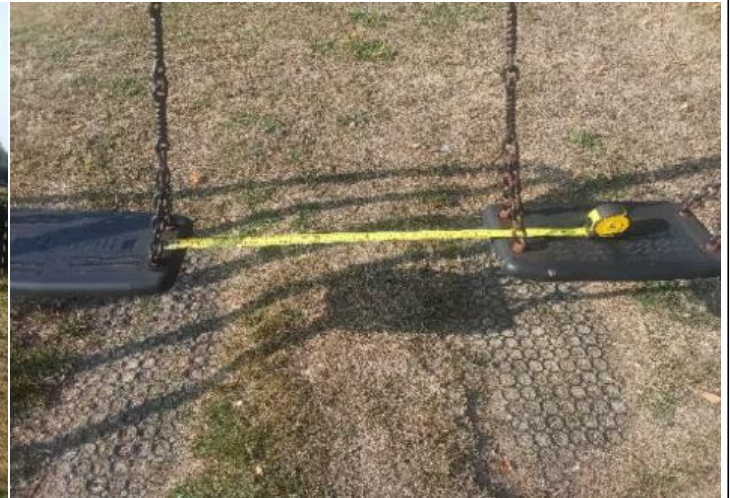
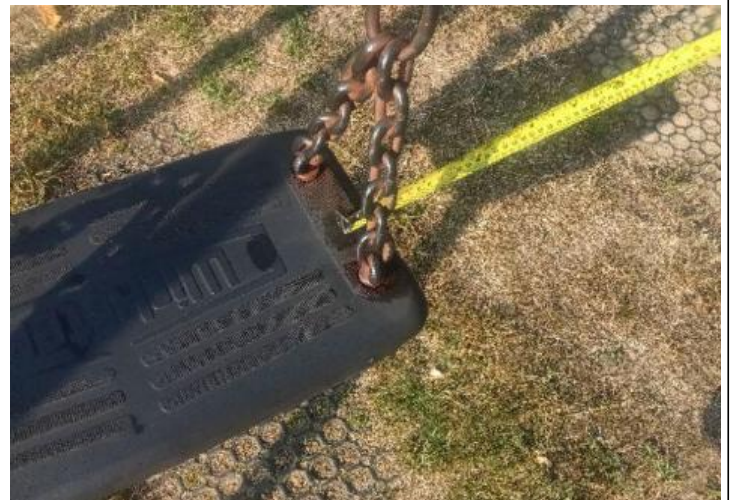
Item: Swings - 1 Bay 2 Seat (Flat)
Manufacturer: Wicksteed Playgrounds

The seats are too close to each other as defined in BS EN 1176 Part 2; this is a low risk failure and no remedial action is required - Monitor - No action given the risk assessment

Finding: The seats are too close to each other as defined in BS EN 1176 Part 2; this is a low risk failure and no remedial action is required
Action: Monitor - No action given the risk assessment

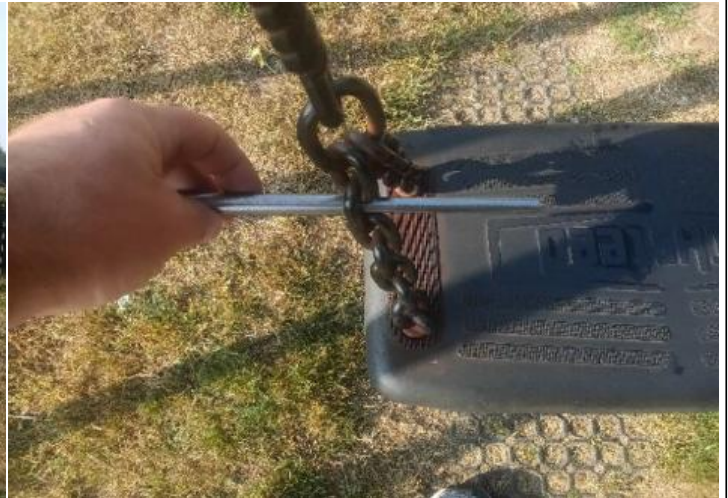
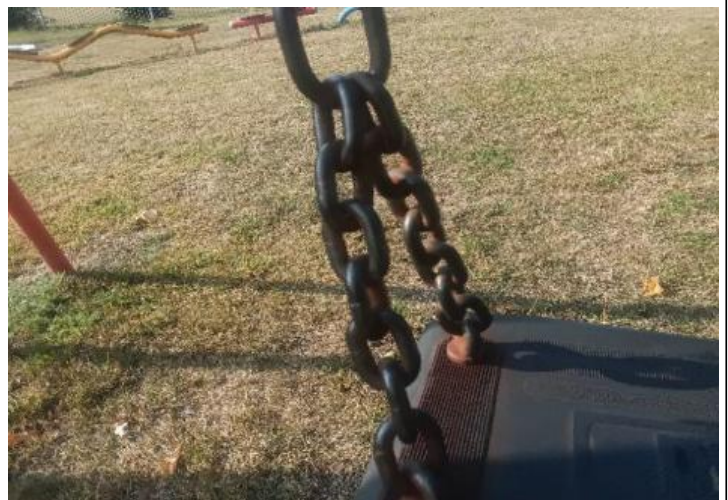
Item: Swings - 1 Bay 2 Seat (Flat)
Manufacturer: Wicksteed Playgrounds

Finding: The chain openings are in excess of the 8.6mm as recommended by BS EN 1176 **Action:** Monitor - No action given the risk assessment

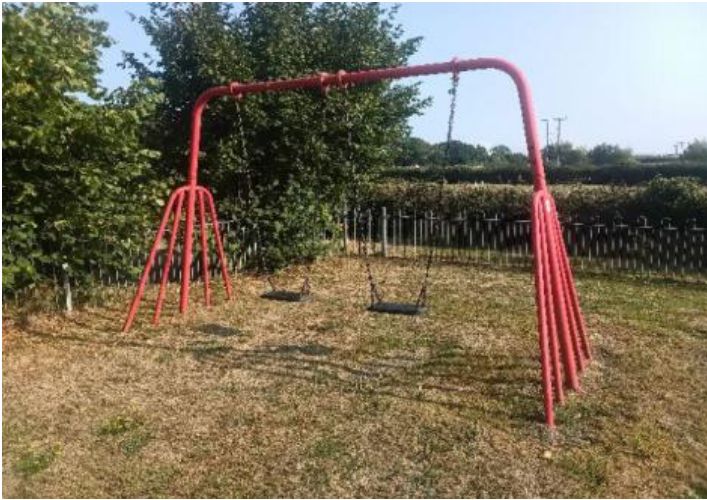
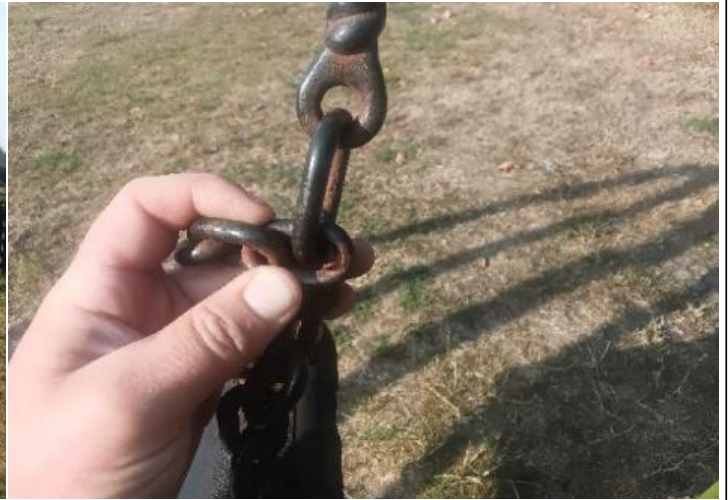
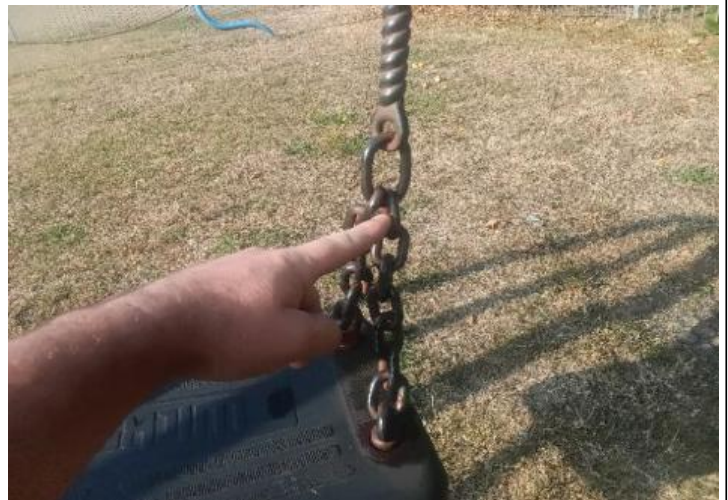
Item: Swings - 1 Bay 2 Seat (Flat)
Manufacturer: Wicksteed Playgrounds

The chain links are worn excessively and require renewing - Replace worn chains

Finding: The chain links are worn excessively and require renewing

Action: Replace worn chains

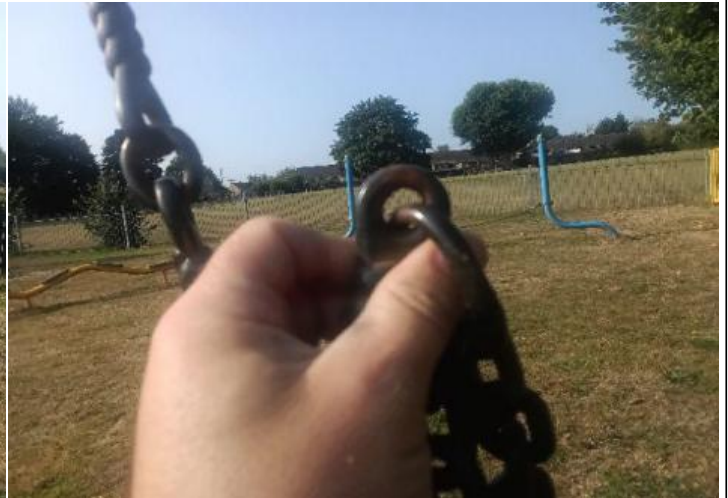
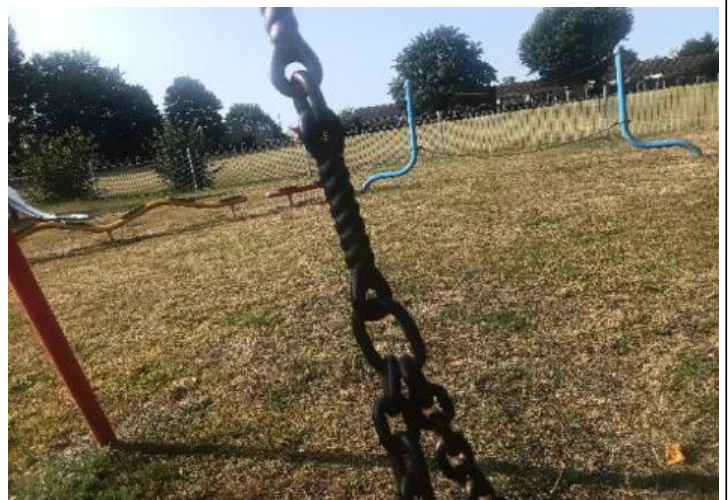
Item: Swings - 1 Bay 2 Seat (Flat)
Manufacturer: Wicksteed Playgrounds

The connecting lugs are showing signs of wear - Monitor for any further deterioration and repair as required

Finding: The connecting lugs are showing signs of wear

Action: Monitor for any further deterioration and repair as required

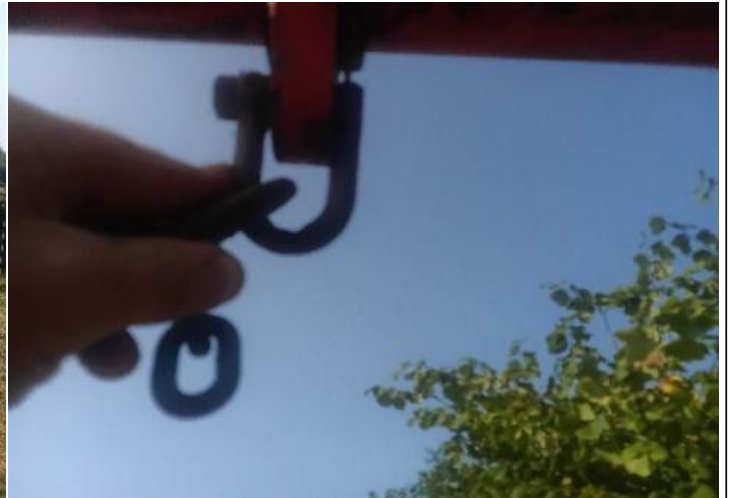
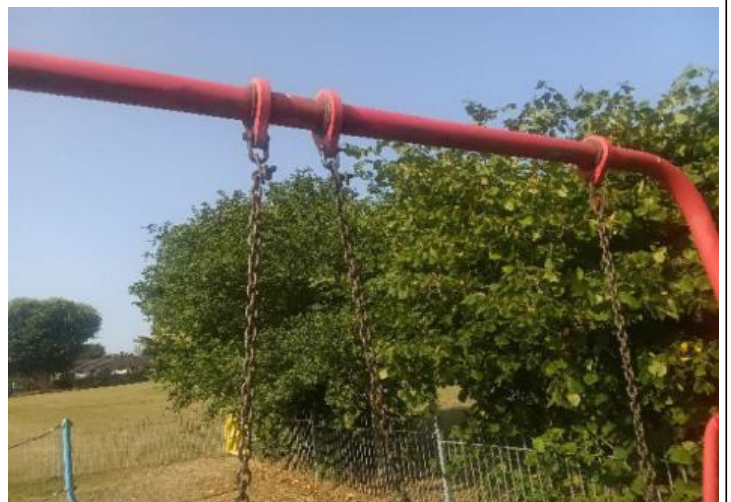
Item: Swings - 1 Bay 2 Seat (Flat)
Manufacturer: Wicksteed Playgrounds

Finding: There is some wear to the shackles.

Action: Monitor for any further deterioration and replace when 40% worn

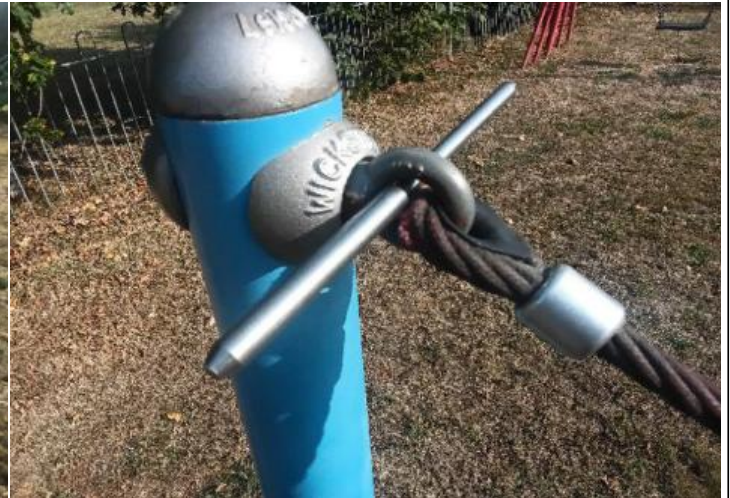
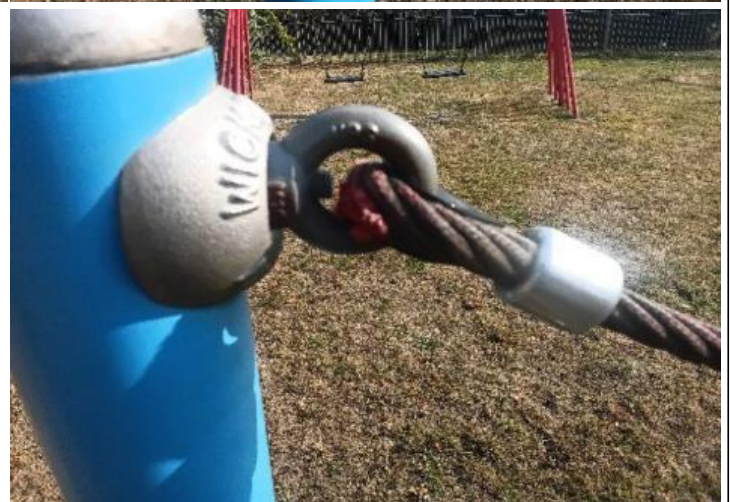
Item: Activity Equipment - Activity Trail
Manufacturer: Wicksteed Playgrounds

The connecting links are in excess of 8.6mm and less than 12mm and fail the requirements of BS EN 1176 Part 1; clause 4.2.13, Chains - Monitor - No action given the risk assessment

Finding: The connecting links are in excess of 8.6mm and less than 12mm and fail the requirements of BS EN 1176 Part 1; clause 4.2.13, Chains

Action: Monitor - No action given the risk assessment

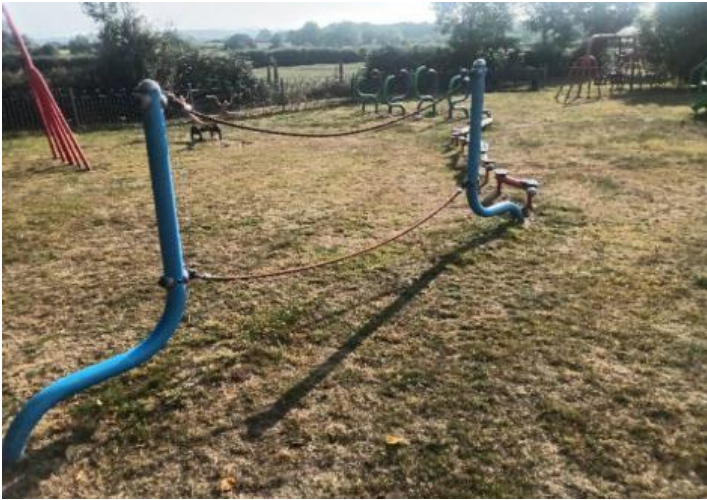
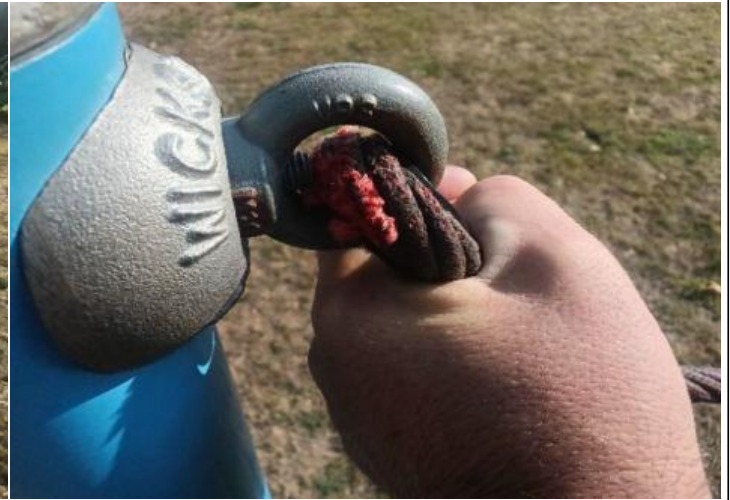
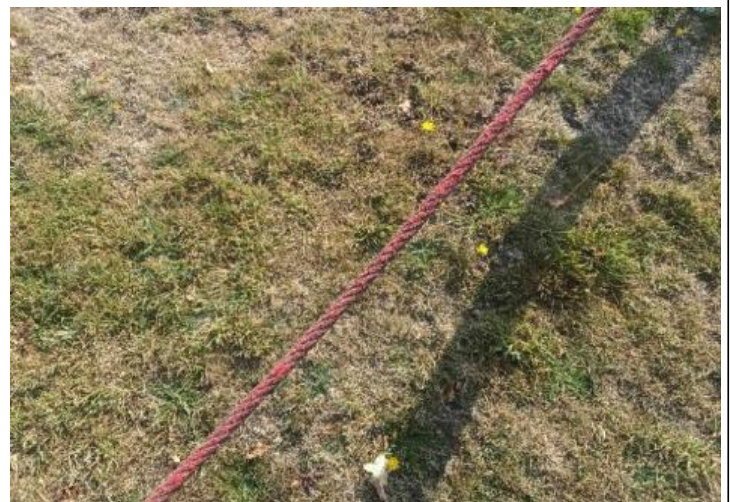
Item: Activity Equipment - Activity Trail
Manufacturer: Wicksteed Playgrounds

Finding: The ropes/nets are worn/damaged in places

Action: Monitor for any further deterioration and repair or replace as required

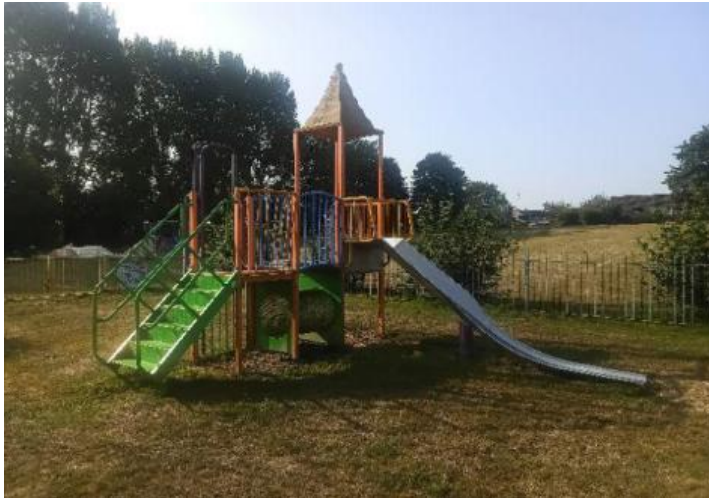
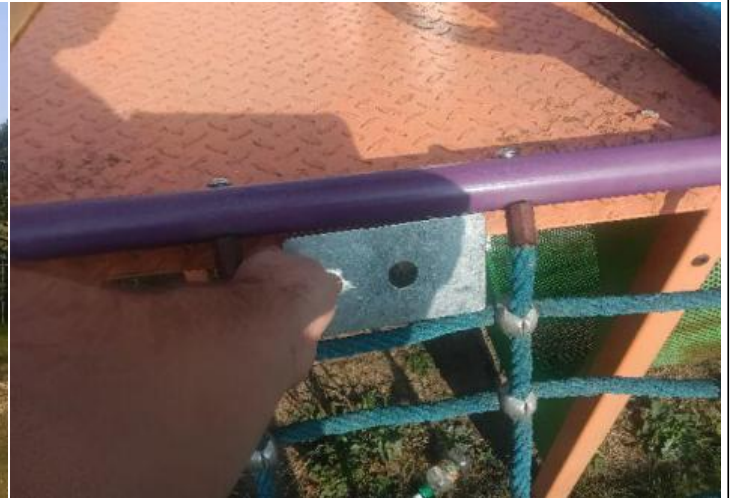
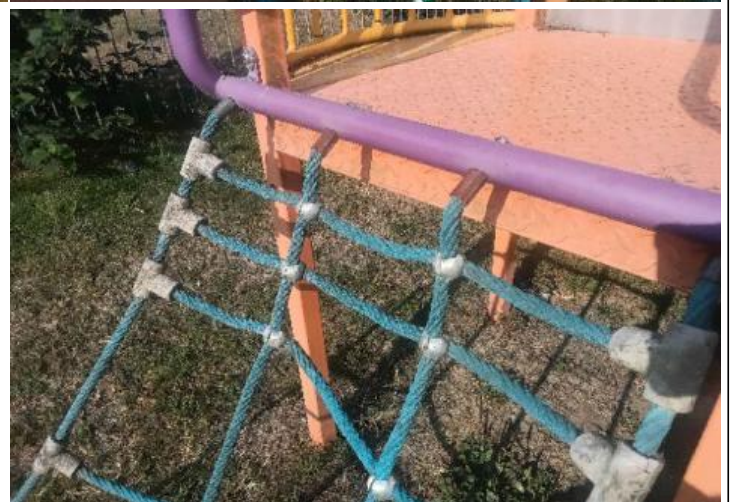
Item: Activity Equipment - Multi Play (Junior)
Manufacturer: Wicksteed Playgrounds

The item fails to meet the requirements of BS EN 1176 Part 1 4.2.7.2 for head and neck entrapment in the rope - Monitor - No action given the risk assessment

Finding: The item fails to meet the requirements of BS EN 1176 Part 1 4.2.7.2 for head and neck entrapment in the rope

Action: Monitor - No action given the risk assessment

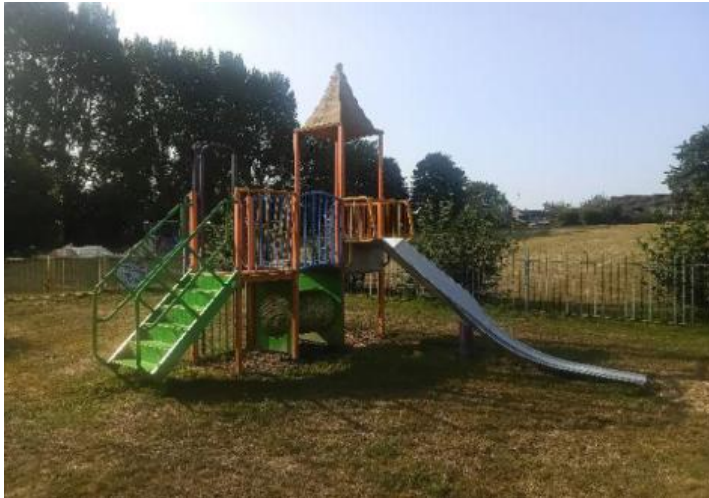
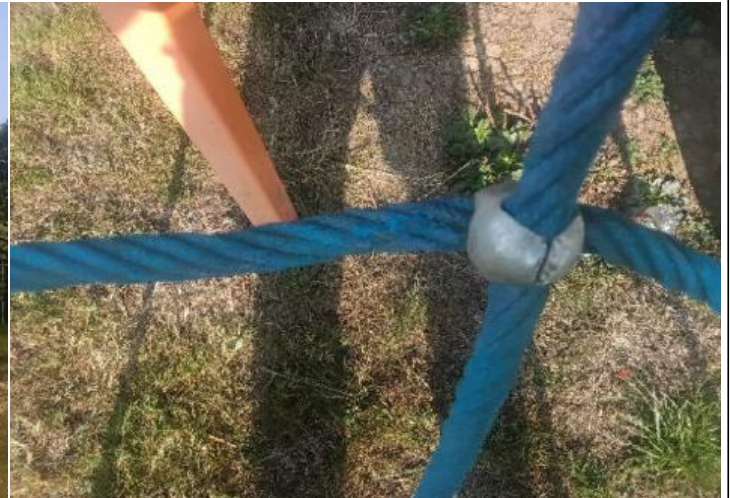
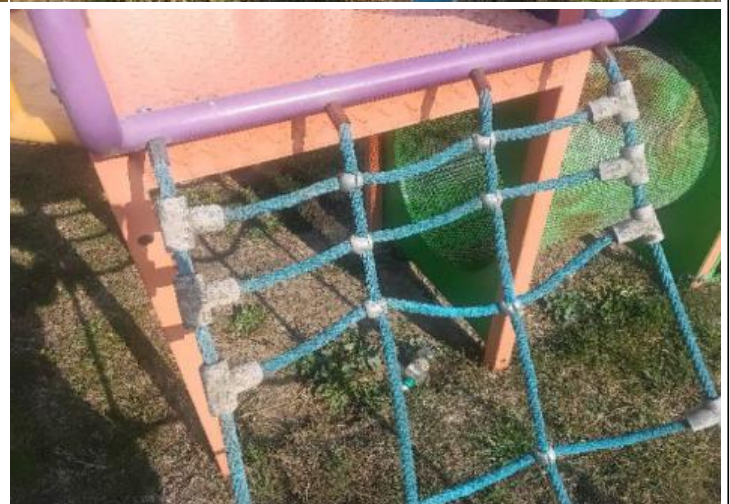
Item: Activity Equipment - Multi Play (Junior)
Manufacturer: Wicksteed Playgrounds

Finding: The ropes/nets are worn/damaged in places

Action: Monitor for any further deterioration and repair or replace as required

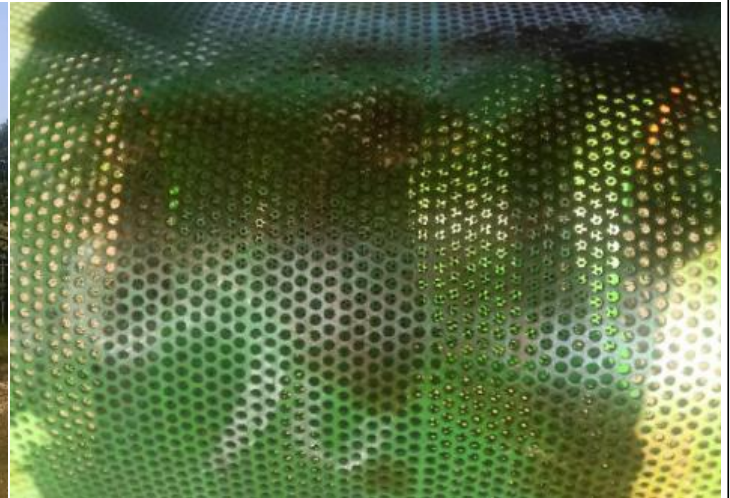
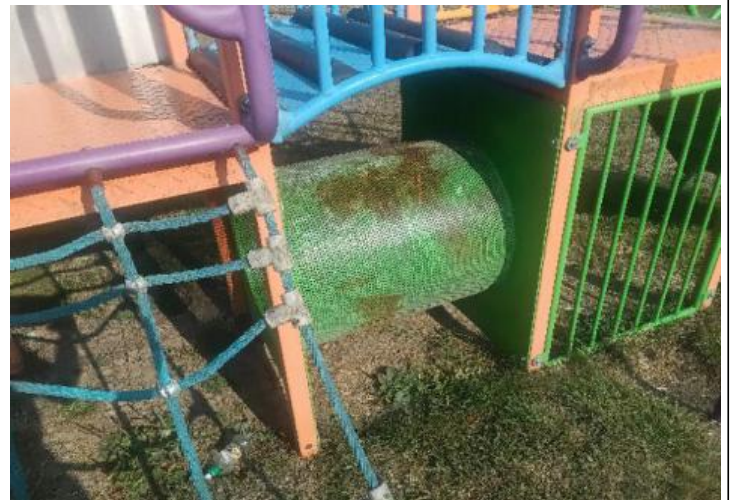
Item: Activity Equipment - Multi Play (Junior)
Manufacturer: Wicksteed Playgrounds

Finding: The paintwork on this item has been damaged or worn exposing the metal underneath which is rusting / corroding

Action: Treat affected areas and repaint

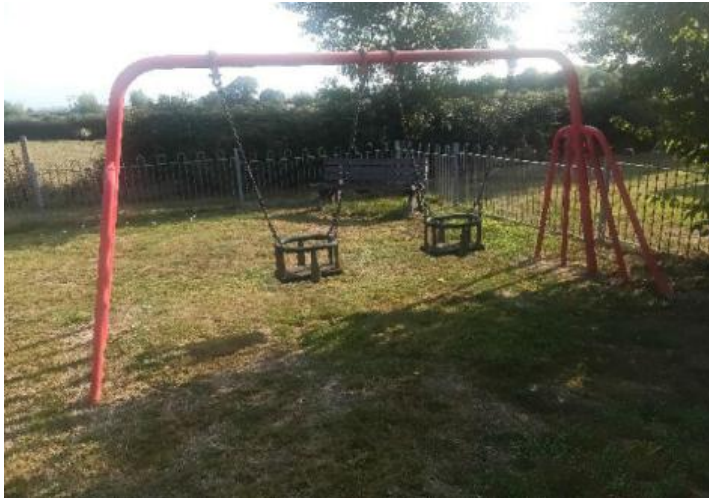
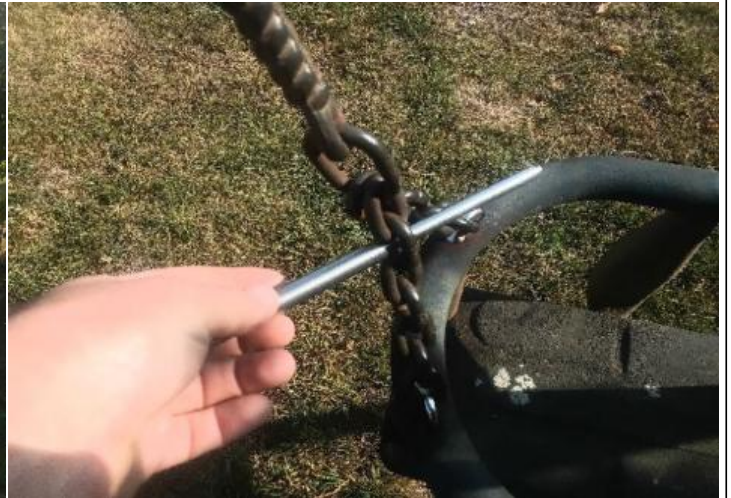
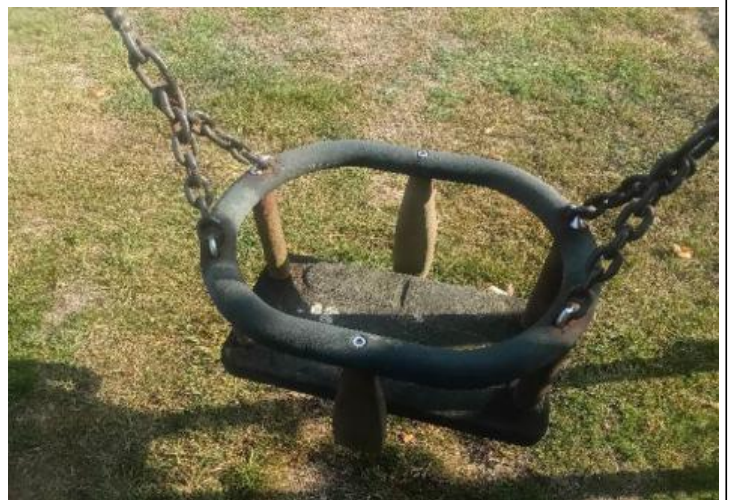
Item: Swings - 1 Bay 2 Seat (Cradle)
Manufacturer: Wicksteed Playgrounds

Finding: The chain openings are in excess of the 8.6mm as recommended by BS EN 1176 **Action:** Monitor - No action given the risk assessment

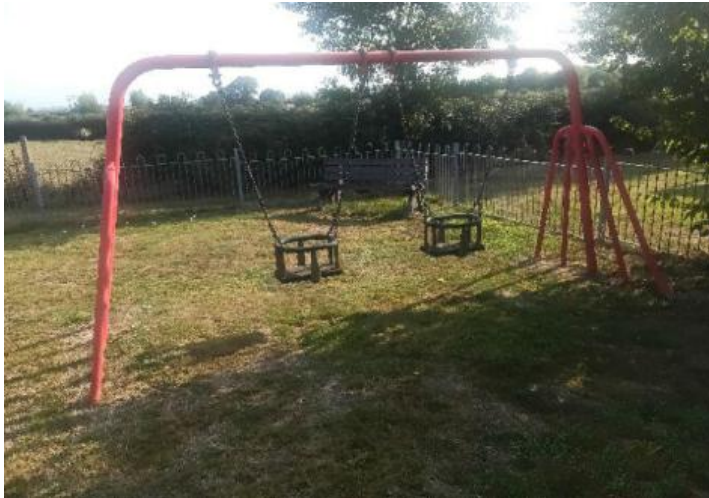
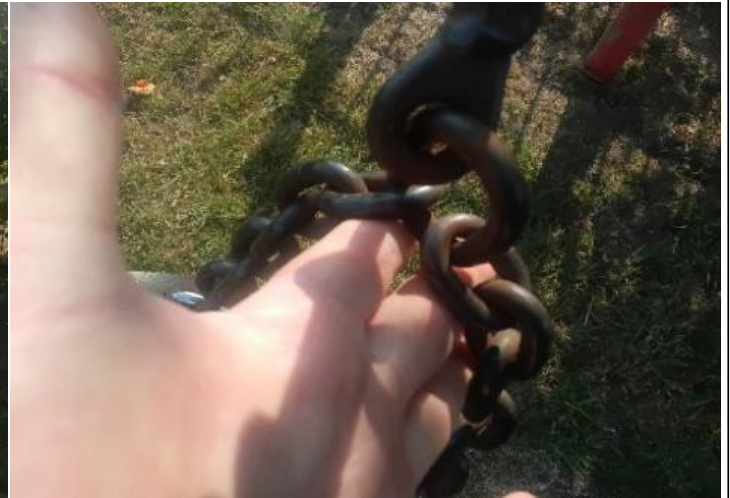
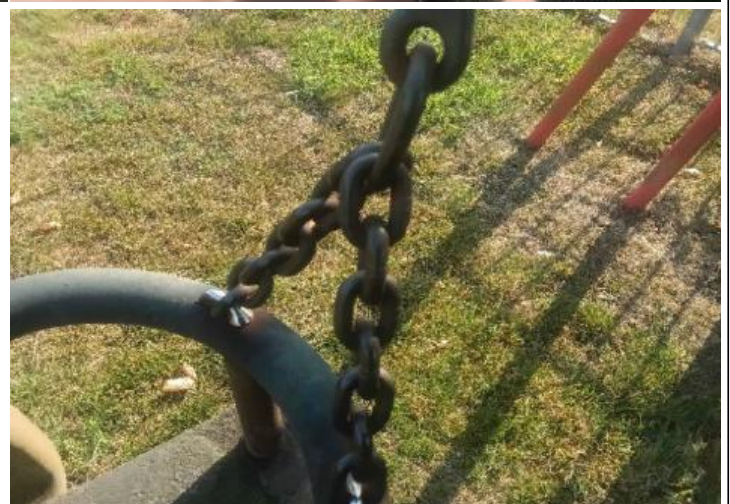
Item: Swings - 1 Bay 2 Seat (Cradle)
Manufacturer: Wicksteed Playgrounds

There is some notable evidence of chain wear - Monitor for any further deterioration and replace when 40% worn

Finding: There is some notable evidence of chain wear

Action: Monitor for any further deterioration and replace when 40% worn

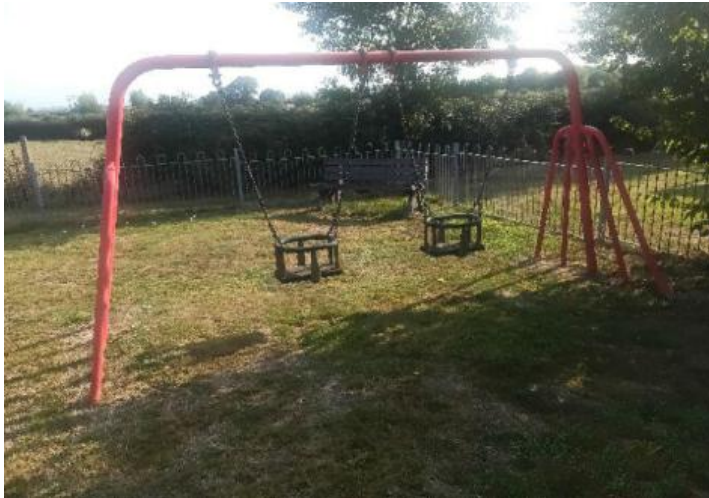
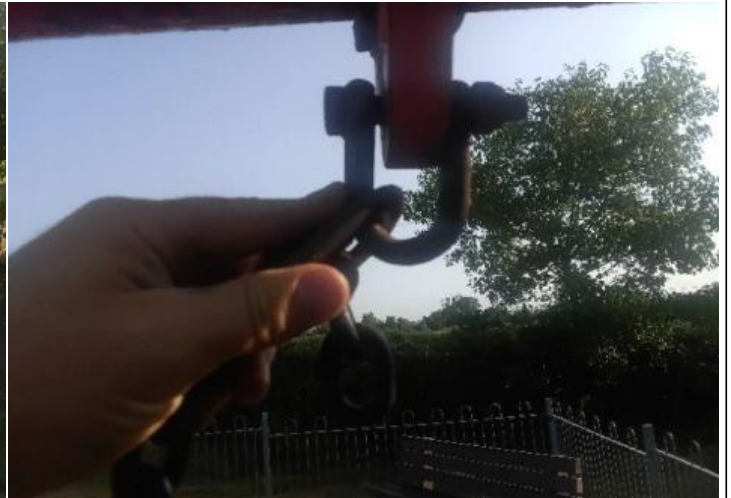
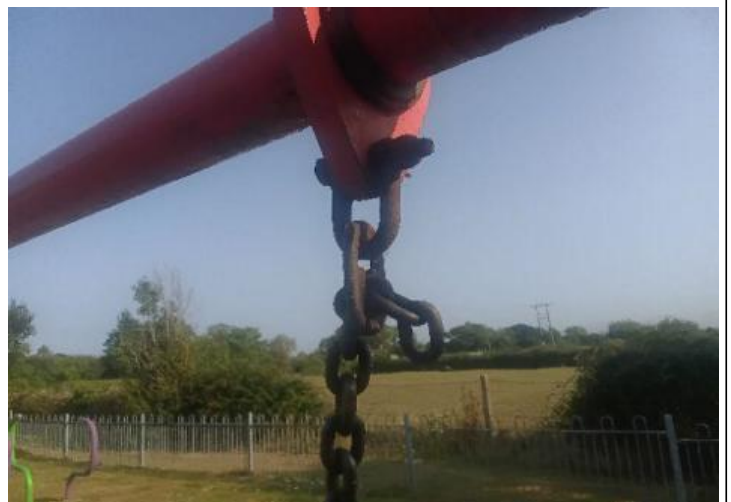
Item: Swings - 1 Bay 2 Seat (Cradle)
Manufacturer: Wicksteed Playgrounds

Finding: There is some wear to the shackles.

Action: Monitor for any further deterioration and replace when 40% worn

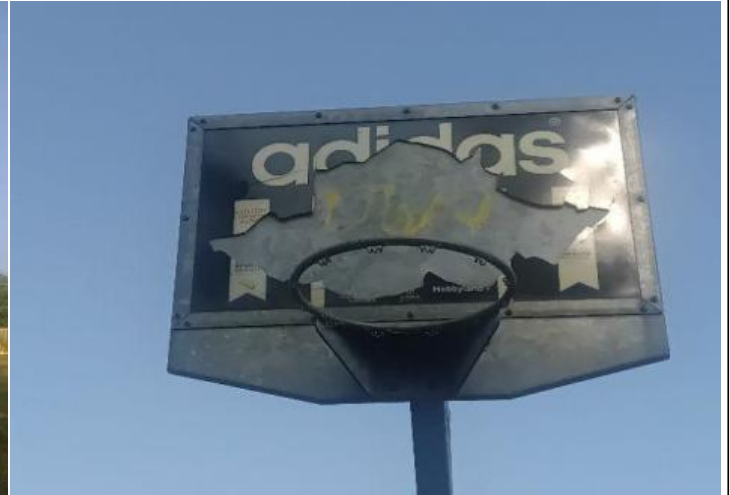
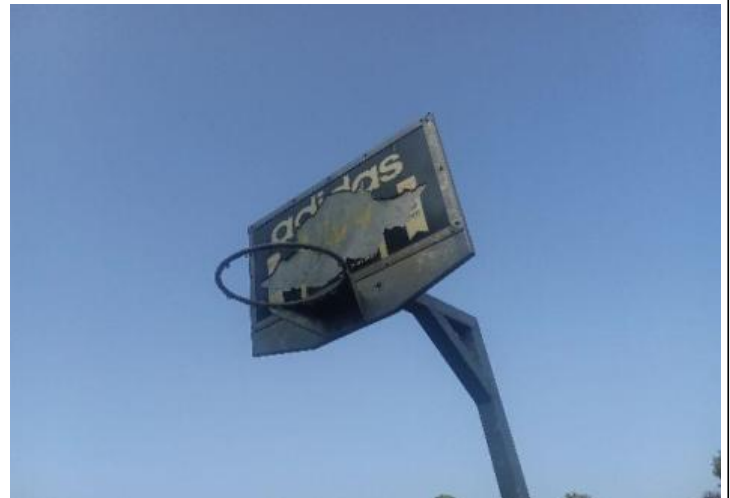
Item: Multi Use Games Area - Basketball Post
Manufacturer: Adidas

The backboard graphics card is damaged - Replace

Finding: The backboard graphics card is damaged

Action: Replace

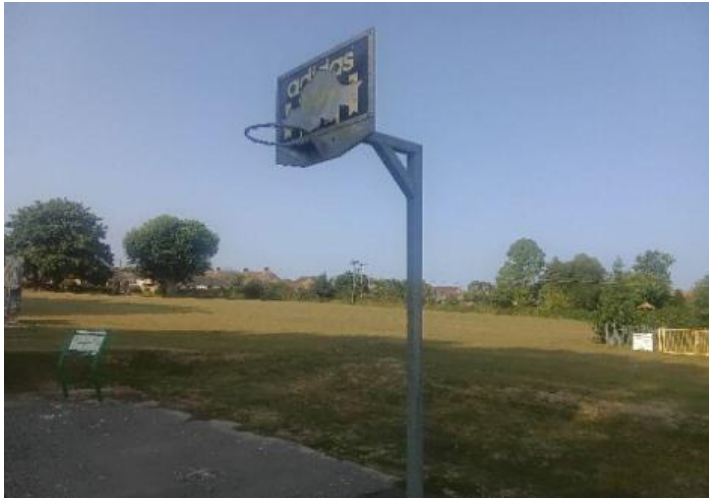
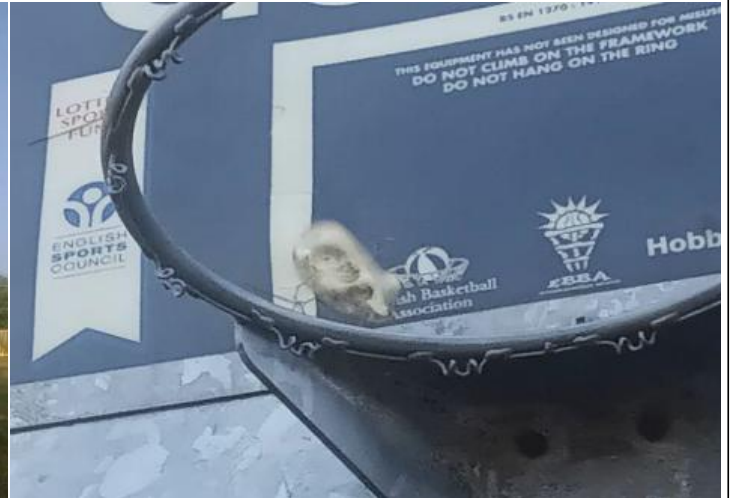
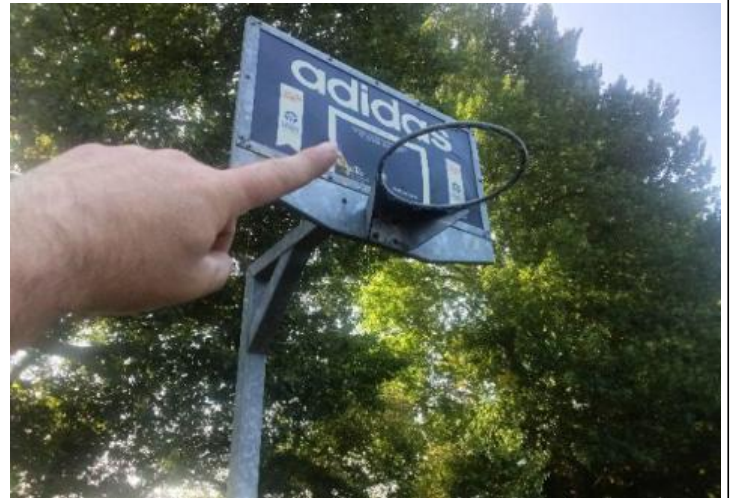
Item: Multi Use Games Area - Basketball Post
Manufacturer: Adidas

There is some evidence of fire damage to the item - Monitor for any further deterioration and repair as required

Finding: There is some evidence of fire damage to the item **Action:** Monitor for any further deterioration and repair as required
