the **play inspection** company

Annual Inspection

Mudford Parish Council

Mudford Play Ground

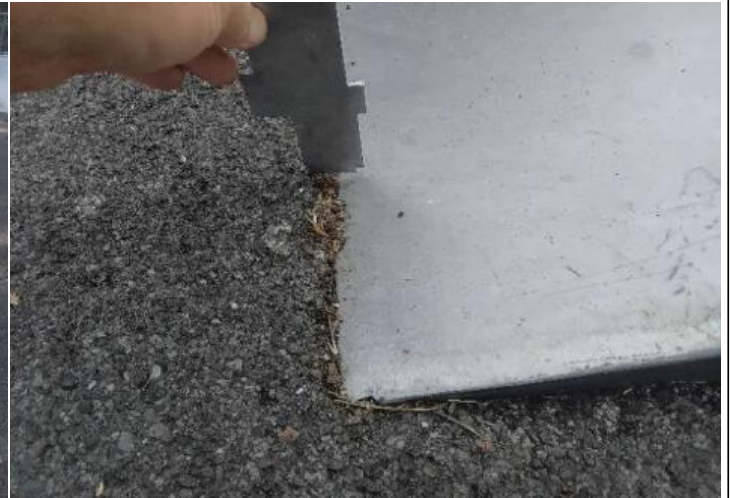
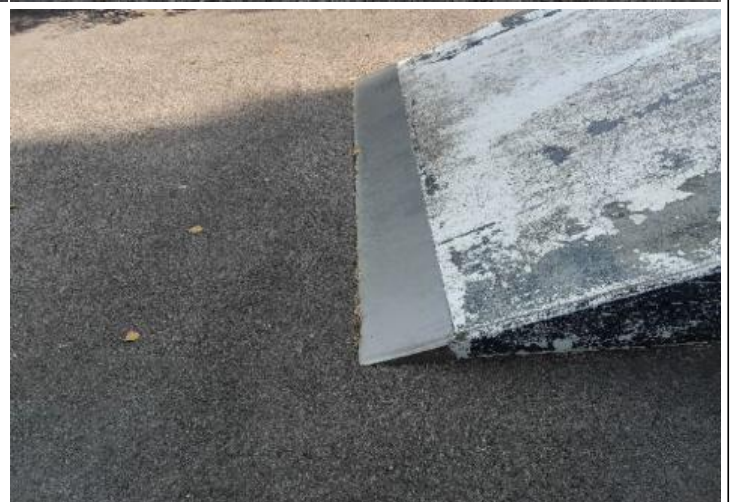
Item: Wheeled Sports - Fun Box
Manufacturer: Not Identified

Finding: The surrounding surface protrudes more than 5mm above the kicker plate level, BS EN 14974 - 6.1.4 recommends a maximum of 5mm
Action: Adjust height to ensure a maximum of 5mm change in level

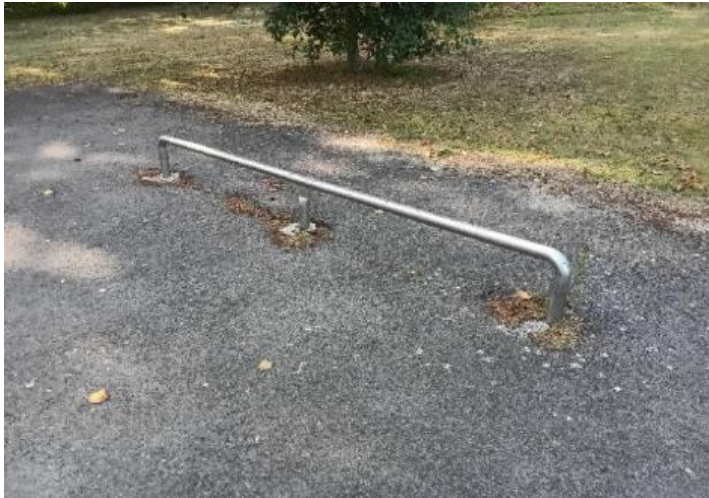
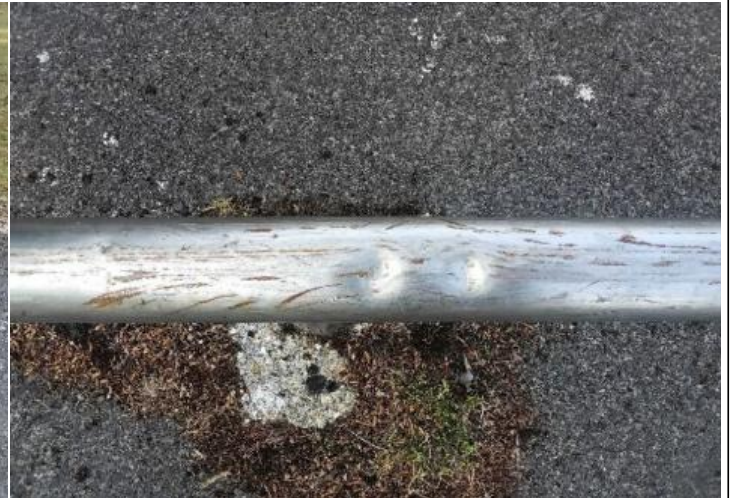
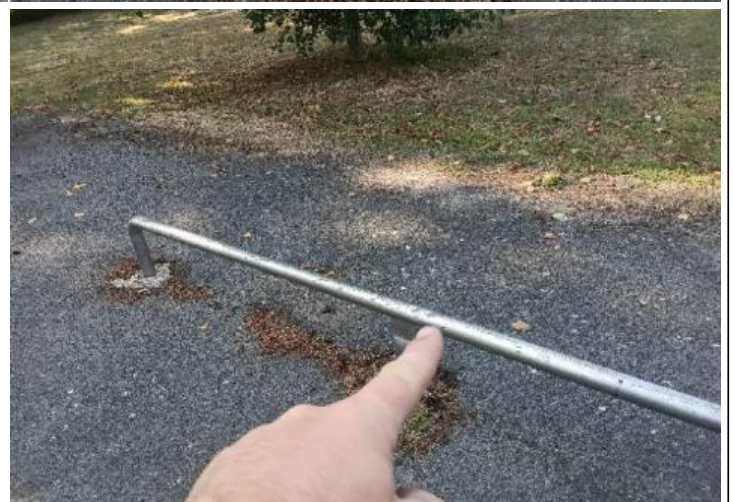
Item: Wheeled Sports - Grind Rail
Manufacturer: Not Identified

The item has been damaged - Monitor for any further deterioration and replace as required

Finding: The item has been damaged

Action: Monitor for any further deterioration and replace as required

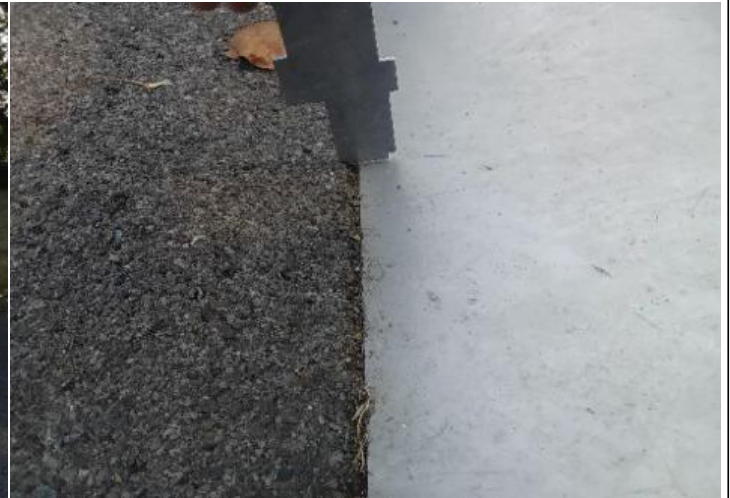
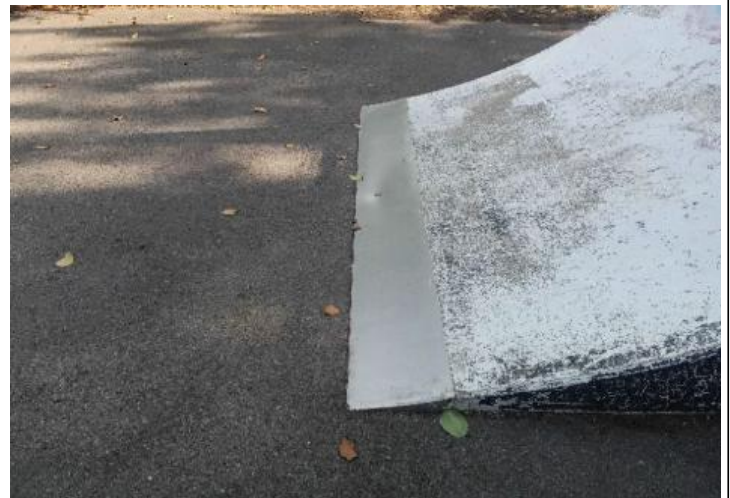
Item: Wheeled Sports - Quarter Pipe
Manufacturer: Not Identified

Finding: The surrounding surface protrudes more than 5mm above the kicker plate level, BS EN 14974 - 6.1.4 recommends a maximum of 5mm
Action: Adjust height to ensure a maximum of 5mm change in level

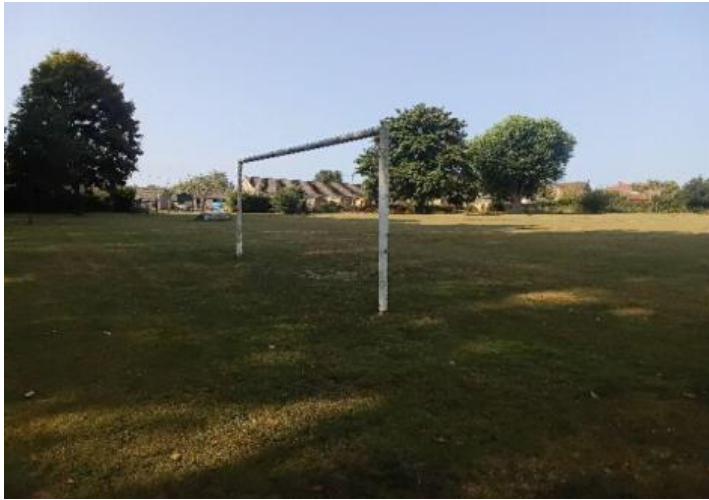
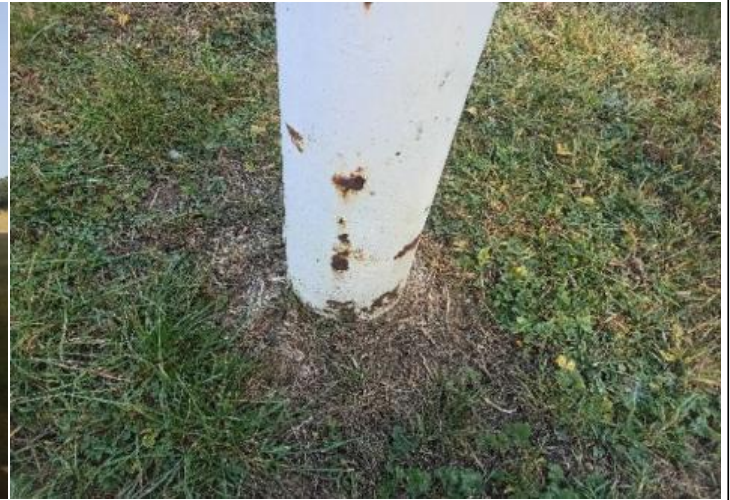
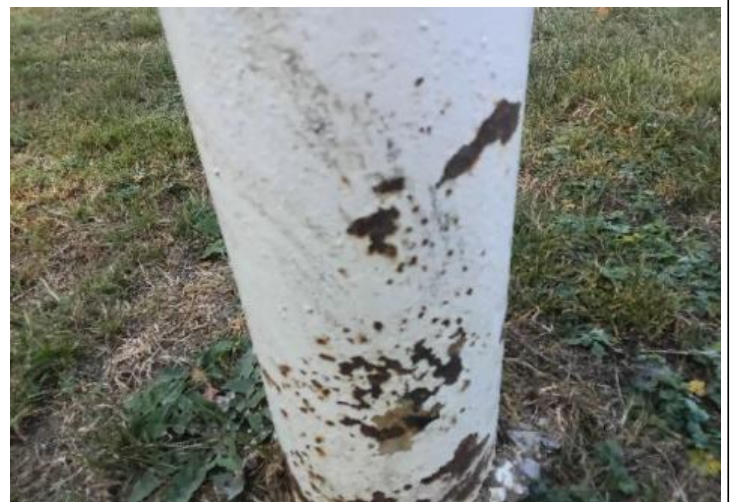
Item: Multi Use Games Area - Football Goal
Manufacturer: Not Identified

Finding: The paintwork on this item has been damaged or worn exposing the metal underneath which is rusting / corroding

Action: Treat affected areas and repaint

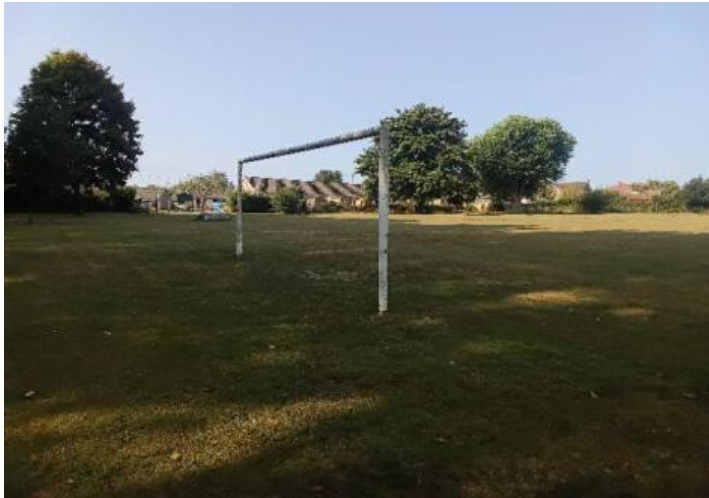
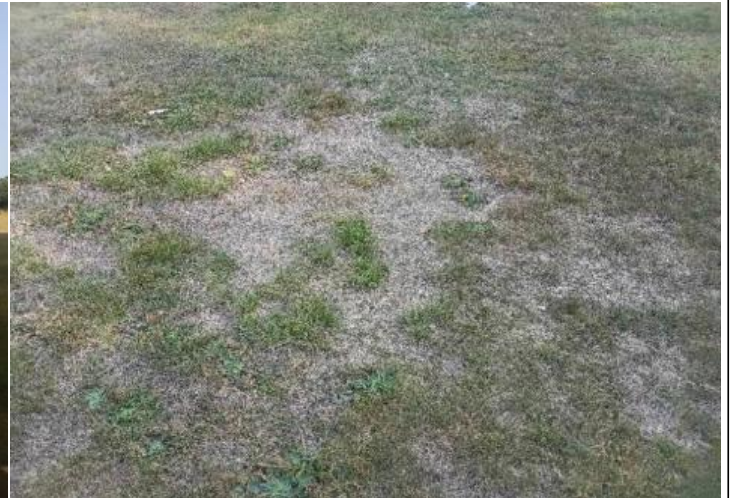
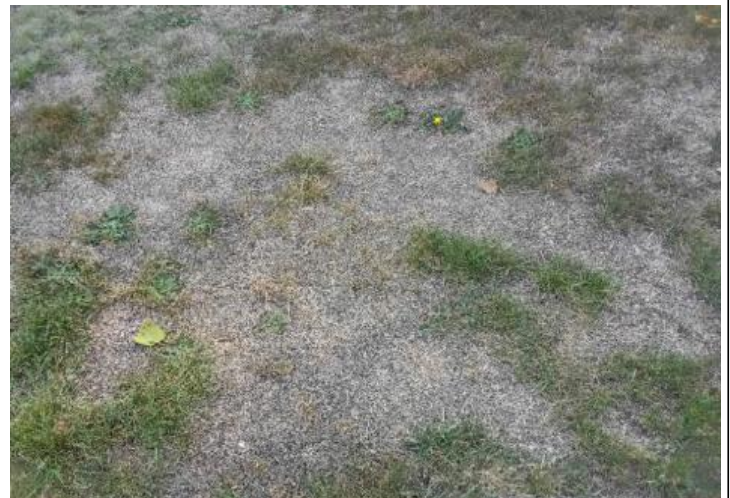
Item: Multi Use Games Area - Football Goal
Manufacturer: Not Identified

The surface has eroded in some areas and may be slippery in wet conditions - Reinstate the surface

Finding: The surface has eroded in some areas and may be slippery in wet conditions
Action: Reinstate the surface
