Annual Inspection

Mudford Parish Council

Mudford Play Ground

Inspected: 26-August-2024 - 14:26 by Lyn Williams (RPII Annual Inspector)

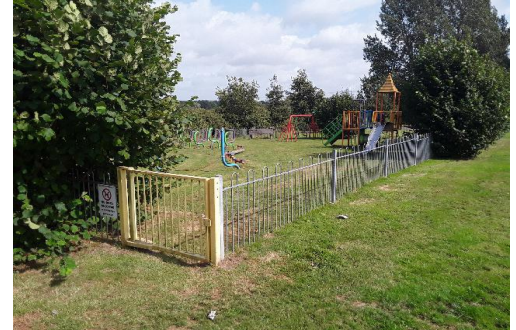
Item: Site General
Manufacturer: Owner/Operator
Surface Type: N/A
Item Quantity: 1
Equipment Compliance: N/A
Surface Area Compliance: N/A

There is some graffiti present - Remove the graffiti

The graphics around the fitness equipment is breaking up - Remove the loose material and consider re painting the graphics

The tarmac surface has subsided in some areas - Monitor for any further deterioration and repair as required

There is algae, silt or moss growth on the tarmac surface resulting in slippery conditions - Clean and treat appropriately

There are minor stress fractures in the tarmac surface - Monitor and repair if required

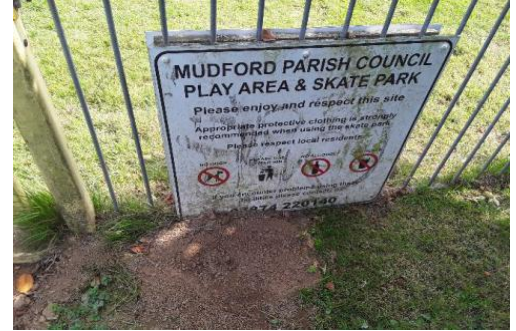
Item: Sign
Manufacturer: Owner/Operator
Surface Type: N/A
Item Quantity: 1
Equipment Compliance: N/A
Surface Area Compliance: N/A

The signage is damaged - Replace signage

Signage of the wheeled sports area should be provided as recommended in BS EN 14974; this will include, but not exclusively, the use of the area, a recommendation to wear protective equipment, emergency contact details etc - Provide signage as recommended by BS EN 14974 for wheeled sports areas

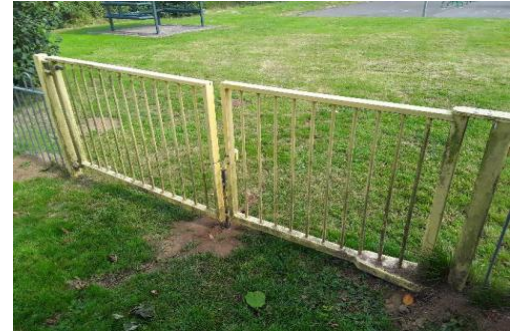
Item: Gate - Combination
Manufacturer: Easy Gate Ltd
Surface Type: Grass
Item Quantity: 1
Equipment Compliance: N/A
Surface Area Compliance: N/A

The gate has no drop bolt sleeves fitted and the drop bolt has damaged the surface - Provide drop bolt sleeves and reinstate the surrounding surface

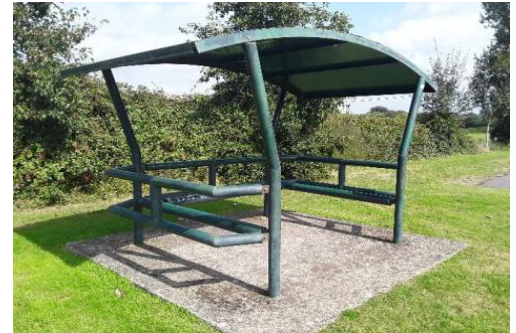
Item: Teenage Shelter
Manufacturer: Not Identified
Surface Type: Concrete
Item Quantity: 1
Equipment Compliance: N/A
Surface Area Compliance: N/A

There are trip hazards present over the concrete base - Remove trip hazard

There is surface corrosion / rust present on the item - Consider treating the item

There is algae, silt or moss growth on the surface resulting in slippery conditions - Clean and treat appropriately

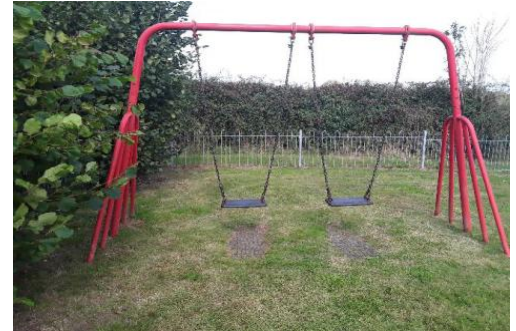
Item: 1 Bay 2 Seat (Flat)
Manufacturer: Wicksteed Playgrounds
Surface Type: Grass Matrix Tiles
Item Quantity: 1
Equipment Compliance: No
Surface Area Compliance: Yes

There is some wear to the shackles - Monitor for any further deterioration and replace when 40% worn

There is surface corrosion / rust present on the item - Consider treating the item

The chain openings are in excess of the 8.6mm as recommended by BS EN 1176 - Monitor - No remedial work recommended

There is some notable evidence of chain wear - Monitor for any further deterioration and replace when 40% worn

The seats are too close to each other as defined in BS EN 1176 Part 2; this is a low risk failure and no remedial action is required - Monitor - No remedial work recommended

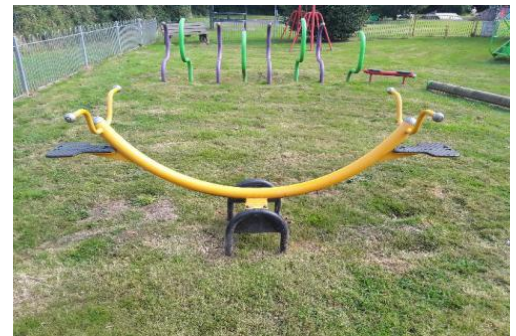
Item: See Saw
Manufacturer: Wicksteed Playgrounds
Surface Type: Grass Matrix Tiles
Item Quantity: 1
Equipment Compliance: Yes
Surface Area Compliance: Yes

The surface has subsided creating trip hazards - Repair as required to provide a uniform surface

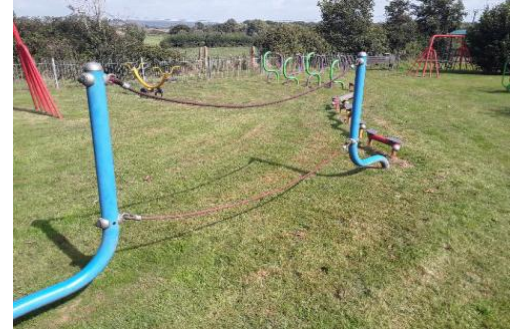
Item: Activity Trail
Manufacturer: Wicksteed Playgrounds
Surface Type: Grass
Item Quantity: 1
Equipment Compliance: No
Surface Area Compliance: Yes

The rope has worn and wire strands are exposed - Replace rope or net

The connecting links are in excess of 8.6mm and less than 12mm and fail the requirements of BS EN 1176 Part 1; clause 4.2.13, Chains - Monitor use and replace with compliant links at the next maintenance cycle

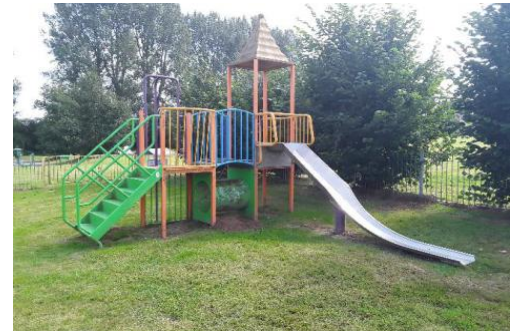
Item: Multi Play (Junior)
Manufacturer: Wicksteed Playgrounds
Surface Type: Grass Matrix Tiles
Item Quantity: 1
Equipment Compliance: No
Surface Area Compliance: Yes

The item fails to meet the requirements of BS EN 1176 Part 1 4.2.7.2 for head and neck entrapment in the rope openings - Monitor - No remedial work recommended

The ropes/nets are worn/damaged in places - Monitor for any further deterioration and repair or replace as required

There is surface corrosion / rust present on the item - Consider treating the item

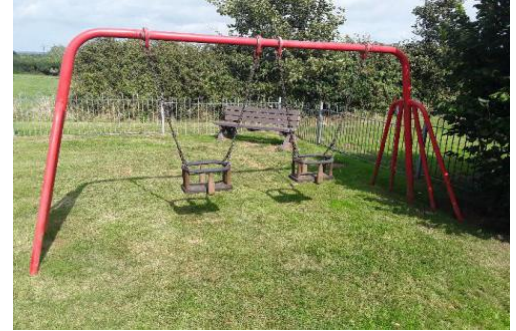
Item: 1 Bay 2 Seat (Cradle)
Manufacturer: Wicksteed Playgrounds
Surface Type: Grass Matrix Tiles
Item Quantity: 1
Equipment Compliance: No
Surface Area Compliance: Yes

The chain openings are in excess of the 8.6mm as recommended by BS EN 1176 - Monitor - No remedial work recommended

There is some notable evidence of chain wear - Monitor for any further deterioration and replace when 40% worn

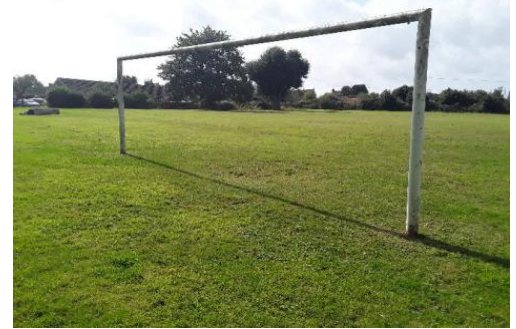
Item: Football Goal
Manufacturer: Not Identified
Surface Type: Grass
Item Quantity: 1
Equipment Compliance: N/A
Surface Area Compliance: N/A

NB: We have undertaken a maintenance inspection only of the football goal(s); full load testing falls outside the scope of our inspection. - Implement load testing as required

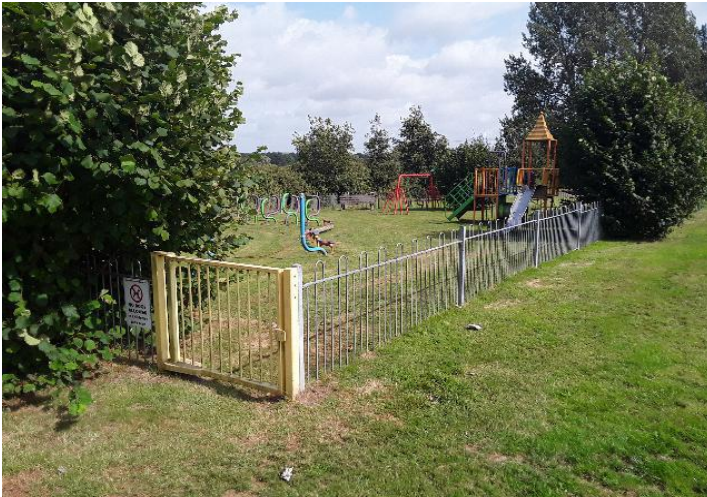
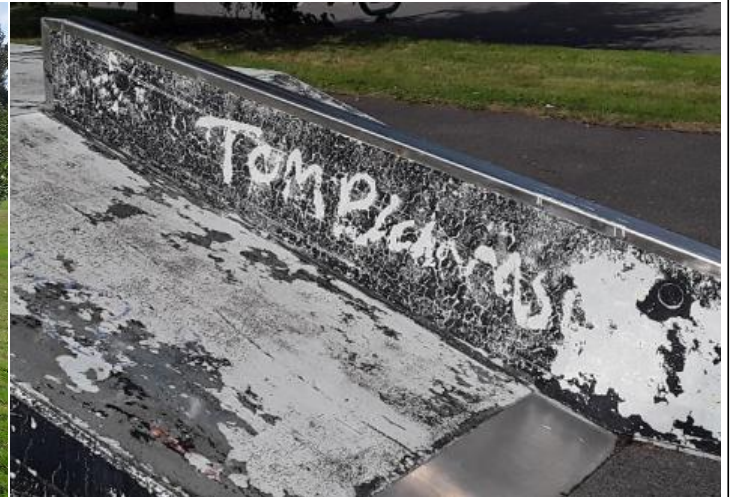
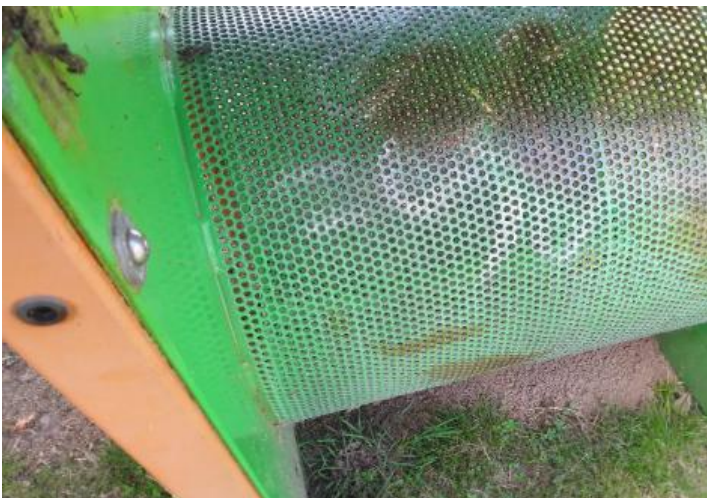
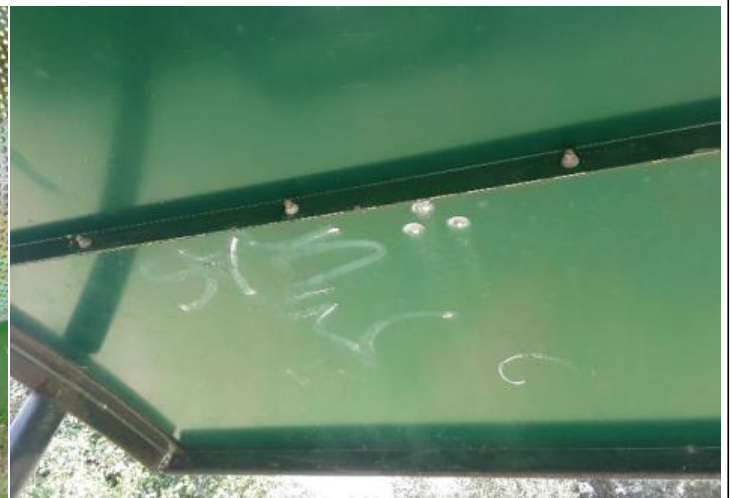
Item: Ancillary Items - Site General
Manufacturer: Owner/Operator

Finding: There is some graffiti present

Action: Remove the graffiti

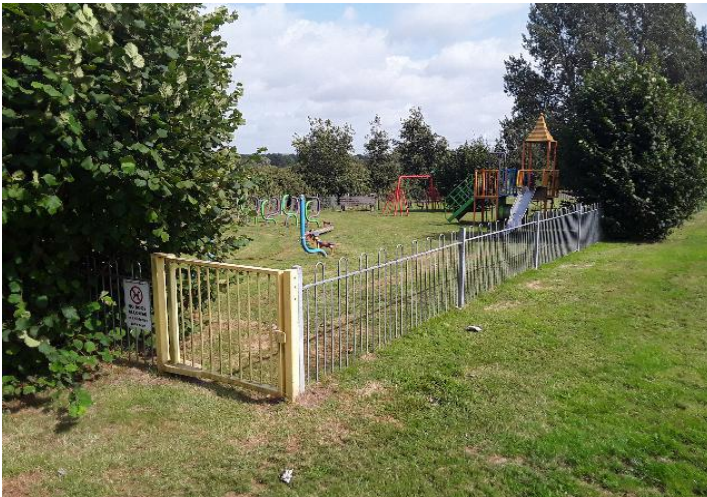
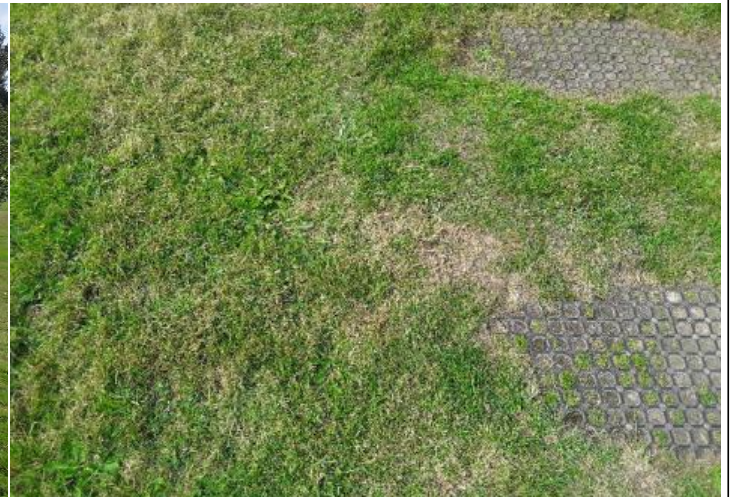
Item: Ancillary Items - Site General
Manufacturer: Owner/Operator

Finding: The grass mats are silted up, the soil is compacted and the area will become very slippery when the soil is wet.

Action: Reinstate as required

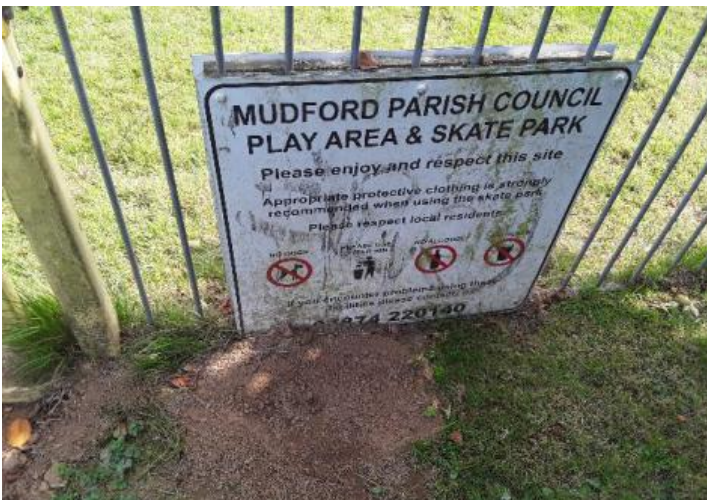
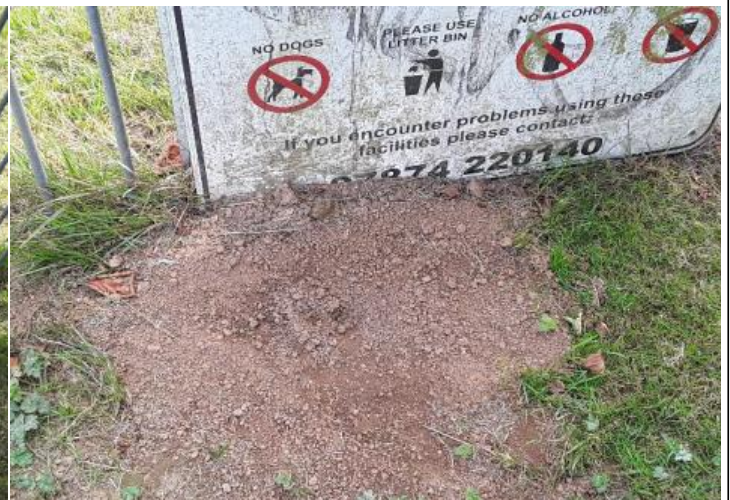
Item: Ancillary Items - Sign
Manufacturer: Owner/Operator

Finding: The Contact phone number has been obscured by soil

Action: Remove the soil

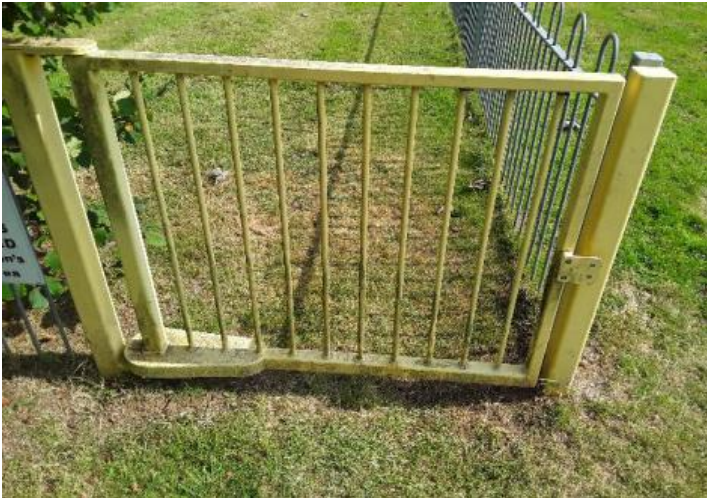
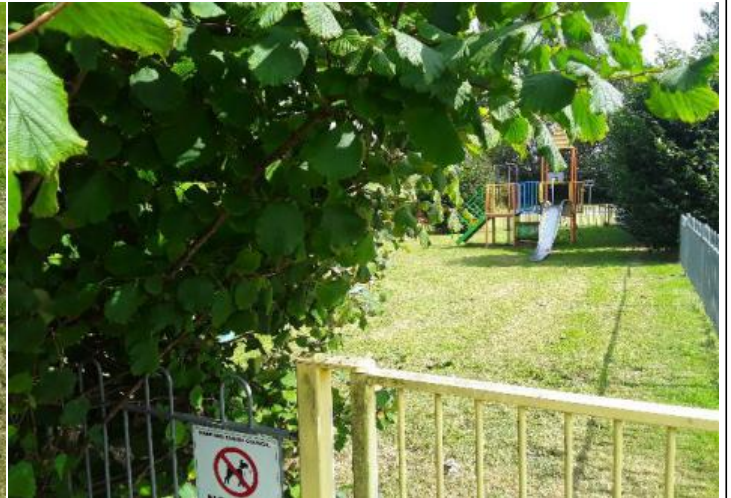
Item: Gates - Gate - Self Closing
Manufacturer: Easy Gate Ltd

Finding: The adjacent foliage is overhanging the gate

Action: Cut back and maintain

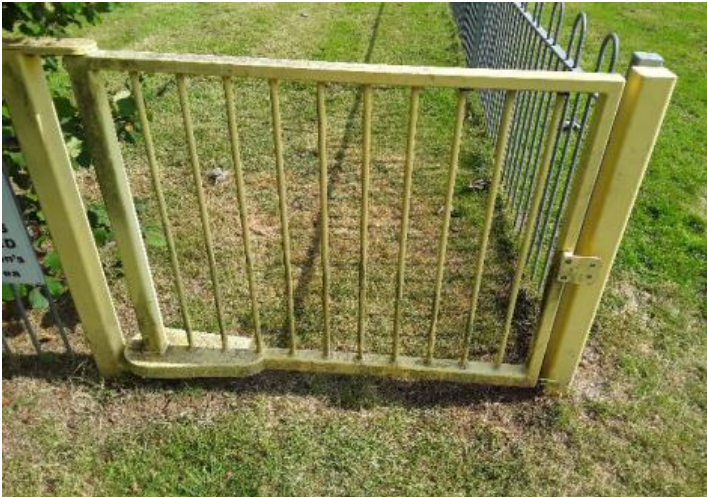
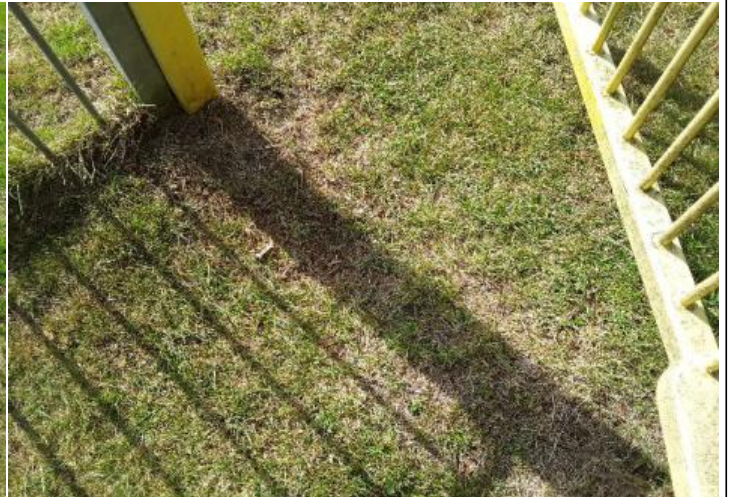
Item: Gates - Gate - Self Closing
Manufacturer: Easy Gate Ltd

Finding: There is a shallow hole in the grass under the gate

Action: Reinstate to provide a uniform surface

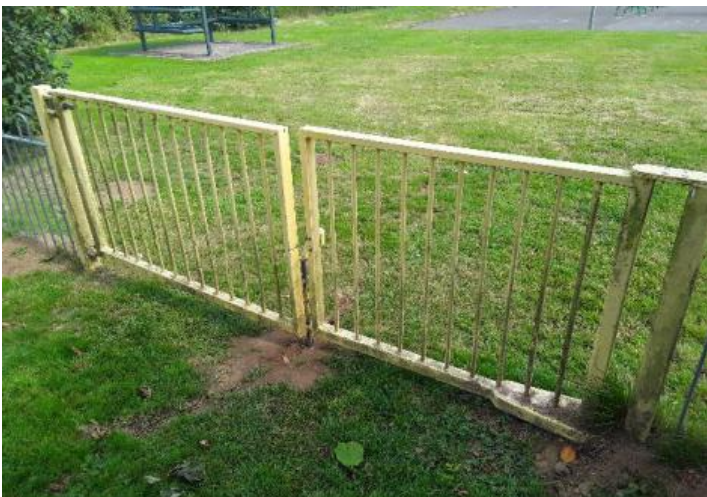
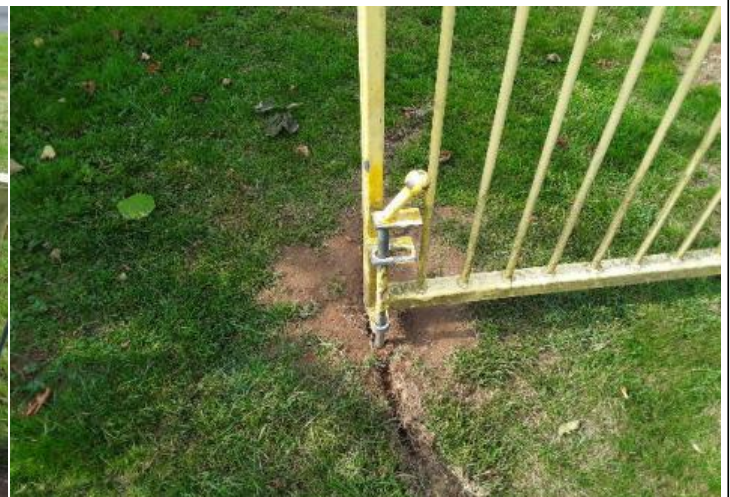
Item: Gates - Gate - Combination
Manufacturer: Easy Gate Ltd

Finding: There is no padlock on the maintenance gate

Action: Provide a padlock to secure the gate

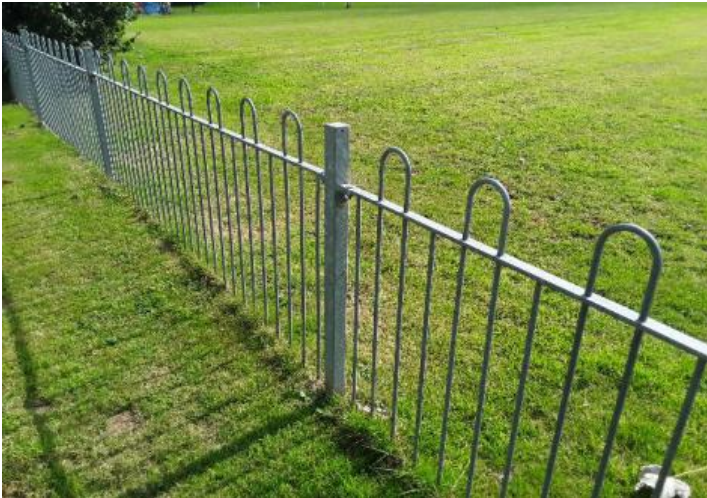
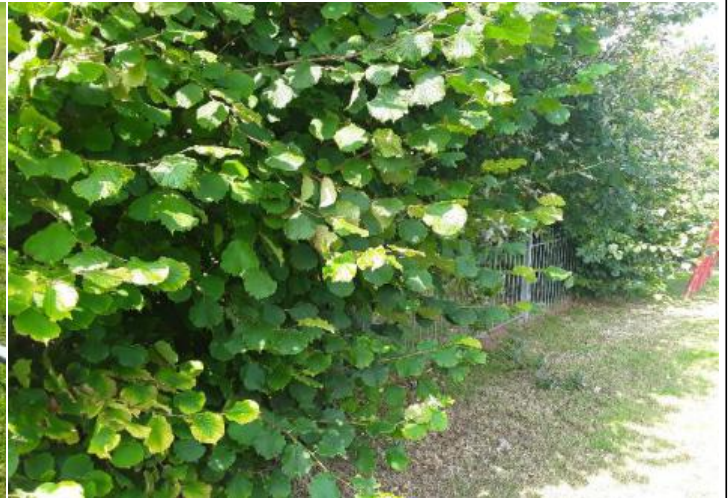
Item: Fences - Fence - Bow Top
Manufacturer: Not Identified

Finding: The adjacent foliage is overhanging or growing through the fence

Action: Cut back and maintain

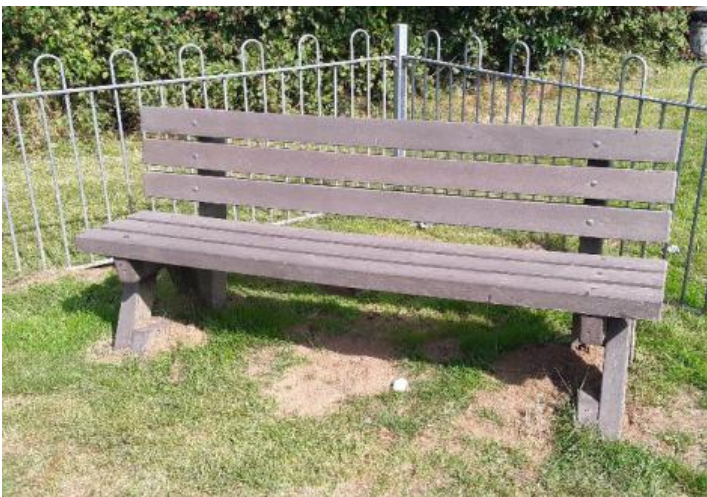
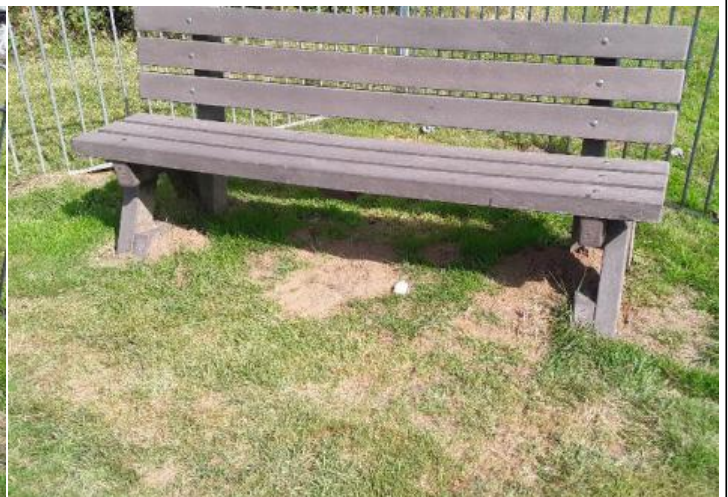
Item: Ancillary Items - Bench
Manufacturer: Not Identified

Finding: The area around the item has eroded and may become slippery

Action: Reinstate eroded area

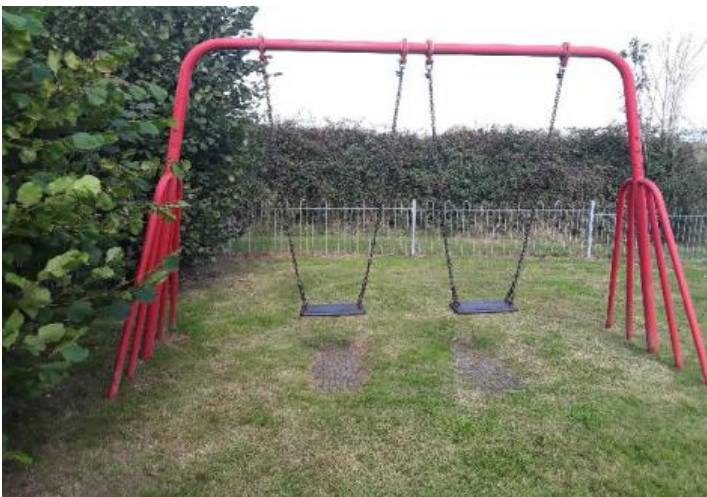
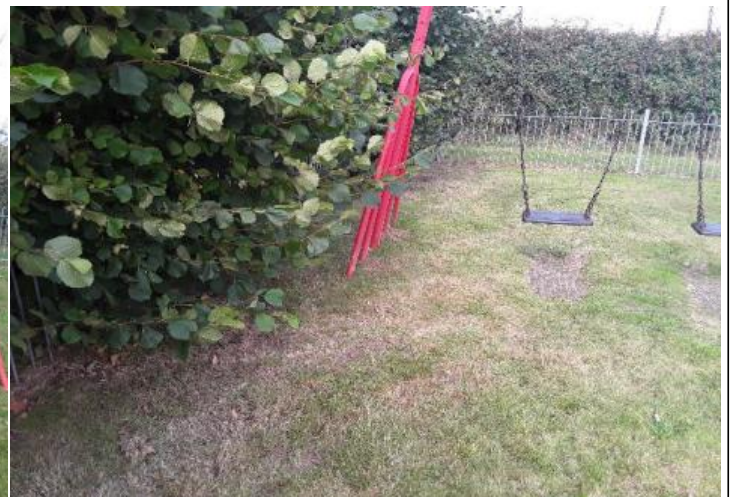
Item: Swings - 1 Bay 2 Seat (Flat)
Manufacturer: Wicksteed Playgrounds

Finding: The adjacent foliage is overhanging the falling space of the equipment

Action: Cut back and maintain the foliage

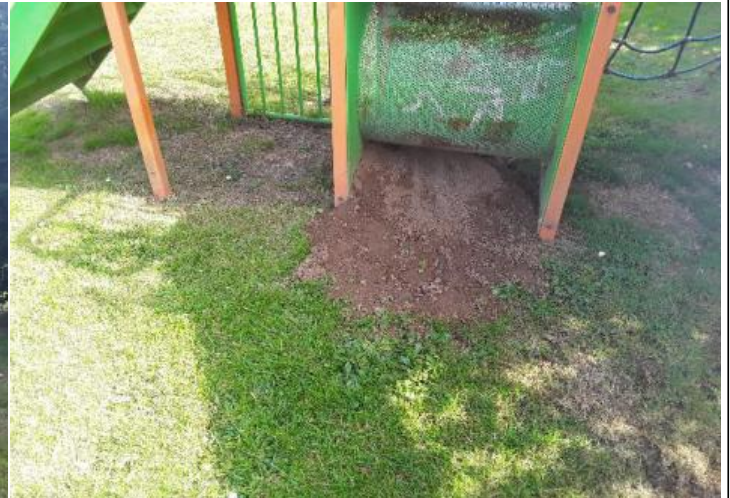
Item: Activity Equipment - Multi Play (Junior)
Manufacturer: Wicksteed Playgrounds

Finding: There is a build up of soil under the tunnel

Action: Remove the soil and reinstate the surrounding surface

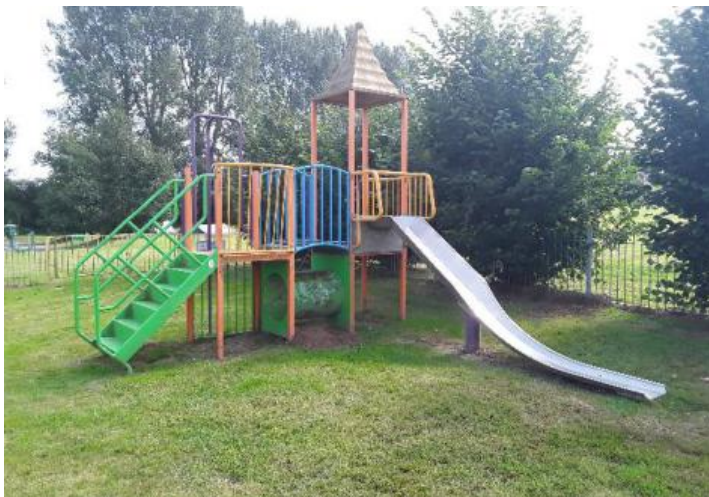
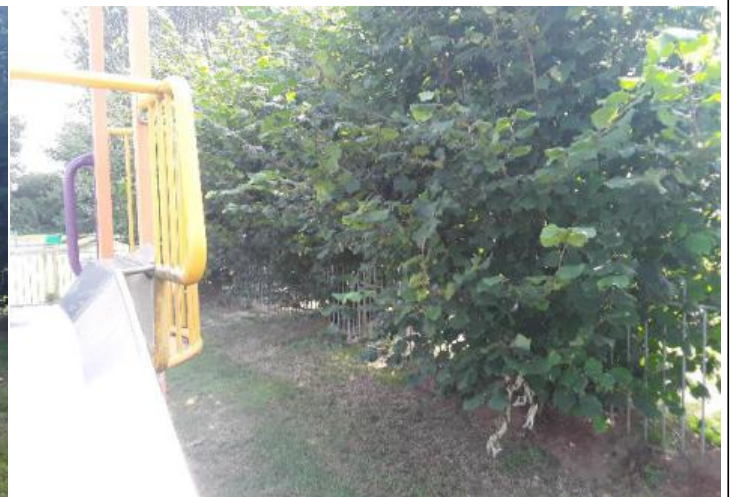
Item: Activity Equipment - Multi Play (Junior)
Manufacturer: Wicksteed Playgrounds

Finding: The adjacent foliage is overhanging the falling space of the equipment

Action: Cut back and maintain the foliage

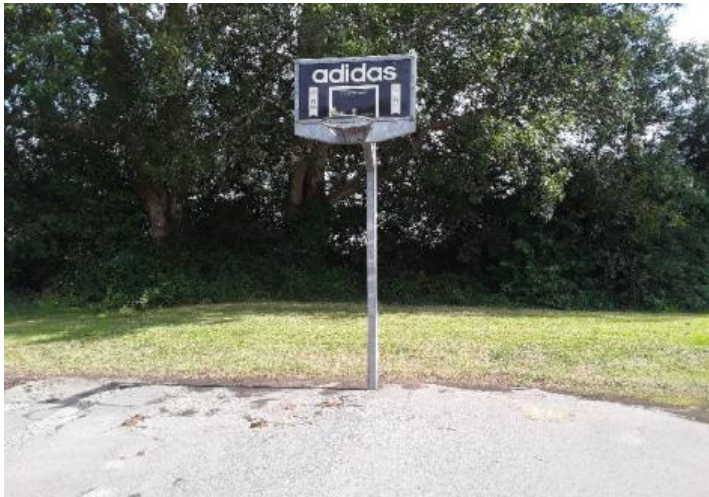
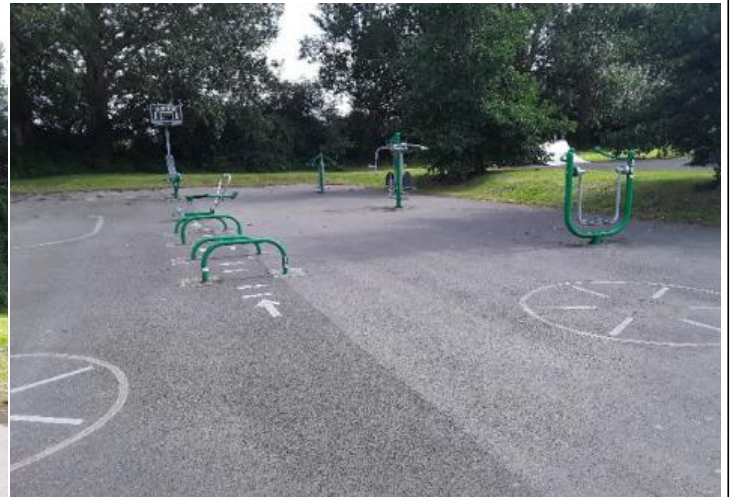
Item: Multi Use Games Area - Basketball Post
Manufacturer: Not Identified

Finding: There is a potential conflict between the users of the basketball post and the users of the fitness equipment

Action: Monitor and take appropriate action if required

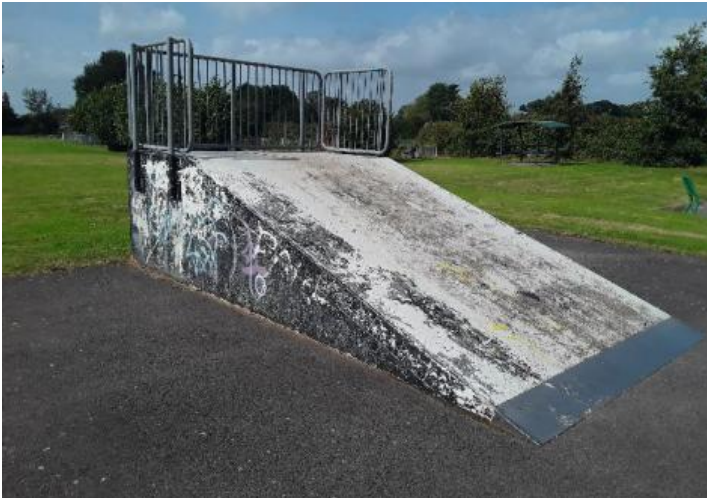
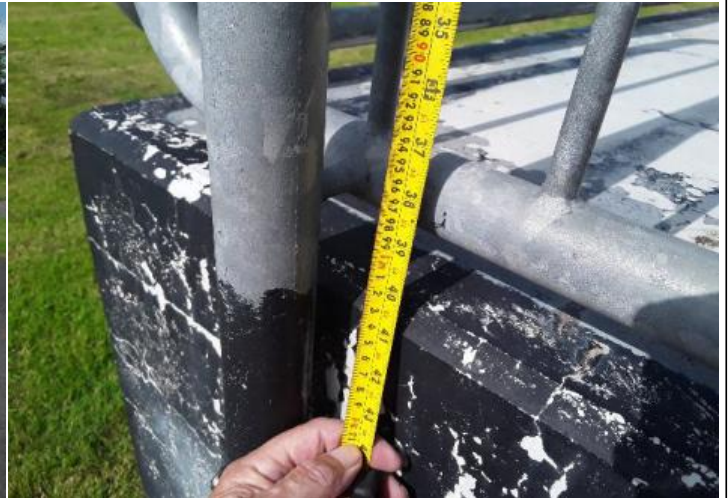
Item: Wheeled Sports - Flat Bank
Manufacturer: Not Identified

Finding: The height of the barrier is less than 1200mm in contravention of BS EN 14974 - 6.2.6. This height must be achieved all around the platform and at a maximum distance of 300mm from the front of the platform.

Action: Monitor - no reasonably practicable action given the risk assessment

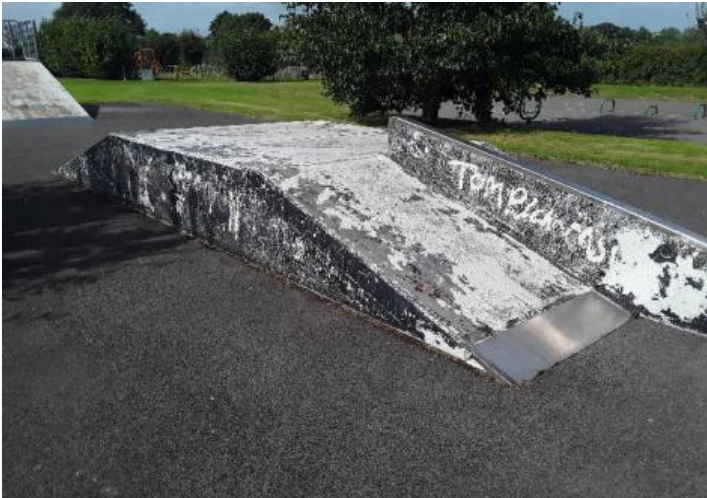
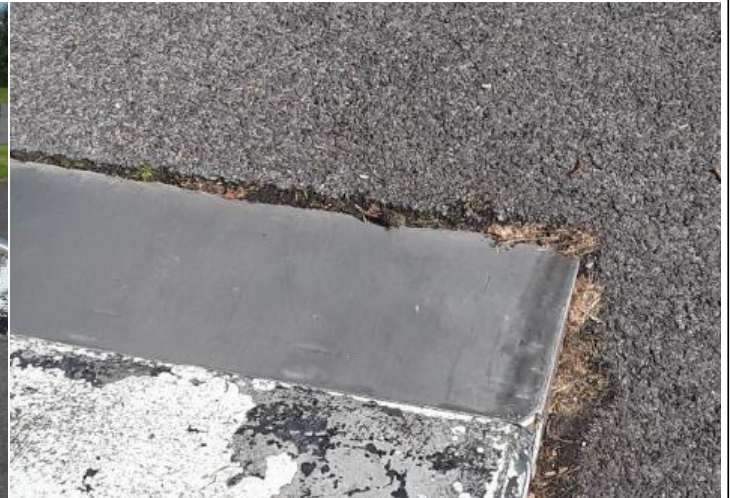
Item: Wheeled Sports - Fun Box
Manufacturer: Not Identified

Finding: There are differences in height exceeding 3mm on the rolling / riding surfaces in contravention of the requirements of BS EN 14974 - 6.2.4

Action: Take corrective action to ensure that the gaps between the joints do not exceed 3mm

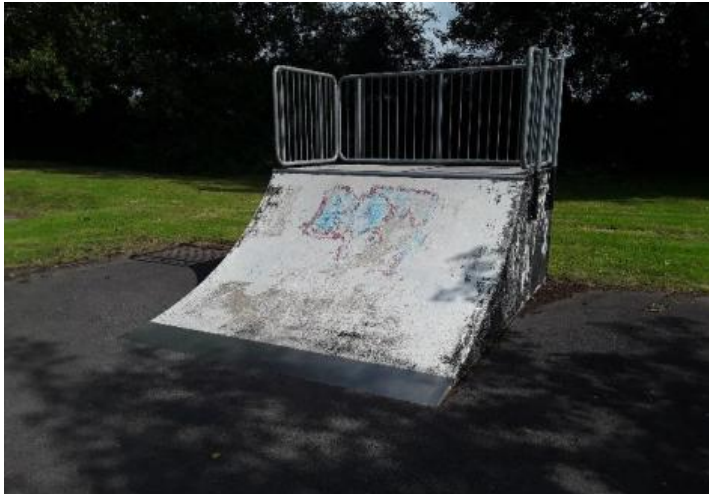
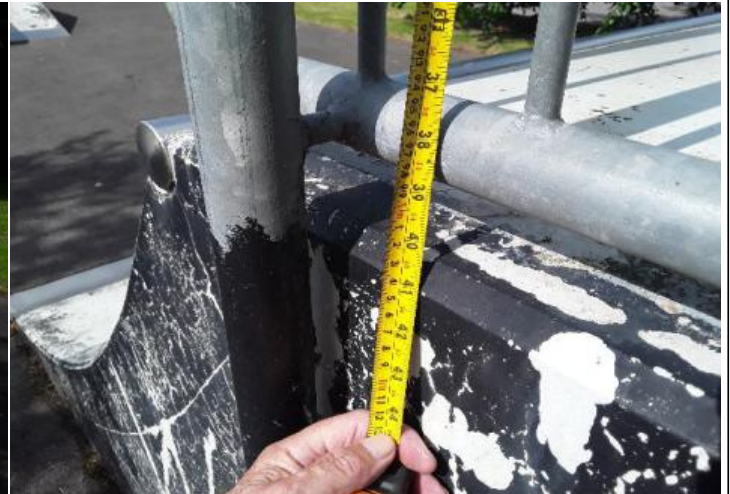
Item: Wheeled Sports - Quarter Pipe
Manufacturer: Not Identified

Finding: The height of the barrier is less than 1200mm in contravention of BS EN 14974 - 6.2.6. This height must be achieved all around the platform and at a maximum distance of 300mm from the front of the platform.

Action: Monitor - no reasonably practicable action given the risk assessment

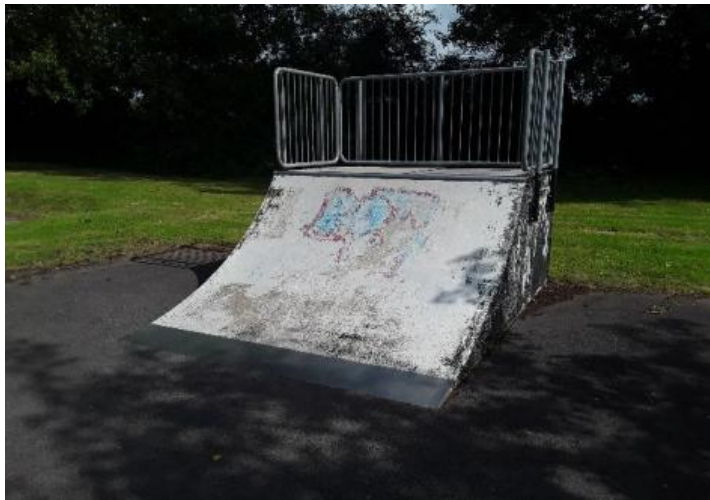
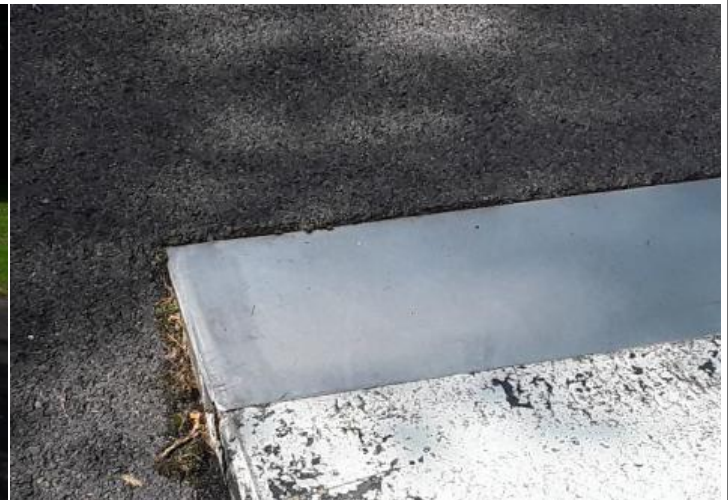
Item: Wheeled Sports - Quarter Pipe
Manufacturer: Not Identified
Risk Level: L - Low Risk
Surface: Bitmac

Finding: There are differences in height exceeding 3mm on the rolling / riding surfaces in contravention of the requirements of BS EN 14974 - 6.2.4
Action: Take corrective action to ensure that the gaps between the joints do not exceed 3mm

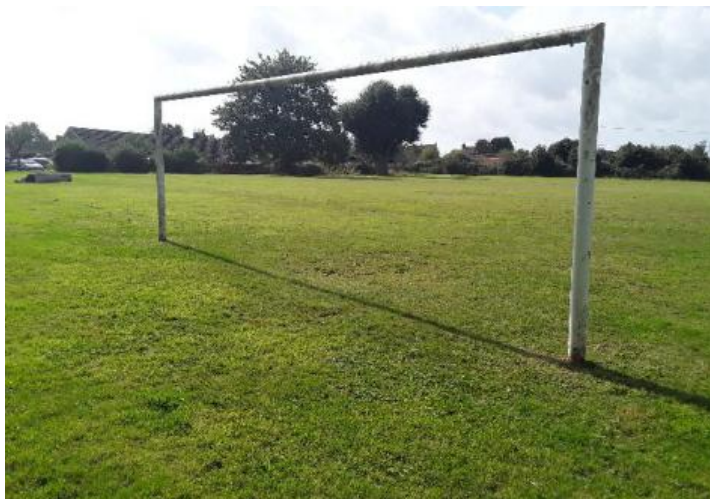
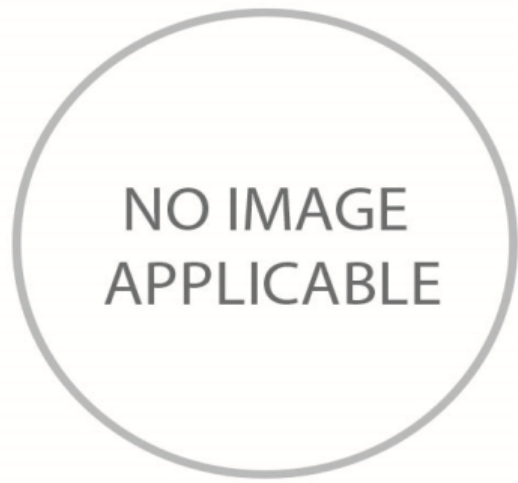
Item: Multi Use Games Area - Football Goal
Manufacturer: Not Identified
Risk Level: N - Risk Assessment not Undertaken
Surface: Grass

Finding: NB: We have undertaken a maintenance inspection only of the football goal(s); full load testing falls outside the scope of our inspection.
Action: Implement load testing as required

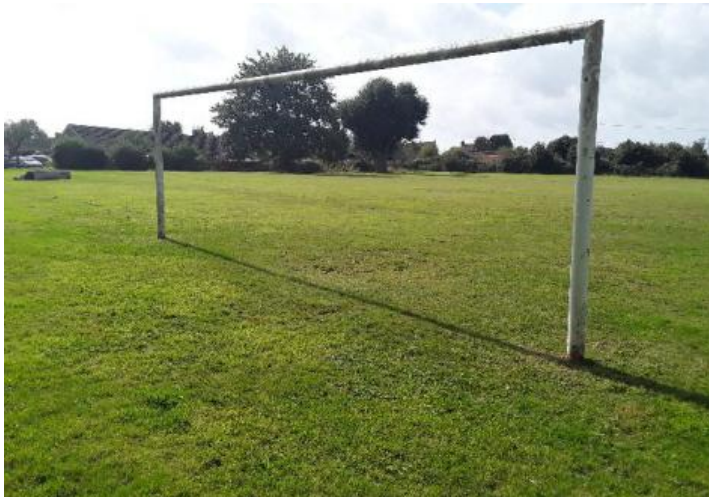
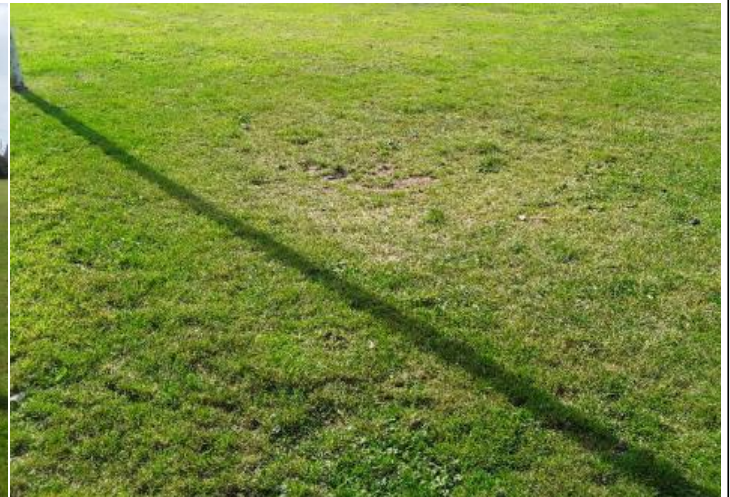
Item: Multi Use Games Area - Football Goal
Manufacturer: Not Identified

Finding: The area around the item has eroded and may become slippery

Action: Reinstate eroded area
