the **play inspection** company

Annual Inspection

Mudford Parish Council

Mudford Play Ground

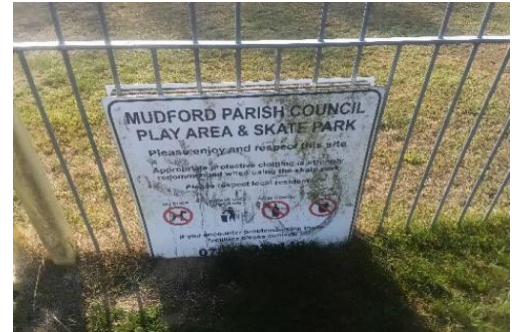
BS EN 1176 Part 7 recommends that signage shall include the site name / address - Provide additional information

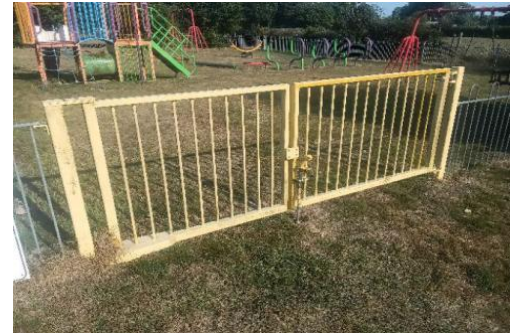
The gate has no drop bolt sleeves fitted and the drop bolt has damaged the surface - Provide drop bolt sleeves and reinstate the surrounding surface

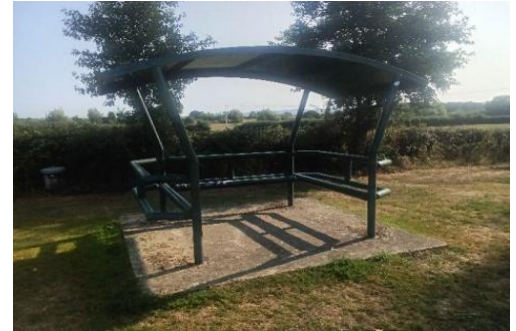
There are trip hazards at the edges of the surface - Remove trip hazard

The paintwork on this item has been damaged or worn exposing the metal underneath which is rusting / corroding - Treat affected areas and repaint

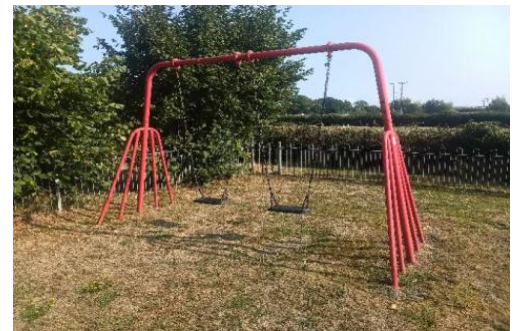
The seats are too close to each other as defined in BS EN 1176 Part 2; this is a low risk failure and no remedial action is required - Monitor - No action given the risk assessment

The chain openings are in excess of the 8.6mm as recommended by BS EN 1176 - Monitor - No action given the risk assessment

The chain links are worn excessively and require renewing - Replace worn chains

The connecting lugs are showing signs of wear - Monitor for any further deterioration and repair as required

There is some wear to the shackles. - Monitor for any further deterioration and replace when 40% worn

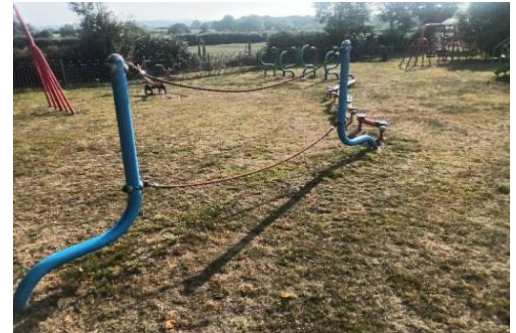
The connecting links are in excess of 8.6mm and less than 12mm and fail the requirements of BS EN 1176 Part 1; clause 4.2.13, Chains - Monitor - No action given the risk assessment

The ropes/nets are worn/damaged in places - Monitor for any further deterioration and repair or replace as required

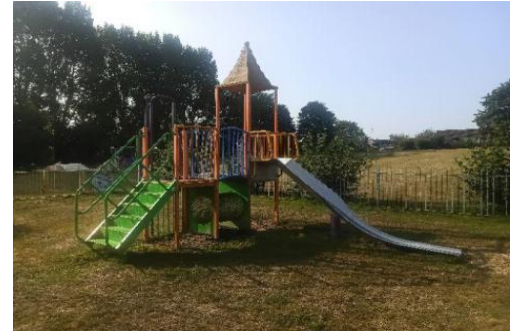
The item fails to meet the requirements of BS EN 1176 Part 1 4.2.7.2 for head and neck entrapment in the rope - Monitor - No action given the risk assessment

The ropes/nets are worn/damaged in places - Monitor for any further deterioration and repair or replace as required

The paintwork on this item has been damaged or worn exposing the metal underneath which is rusting / corroding - Treat affected areas and repaint

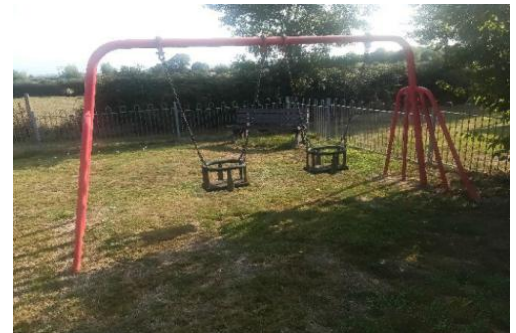
The chain openings are in excess of the 8.6mm as recommended by BS EN 1176 - Monitor - No action given the risk assessment

There is some notable evidence of chain wear - Monitor for any further deterioration and replace when 40% worn

There is some wear to the shackles. - Monitor for any further deterioration and replace when 40% worn

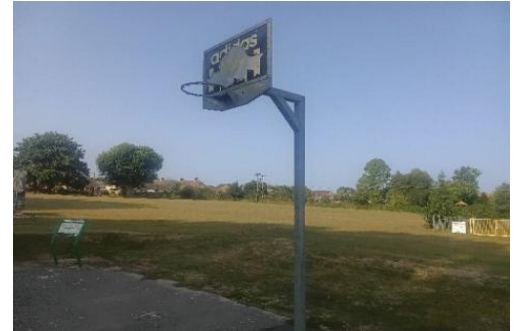
The backboard graphics card is damaged - Replace

There is some evidence of fire damage to the item - Monitor for any further deterioration and repair as required

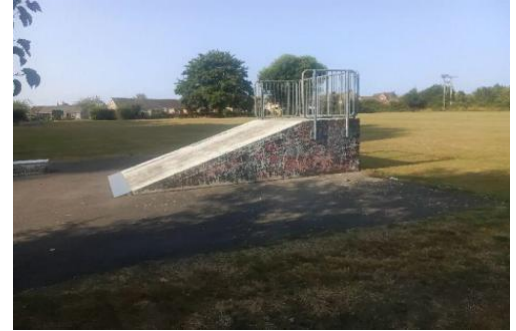
The item has insufficient safety zone allowed as required by BS EN 14974 – 6.4. This should equal at least 2.0 metres on this item - Monitor - No action given the risk assessment

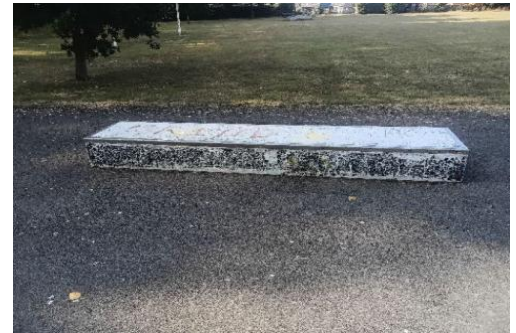
The item has insufficient safety zone allowed as required by BS EN 14974 – 6.4. This should equal at least 2.0 metres on this item - Monitor - No action given the risk assessment

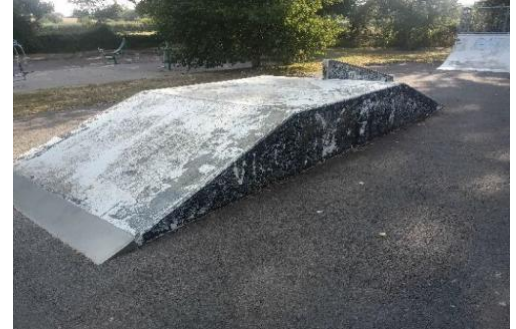
The surrounding surface protrudes more than 5mm above the kicker plate level, BS EN 14974 - 6.1.4 recommends a maximum of 5mm - Adjust height to ensure a maximum of 5mm change in level

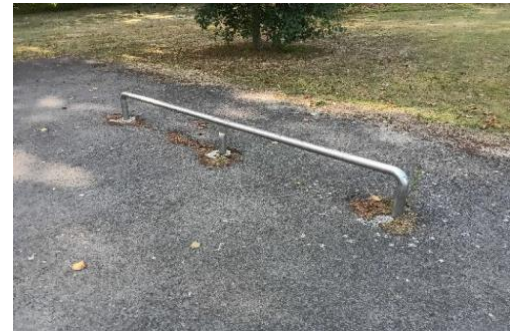
The item has been damaged - Monitor for any further deterioration and replace as required

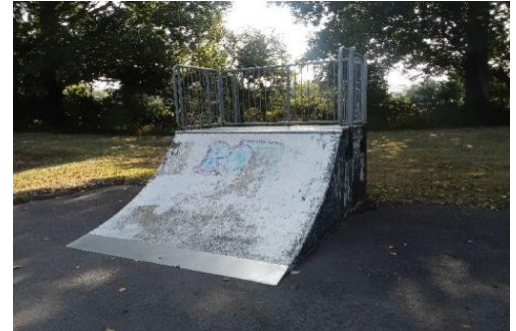
The surrounding surface protrudes more than 5mm above the kicker plate level, BS EN 14974 - 6.1.4 recommends a maximum of 5mm - Adjust height to ensure a maximum of 5mm change in level

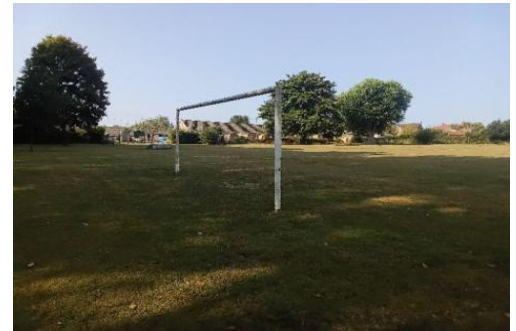
The paintwork on this item has been damaged or worn exposing the metal underneath which is rusting / corroding - Treat affected areas and repaint

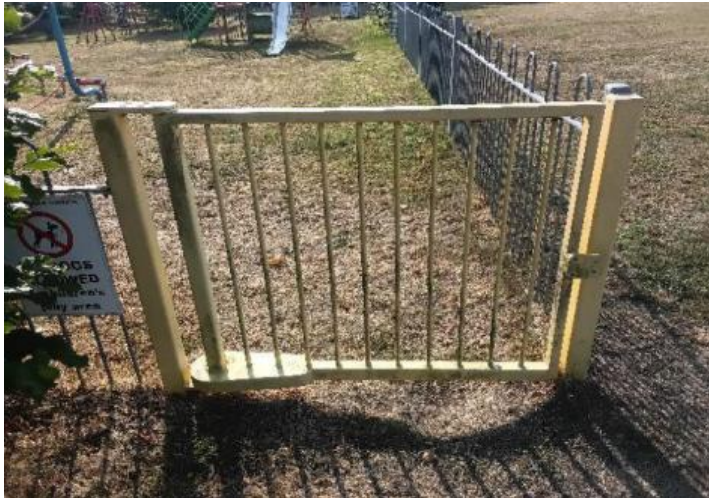
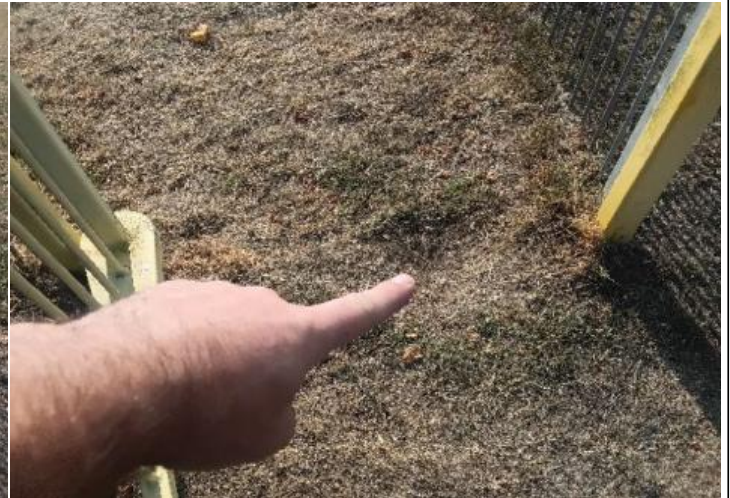
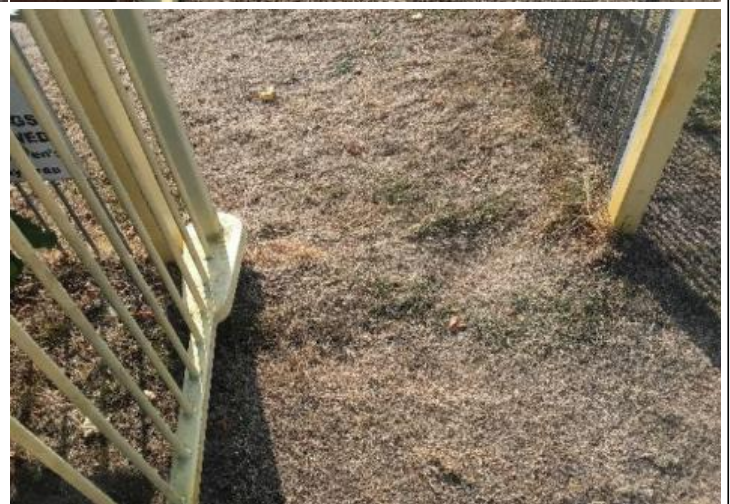
Item: Gates - Gate - Self Closing
Manufacturer: I.A.E. Fencing

Finding: There is a shallow hole in the grass under the gate **Action:** Reinstate to provide a uniform surface

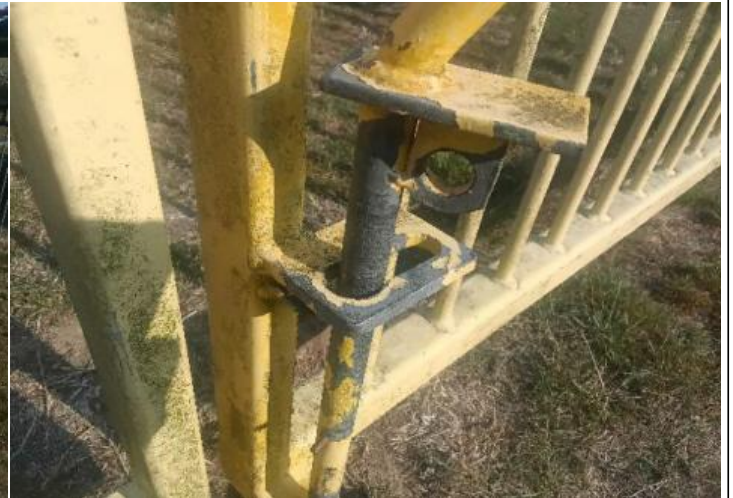
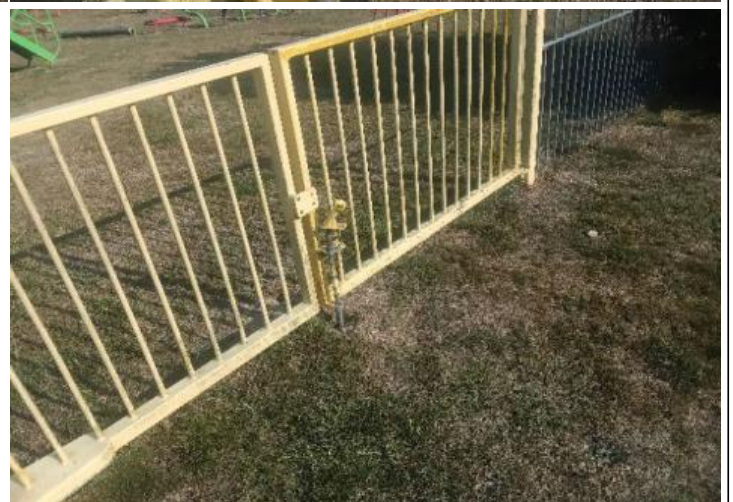
Item: Gates - Gate - Combination
Manufacturer: I.A.E. Fencing

Finding: There is no padlock on the maintenance gate

Action: Provide a padlock to secure the gate

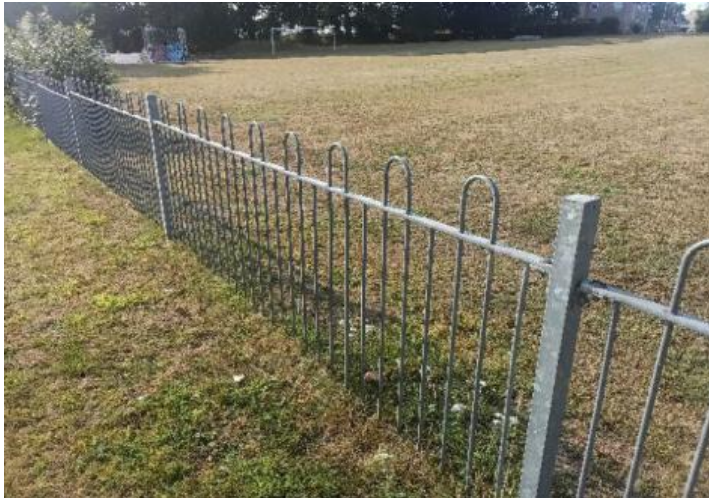
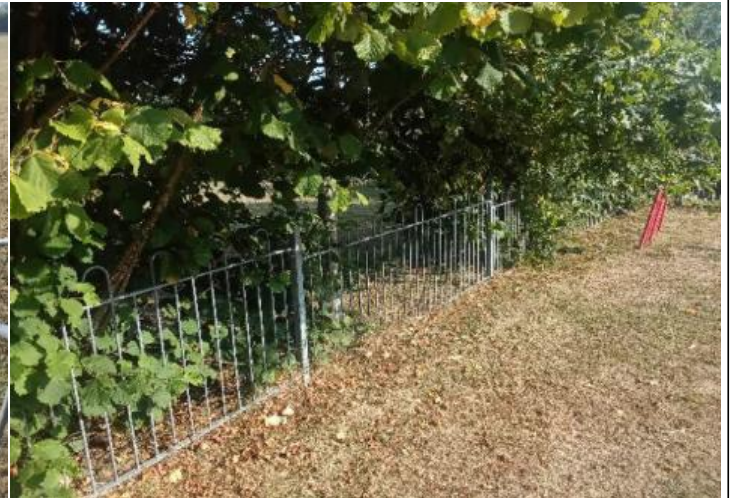
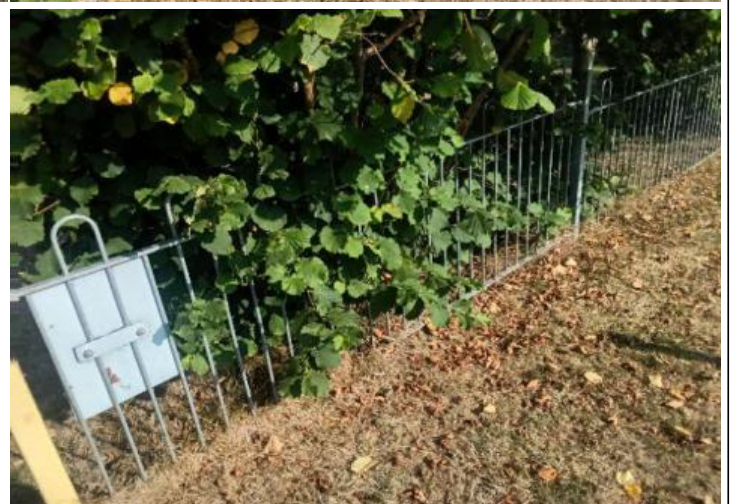
Item: Fences - Fence - Bow Top
Manufacturer: Not Identified

Finding: The adjacent foliage is overhanging

Action: Cut back and maintain

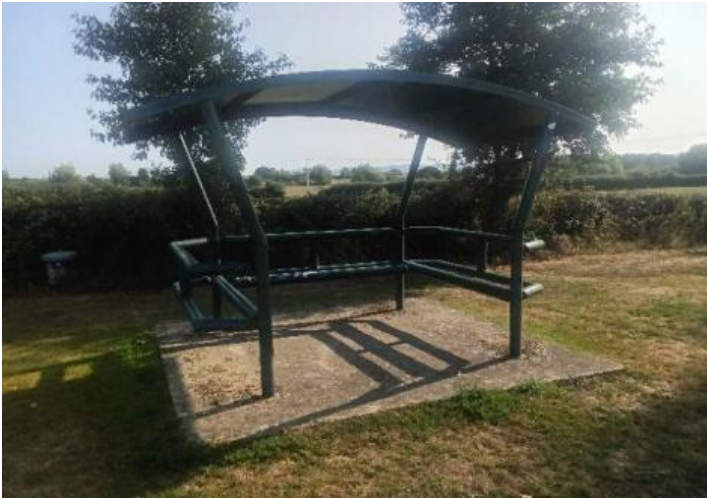
Item: Ancillary Items - Teenage Shelter
Manufacturer: Not Identified

Finding: There are trip hazards at the edges of the surface **Action:** Remove trip hazard

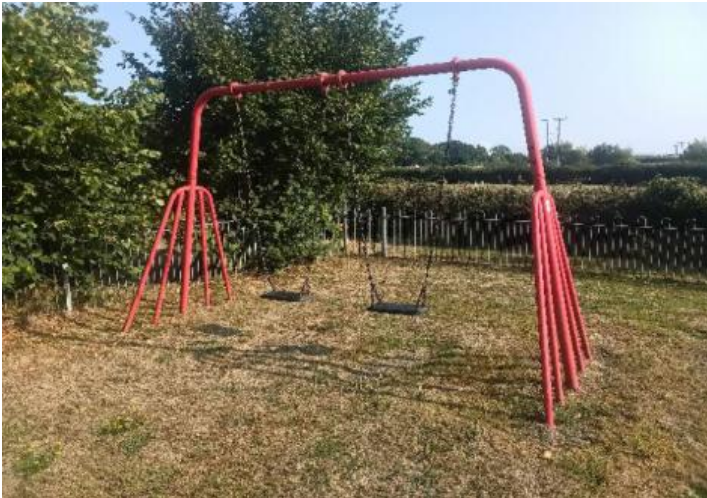
Item: Swings - 1 Bay 2 Seat (Flat)
Manufacturer: Wicksteed Playgrounds

Finding: The seats are too close to each other as defined in BS EN 1176 Part 2; this is a low risk failure and no remedial action is required
Action: Monitor - No action given the risk assessment

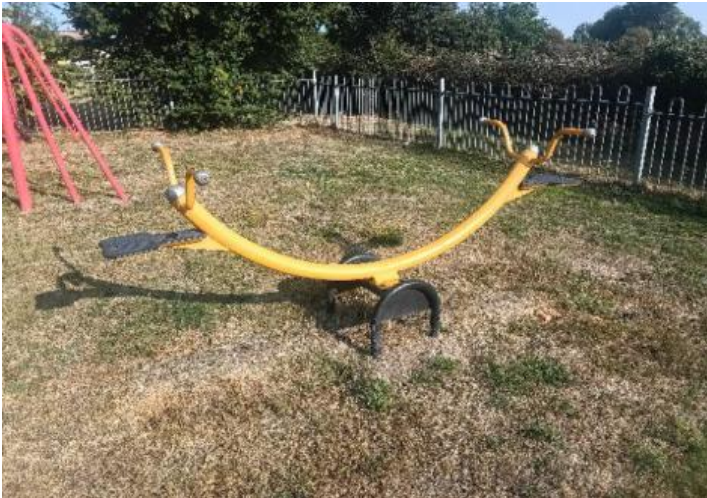
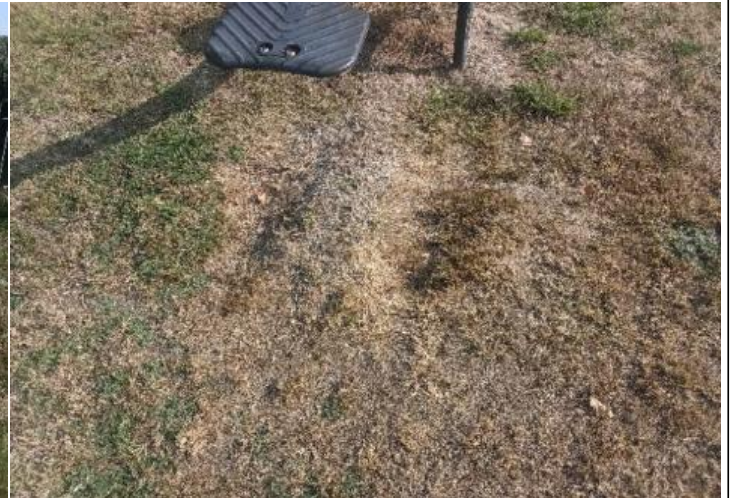
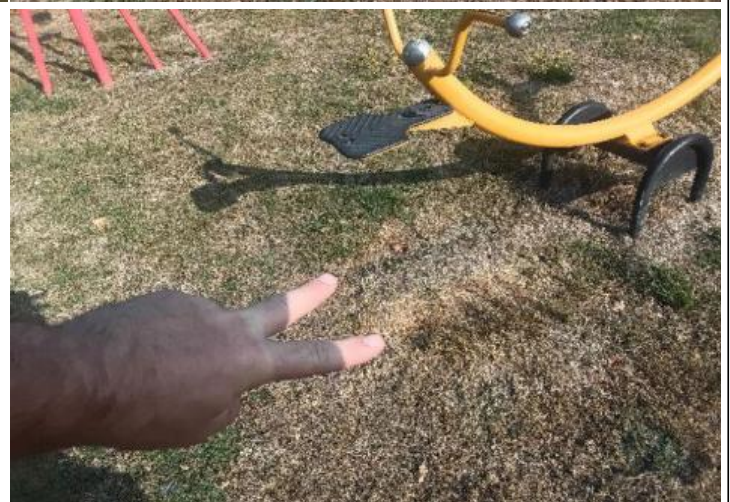
Item: Rocking Equipment - See Saw
Manufacturer: Wicksteed Playgrounds

Finding: The surface has subsided in some areas creating trip point

Action: Reinststate surface

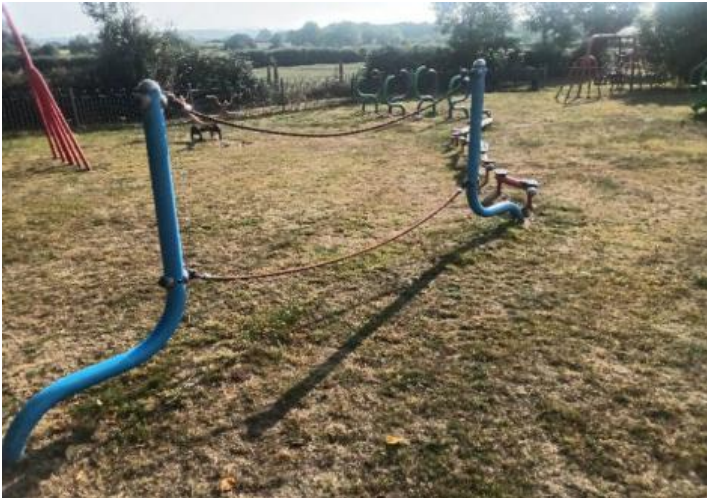
Item: Activity Equipment - Activity Trail
Manufacturer: Wicksteed Playgrounds

Finding: The connecting links are in excess of 8.6mm and less than 12mm and fail the requirements of BS EN 1176 Part 1; clause 4.2.13, Chains

Action: Monitor - No action given the risk assessment

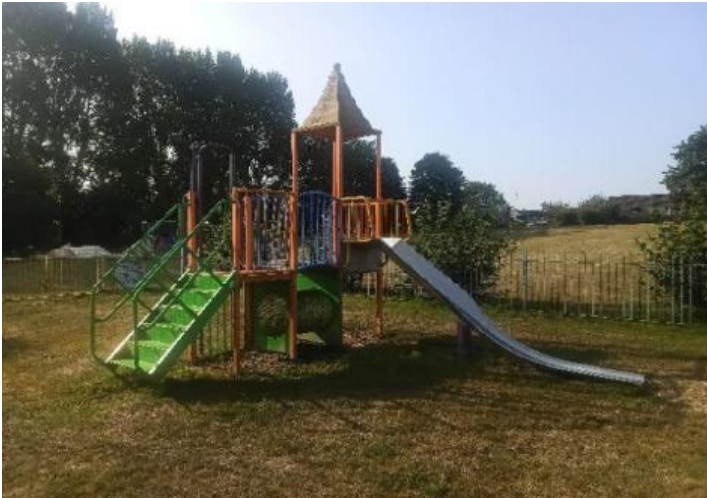
Item: Activity Equipment - Multi Play (Junior)
Manufacturer: Wicksteed Playgrounds

Finding: The paintwork on this item has been damaged or worn exposing the metal underneath which is rusting / corroding

Action: Treat affected areas and repaint

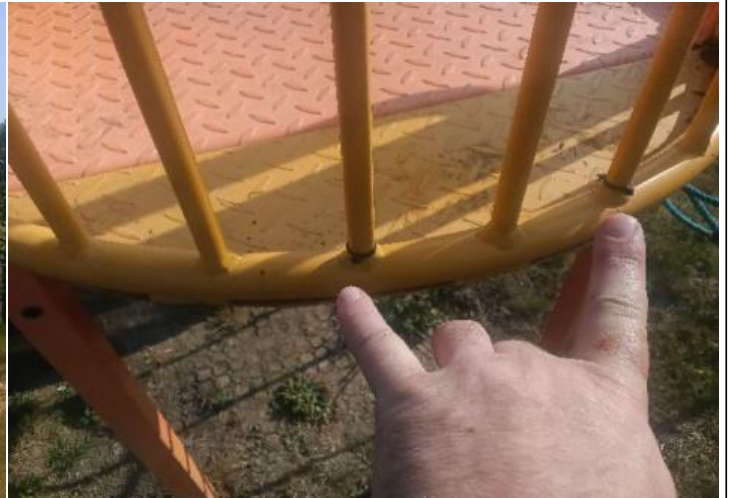
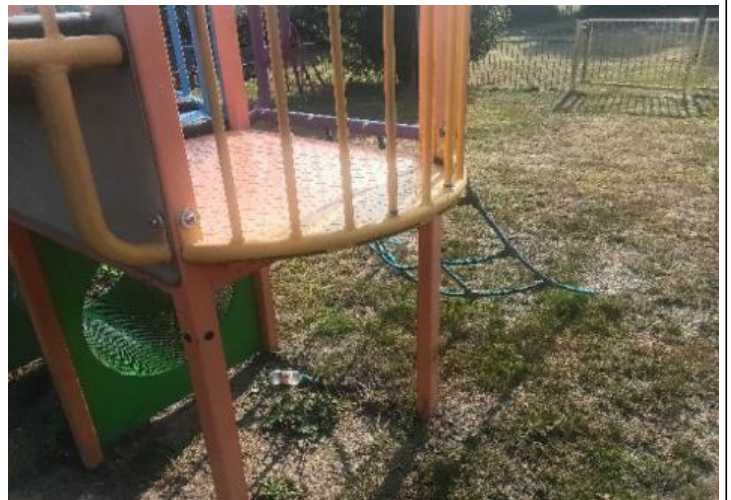
Item: Activity Equipment - Multi Play (Junior)
Manufacturer: Wicksteed Playgrounds

Finding: Cable ties are present and there are sharp projecting ends

Action: Remove

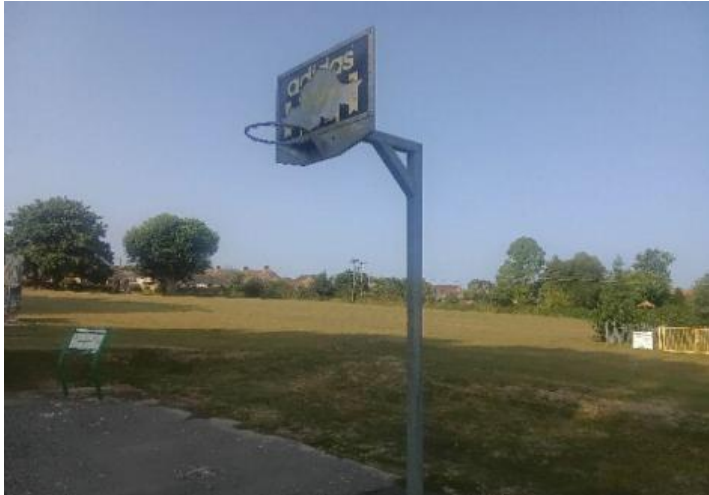
Item: Multi Use Games Area - Basketball Post
Manufacturer: Adidas

Finding: The backboard graphics card is damaged

Action: Replace

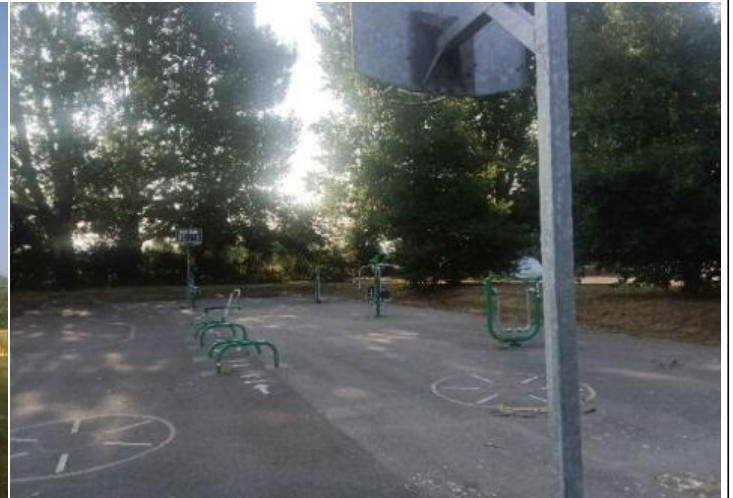
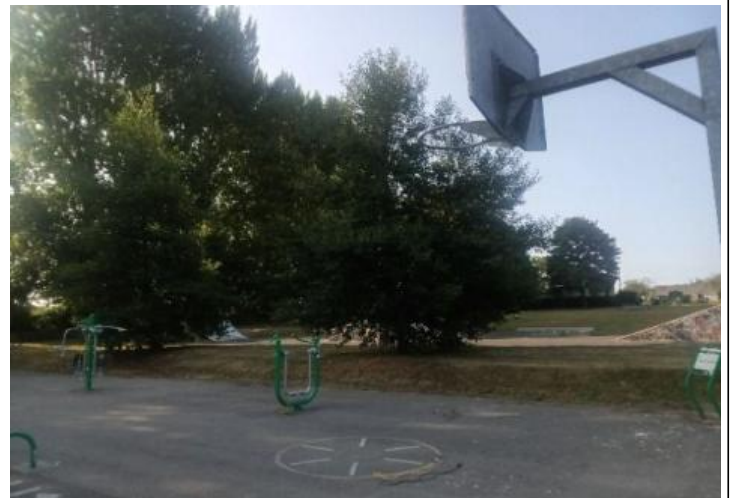
Item: Multi Use Games Area - Basketball Post
Manufacturer: Adidas

Finding: There is a potential conflict between the users of the basketball post and the users of the fitness equipment

Action: Monitor and take appropriate action if required

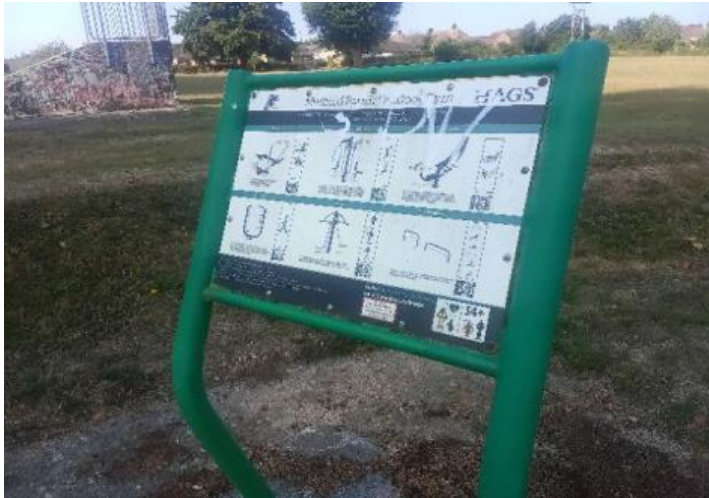
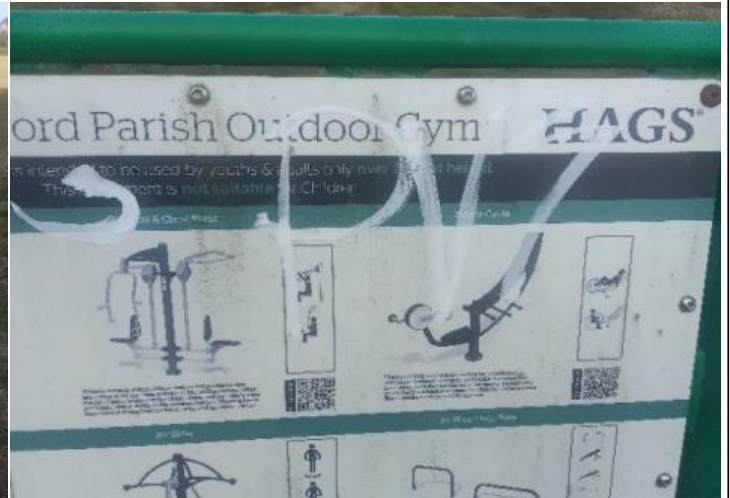
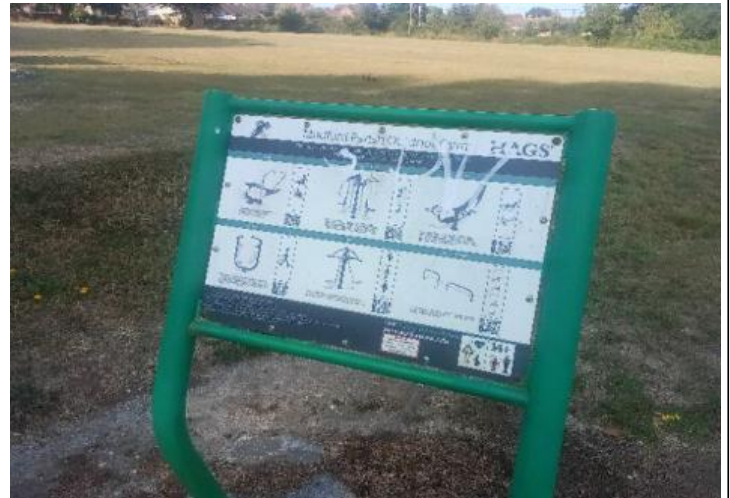
Item: Ancillary Items - Sign
Manufacturer: Hags

Finding: There is some graffiti present

Action: Remove the graffiti

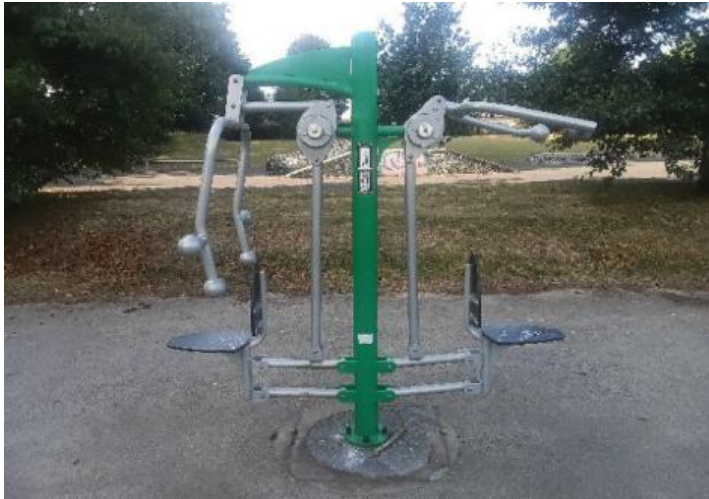
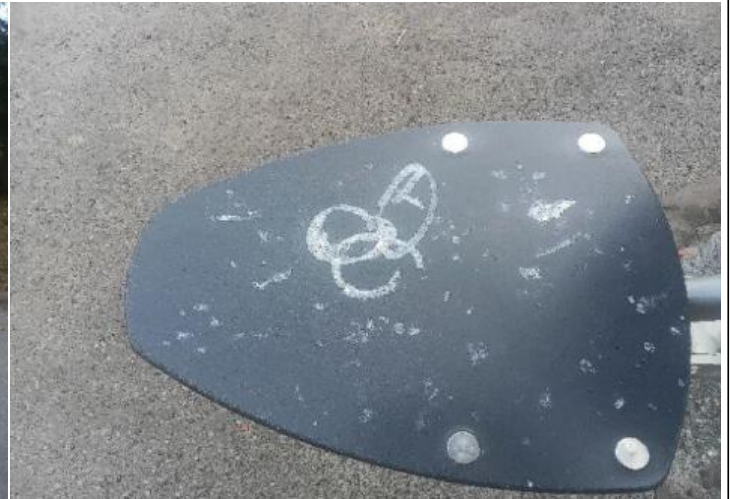
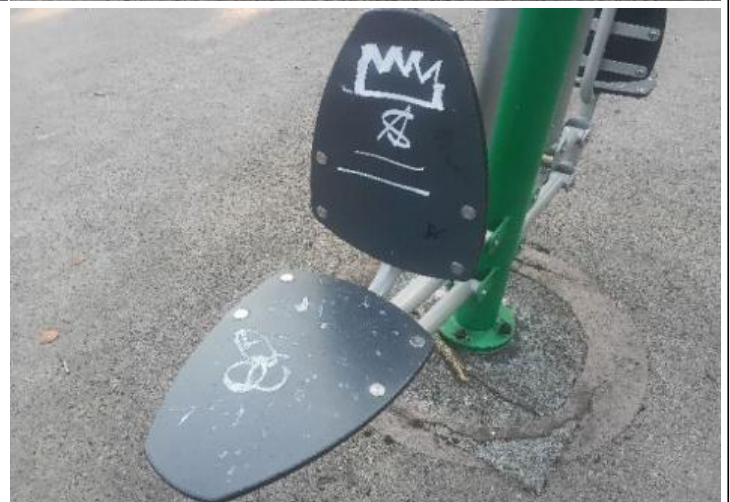
Item: Outdoor Fitness Equipment - Double Fitness Station
Manufacturer: Hags

Finding: There is offensive graffiti present

Action: Remove as soon as practicable

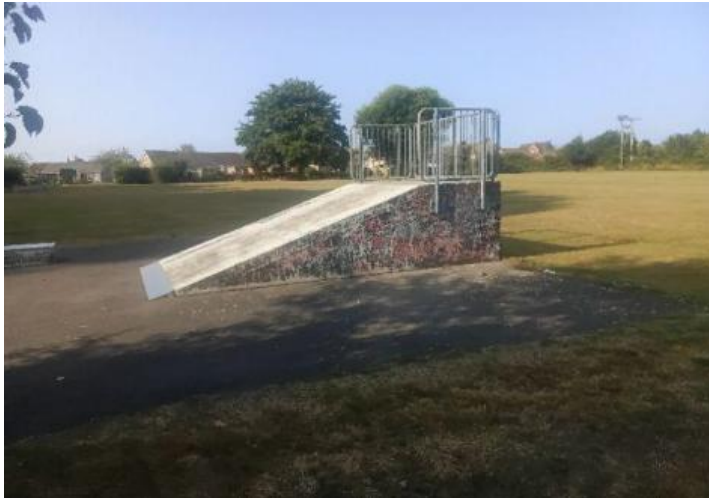
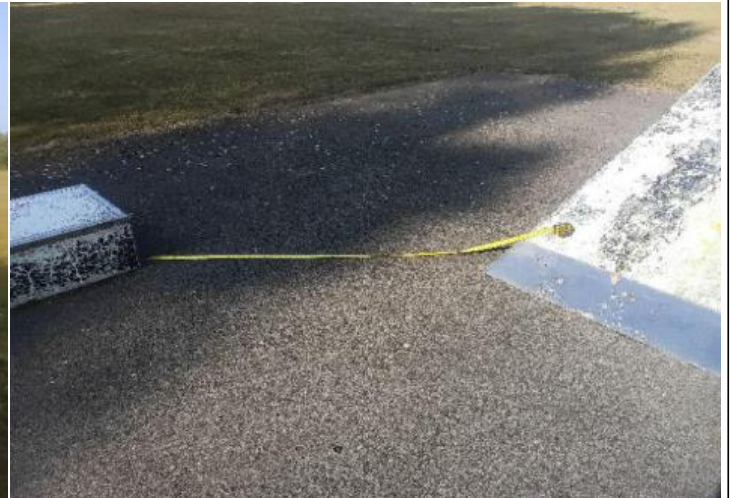
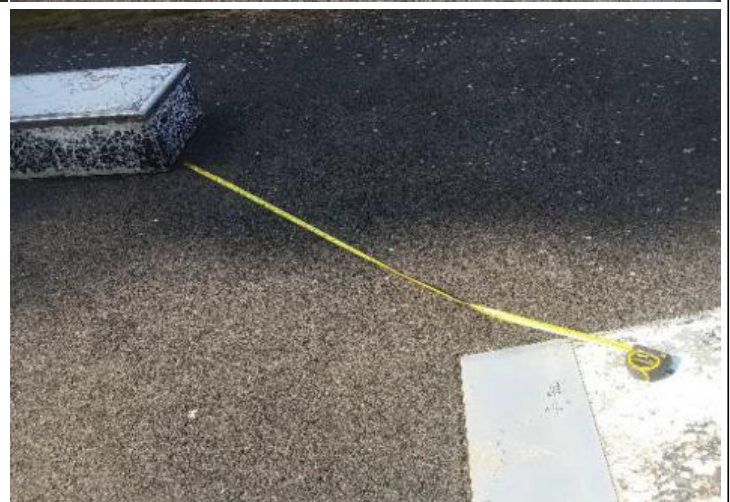
Item: Wheeled Sports - Flat Bank
Manufacturer: Not Identified

Finding: The item has insufficient safety zone allowed as required by BS EN 14974 – 6.4. This should equal at least 2.0 metres on this item

Action: Monitor - No action given the risk assessment

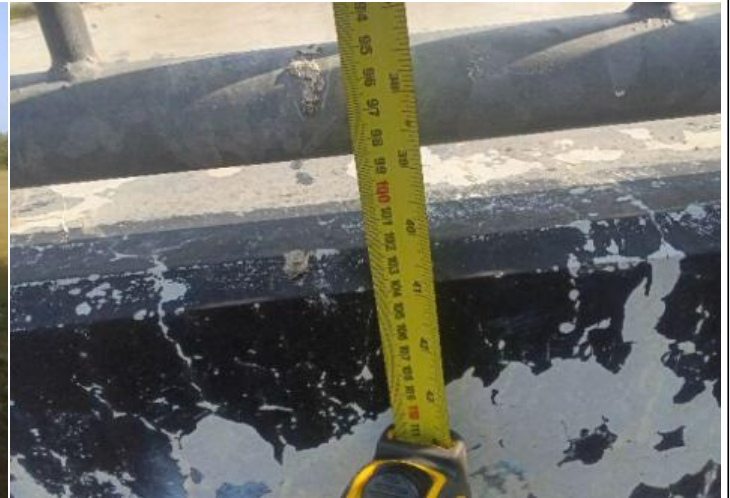
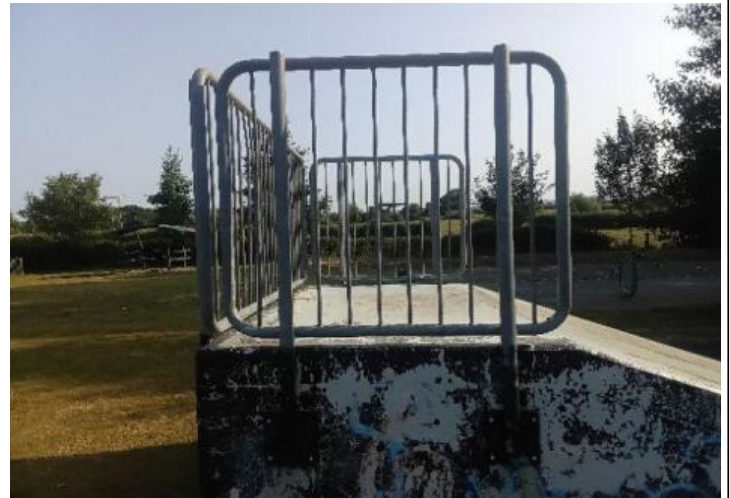
Item: Wheeled Sports - Flat Bank
Manufacturer: Not Identified

Finding: The height of the barrier is less than 1200mm in contravention of BS EN 14974 - 6.2.6. This height must be achieved all around the platform and at a maximum distance of 300mm from the front of the platform.

Action: Monitor - no reasonably practicable action given the risk assessment

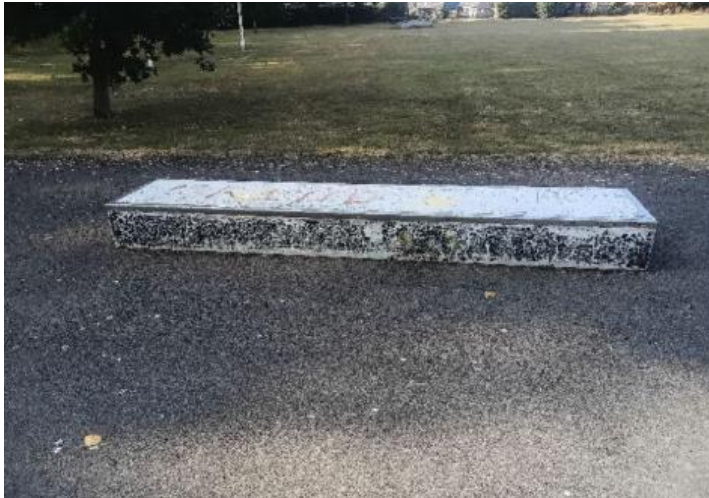
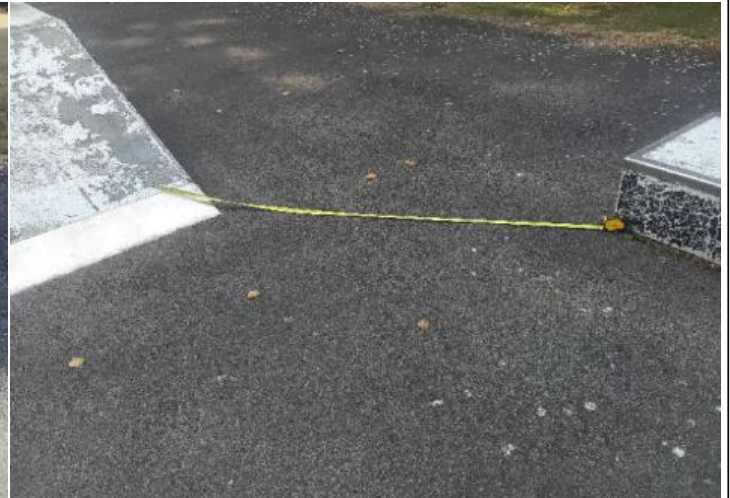
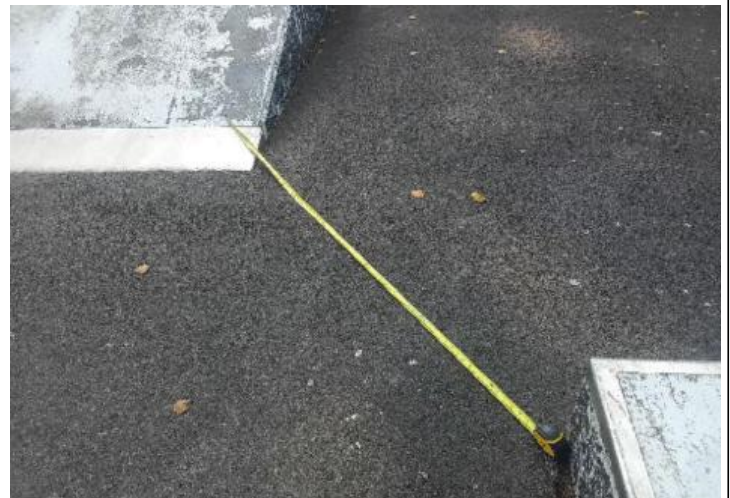
Item: Wheeled Sports - Grind Box
Manufacturer: Not Identified

Finding: The item has insufficient safety zone allowed as required by BS EN 14974 – 6.4. This should equal at least 2.0 metres on this item

Action: Monitor - No action given the risk assessment

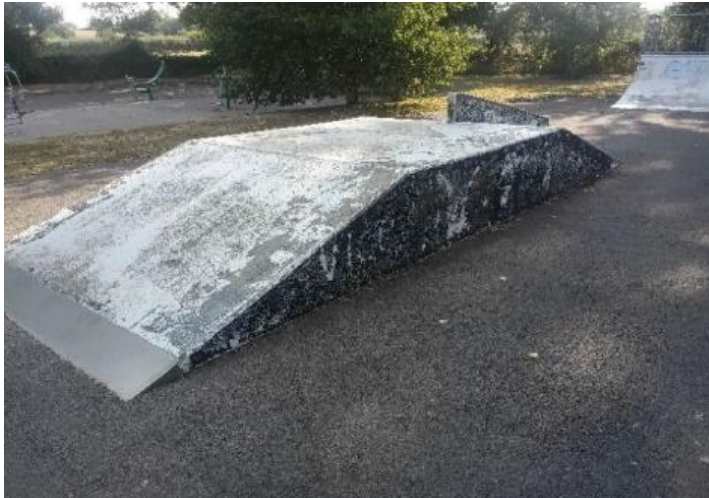
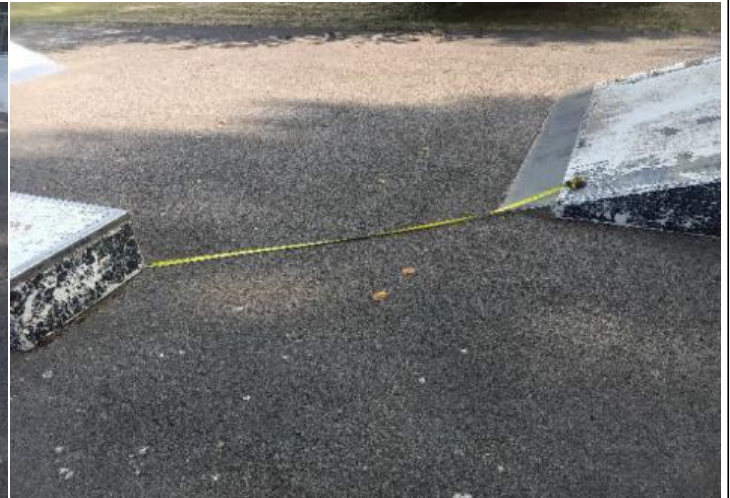
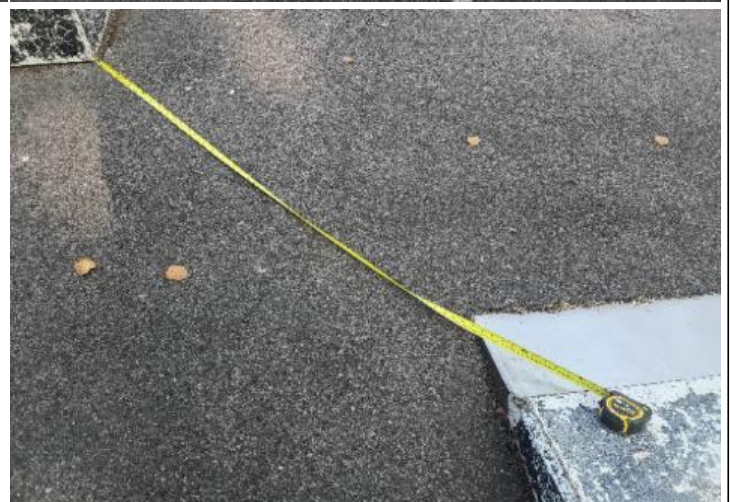
Item: Wheeled Sports - Fun Box
Manufacturer: Not Identified

Finding: The item has insufficient safety zone allowed as required by BS EN 14974 – 6.4. This should equal at least 2.0 metres on this item

Action: Monitor - No action given the risk assessment

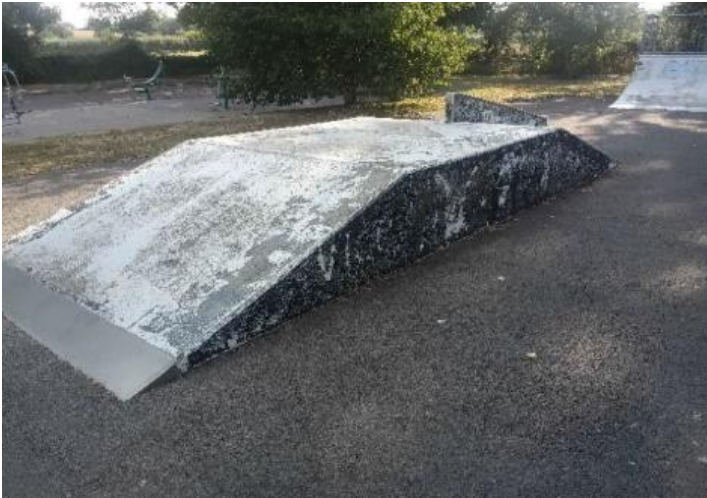
Item: Wheeled Sports - Fun Box
Manufacturer: Not Identified

Finding: The surrounding surface protrudes more than 5mm above the kicker plate level, BS EN 14974 - 6.1.4 recommends a maximum of 5mm
Action: Adjust height to ensure a maximum of 5mm change in level

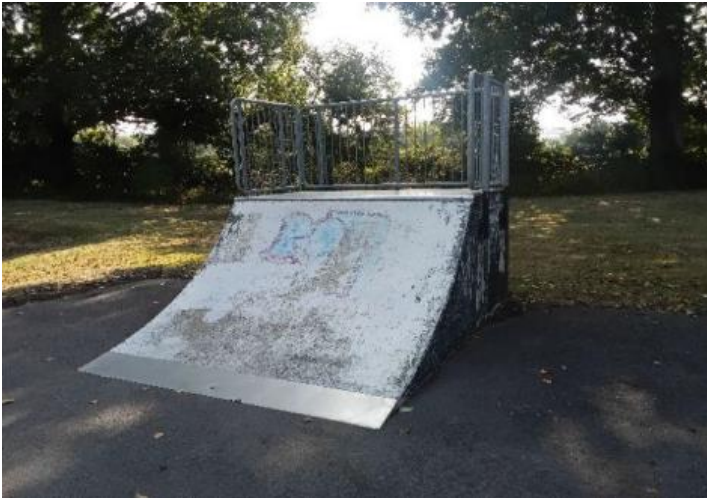
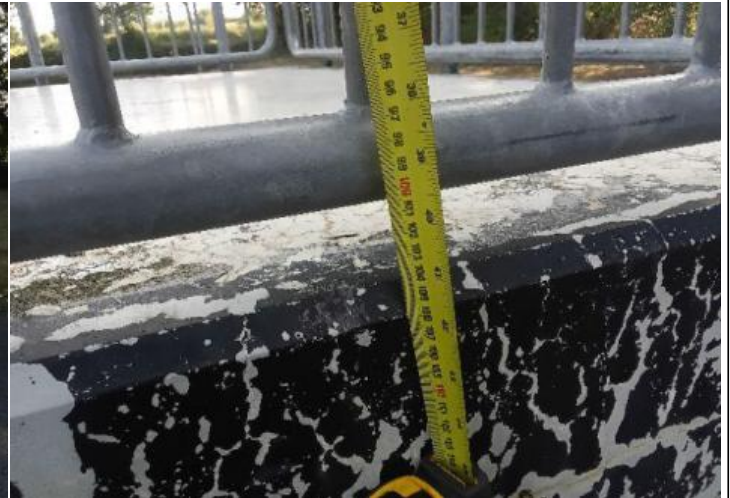
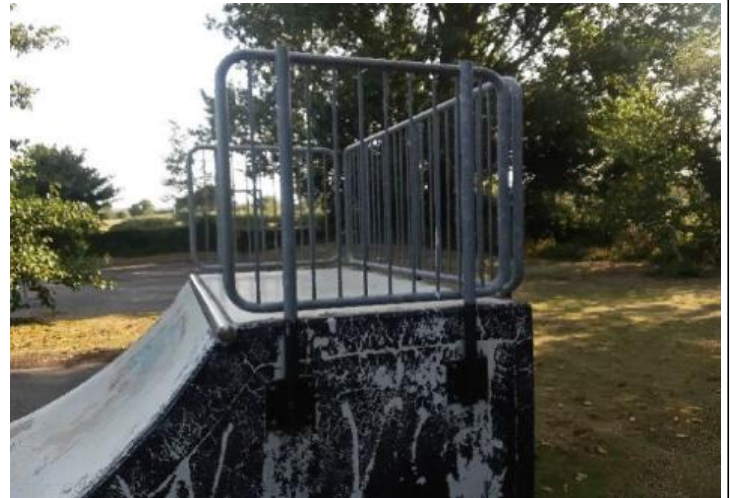
Item: Wheeled Sports - Quarter Pipe
Manufacturer: Not Identified

Finding: The height of the barrier is less than 1200mm in contravention of BS EN 14974 - 6.2.6. This height must be achieved all around the platform and at a maximum distance of 300mm from the front of the platform.

Action: Monitor - no reasonably practicable action given the risk assessment

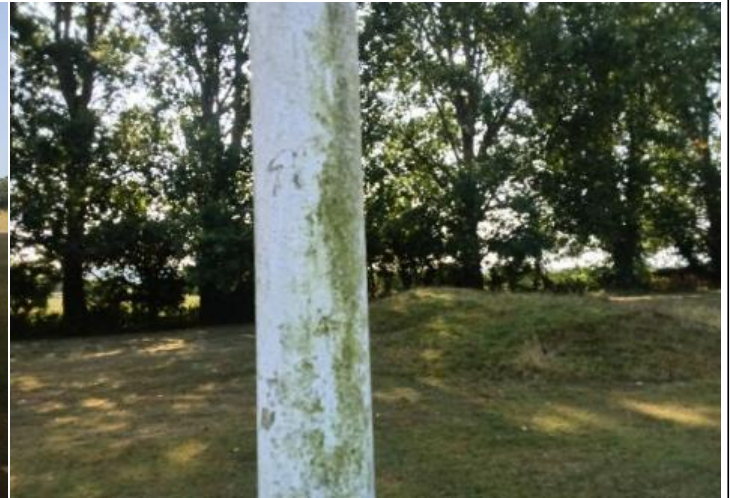
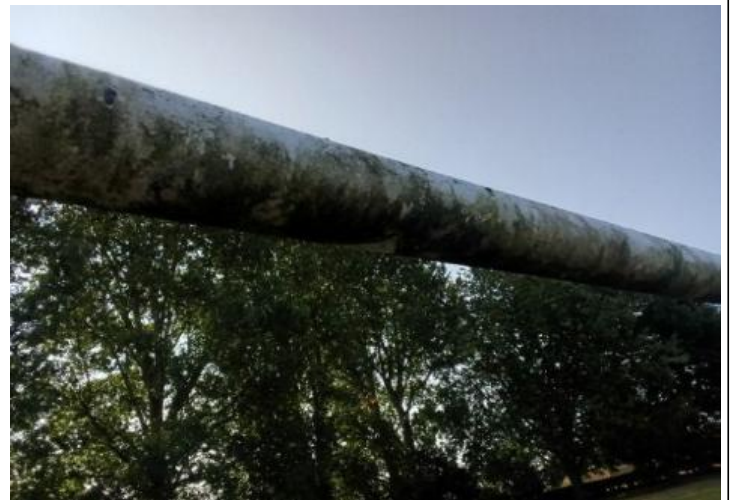
Item: Multi Use Games Area - Football Goal
Manufacturer: Not Identified

Finding: There is algae or moss on the surface of the equipment

Action: Clean and treat appropriately
