# **Supporting Papers**

Mudford Parish Council meeting

24<sup>th</sup> September 2026

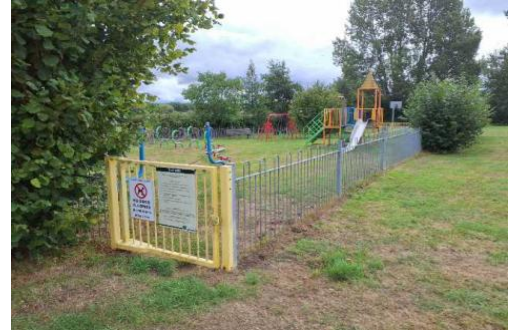
**Item:** Site General  
**Manufacturer:** Owner/Operator  
**Surface Type:** N/A  
**Item Quantity:** 1  
**Equipment Compliance:** Yes  
**Surface Area Compliance:** N/A

There is a potential conflict between the users of the basketball post and the users of the fitness equipment - Monitor and take appropriate action if required

**Finding:** There is a potential conflict between the users of the basketball post and the users of the fitness equipment

**Action:** Monitor and take appropriate action if required

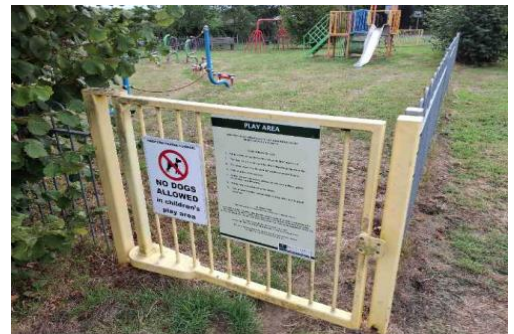
**Item:** Sign  
**Manufacturer:** Not Identified  
**Surface Type:** N/A  
**Item Quantity:** 1  
**Equipment Compliance:** N/A  
**Surface Area Compliance:** N/A

There are projecting bolt thread(s) present - Remove excess thread length and deburr or provide cap

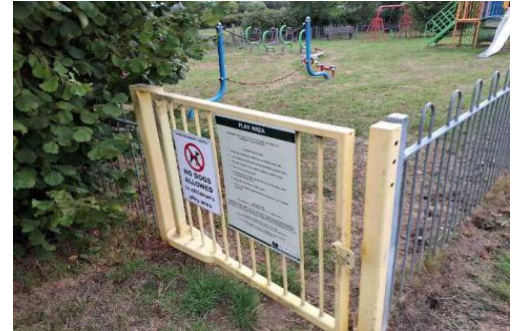
**Item:** Gate - Self Closing  
**Manufacturer:** I.A.E. Fencing  
**Surface Type:** Grass  
**Item Quantity:** 1  
**Equipment Compliance:** N/A  
**Surface Area Compliance:** N/A

There are trip hazards present - Remove trip hazard

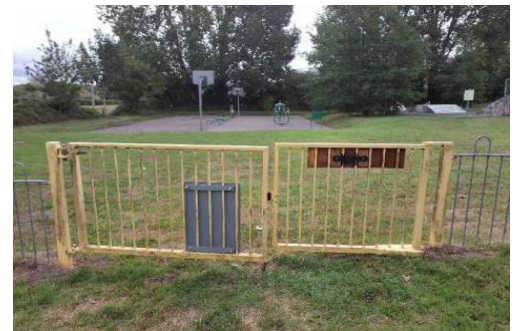
**Item:** Gate - Combination  
**Manufacturer:** I.A.E. Fencing  
**Surface Type:** Grass  
**Item Quantity:** 1  
**Equipment Compliance:** N/A  
**Surface Area Compliance:** N/A

There is no padlock on the maintenance gate - Provide a padlock to secure the gate

**Finding:** The gate has no drop bolt sleeves and/or drop bolts fitted

**Action:** Provide drop bolt sleeves and/or drop bolts

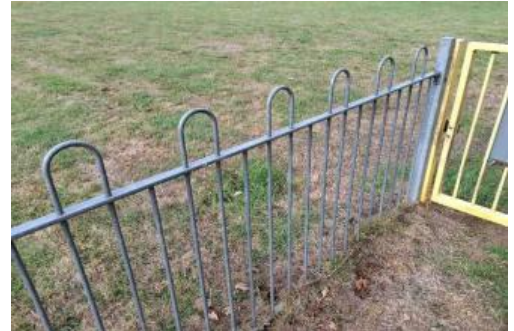
**Item:** Fence - Bow Top  
**Manufacturer:** Not Identified  
**Surface Type:** Grass  
**Item Quantity:** 1  
**Equipment Compliance:** N/A  
**Surface Area Compliance:** N/A

This item is satisfactory - no work required -

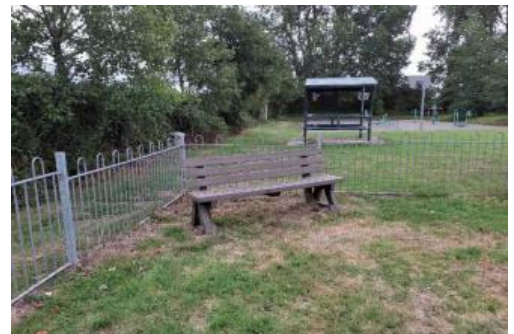
**Item:** Bench  
**Manufacturer:** Not Identified  
**Surface Type:** Grass  
**Item Quantity:** 1  
**Equipment Compliance:** N/A  
**Surface Area Compliance:** N/A

This item is satisfactory - no work required -

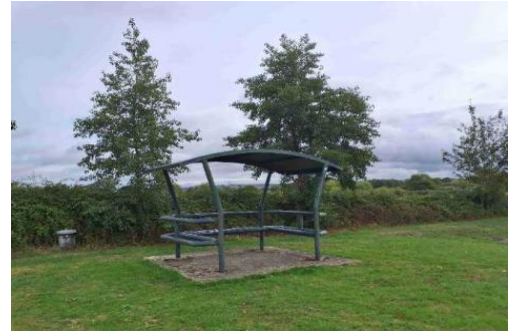
**Item:** Teenage Shelter  
**Manufacturer:** Not Identified  
**Surface Type:** Concrete  
**Item Quantity:** 1  
**Equipment Compliance:** N/A  
**Surface Area Compliance:** N/A

There are trip hazards at the edges of the surface - Remove trip hazard

The paintwork on this item has been damaged or worn exposing the metal underneath which is rusting / corroding - Treat affected areas and repaint

| <b>Item</b> | <b>Page(s)</b> | <b>Clerk's Recommendation</b> |
|---|---|---|
| Teenage Shelter rust/corrosion | 10, 25 | Consider treatment and repainting. |

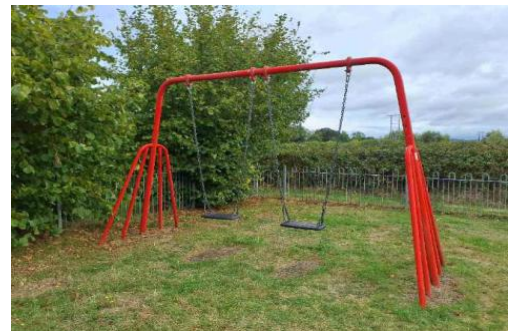
**Item:** 1 Bay 2 Seat (Flat)  
**Manufacturer:** Wicksteed Playgrounds  
**Surface Type:** Grass Matrix Tiles  
**Item Quantity:** 1  
**Equipment Compliance:** No  
**Surface Area Compliance:** Yes

The seats are too close to each other as defined in BS EN 1176 Part 2; this is a low risk failure and no remedial action is required - Monitor - No action given the risk assessment

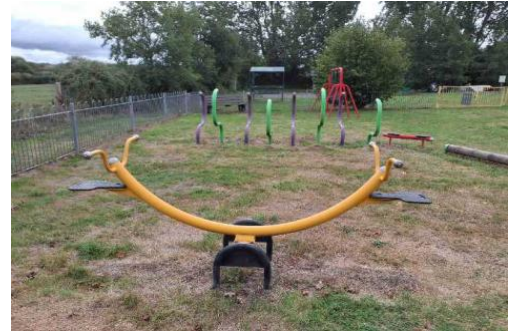
**Item:** See Saw  
**Manufacturer:** Wicksteed Playgrounds  
**Surface Type:** Grass Matrix Tiles  
**Item Quantity:** 1  
**Equipment Compliance:** Yes  
**Surface Area Compliance:** Yes

The torsion joint is very stiff and difficult to operate - Repair or replace

There are trip hazards present - Remove trip hazard

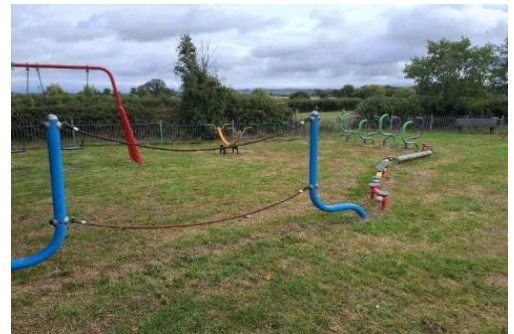
**Item:** Activity Trail  
**Manufacturer:** Wicksteed Playgrounds  
**Surface Type:** Grass  
**Item Quantity:** 1  
**Equipment Compliance:** No  
**Surface Area Compliance:** Yes

The ropes/nets are worn/damaged in places - Monitor for any further deterioration and repair or replace as required

The connecting links are in excess of 8.6mm and less than 12mm and fail the requirements of BS EN 1176 Part 1; clause 4.2.13, Chains - Monitor - No action given the risk assessment

The surface has subsided in some areas - Monitor for any further deterioration and repair as required

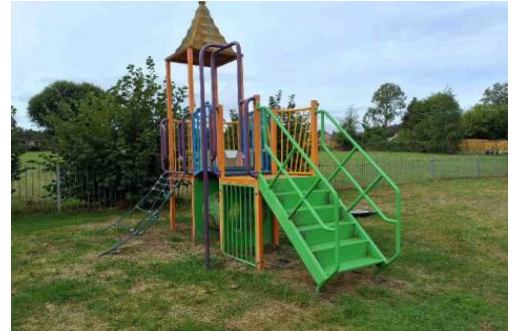
**Item:** Multi Play (Junior)  
**Manufacturer:** Wicksteed Playgrounds  
**Surface Type:** Grass Matrix Tiles  
**Item Quantity:** 1  
**Equipment Compliance:** No  
**Surface Area Compliance:** Yes

The paintwork on this item has been damaged or worn exposing the metal underneath which is rusting / corroding - Treat affected areas and repaint

The item fails to meet the requirements of BS EN 1176 Part 1 4.2.7.2 for head and neck entrapment in the netting due to a loose rope connector - Adjust and secure the rope connector to remove the entrapments

The ropes/nets are worn/damaged in places - Monitor for any further deterioration and repair or replace as required

| <b>Item</b> | <b>Page(s)</b> | <b>Clerk's Recommendation</b> |
|---|---|---|
| Multi Play Junior climbing net | 12, 30 | Consider obtaining quotations to remove the entrapment issue or replace the unit as it shows signs of wear and damage (last year's enquiry – around £1,000 for new climbing net) |
| Multi Play Junior rust/corrosion | 12, 29 | Consider treatment and repainting. |

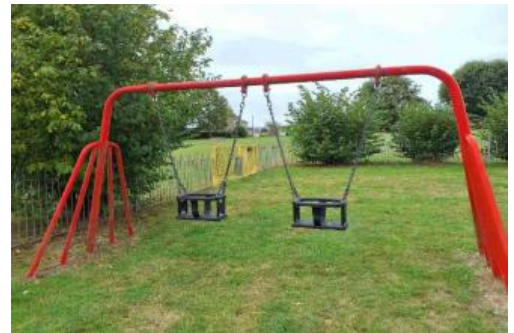
**Item:** 1 Bay 2 Seat (Cradle)  
**Manufacturer:** Wicksteed Playgrounds  
**Surface Type:** Grass Matrix Tiles  
**Item Quantity:** 1  
**Equipment Compliance:** Yes  
**Surface Area Compliance:** Yes

This item is satisfactory - no work required -

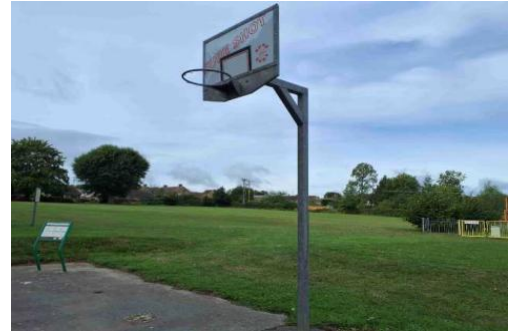
**Item:** Basketball Post  
**Manufacturer:** Adidas  
**Surface Type:** Bitmac  
**Item Quantity:** 2  
**Equipment Compliance:** Yes  
**Surface Area Compliance:** N/A

The backboard graphics card is damaged - Replace

There is some minor damage to the surface - Monitor for any further deterioration and repair as required

| Blackboard | 13 | Consider replacement of the damaged basketball card (last year's replacement of the other card cost £175 + VAT plus labour) |

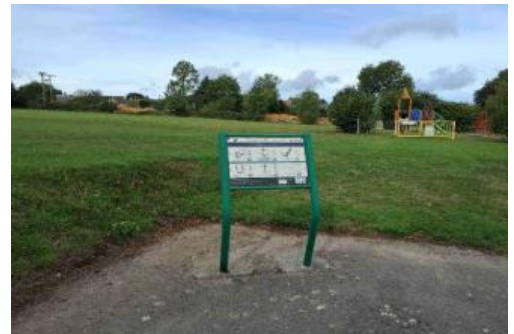
**Item:** Sign  
**Manufacturer:** Hags  
**Surface Type:** Bitmac  
**Item Quantity:** 1  
**Equipment Compliance:** N/A  
**Surface Area Compliance:** N/A

This item is satisfactory - no work required -

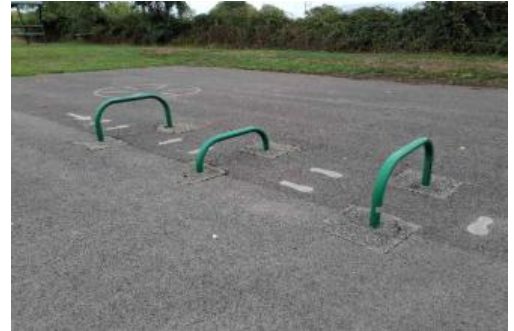
**Item:** Push Up Station  
**Manufacturer:** Hags  
**Surface Type:** Bitmac  
**Item Quantity:** 1  
**Equipment Compliance:** Yes  
**Surface Area Compliance:** Yes

This item is satisfactory - no work required -

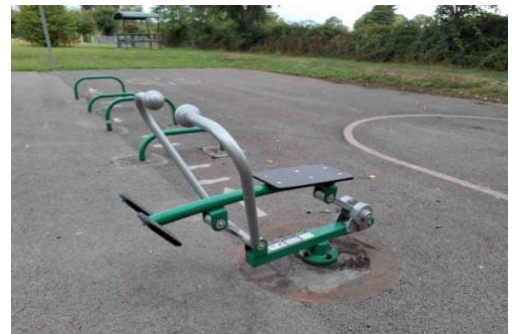
**Item:** Rower  
**Manufacturer:** Hags  
**Surface Type:** Bitmac  
**Item Quantity:** 1  
**Equipment Compliance:** Yes  
**Surface Area Compliance:** Yes

Bolt cap cover/s missing or damaged - Replace

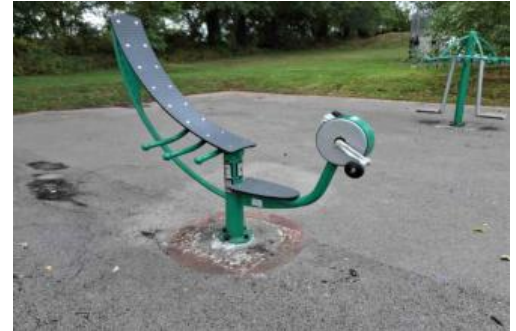
**Item:** Cycle  
**Manufacturer:** Hags  
**Surface Type:** Bitmac  
**Item Quantity:** 1  
**Equipment Compliance:** Yes  
**Surface Area Compliance:** Yes

This item is satisfactory - no work required -

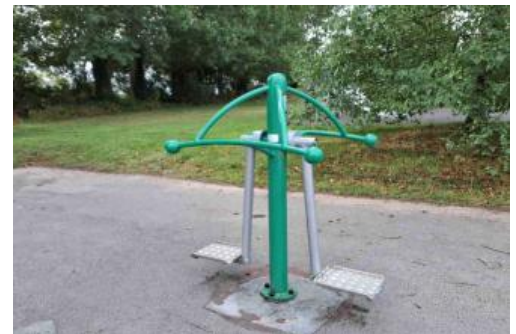
**Item:** Skier  
**Manufacturer:** Hags  
**Surface Type:** Bitmac  
**Item Quantity:** 1  
**Equipment Compliance:** Yes  
**Surface Area Compliance:** Yes

This item is satisfactory - no work required -

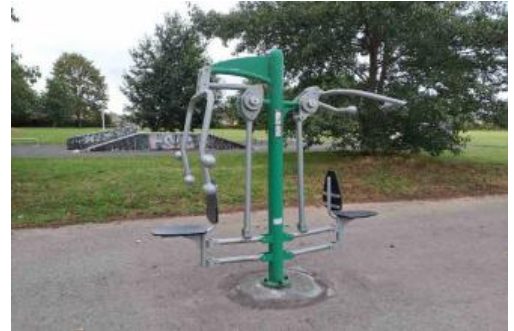
**Item:** Double Fitness Station  
**Manufacturer:** Hags  
**Surface Type:** Bitmac  
**Item Quantity:** 1  
**Equipment Compliance:** Yes  
**Surface Area Compliance:** Yes

This item is satisfactory - no work required -

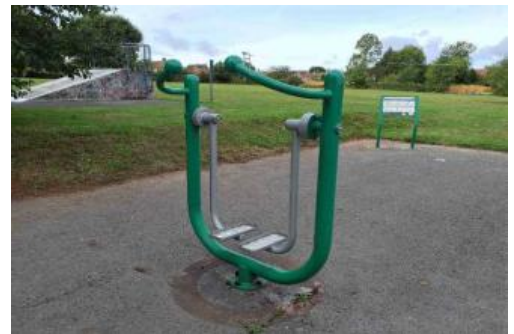
**Item:** Health Walker  
**Manufacturer:** Hags  
**Surface Type:** Bitmac  
**Item Quantity:** 1  
**Equipment Compliance:** Yes  
**Surface Area Compliance:** Yes

This item is satisfactory - no work required -

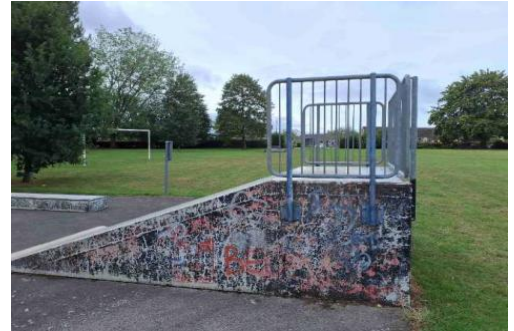
**Item:** Flat Bank  
**Manufacturer:** Not Identified  
**Surface Type:** Bitmac  
**Item Quantity:** 1  
**Equipment Compliance:** No  
**Surface Area Compliance:** No

The item has insufficient safety zone allowed as required by BS EN 14974; 6.4. This should equal at least 2.0 metres on this item - Monitor - No action given the risk assessment

**Finding:** The item has insufficient safety zone allowed as required by BS EN 14974; 6.4. This should equal at least 2.0 metres on this item

**Action:** Monitor - No action given the risk assessment

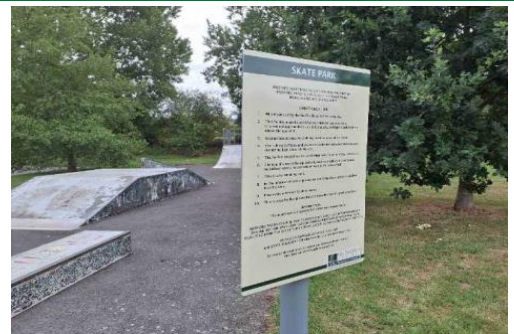
**Item:** Sign  
**Manufacturer:** Not Identified  
**Surface Type:** Grass  
**Item Quantity:** 2  
**Equipment Compliance:** N/A  
**Surface Area Compliance:** N/A

There are projecting bolt thread(s) present - Remove excess thread length and deburr or provide cap

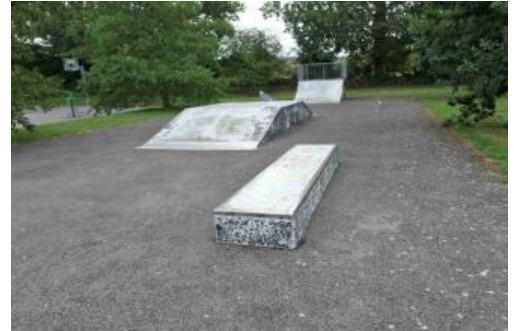
**Item:** Grind Box  
**Manufacturer:** Not Identified  
**Surface Type:** Bitmac  
**Item Quantity:** 1  
**Equipment Compliance:** Yes  
**Surface Area Compliance:** Yes

This item is satisfactory - no work required -

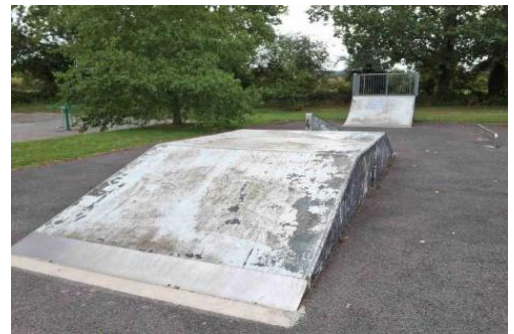
**Item:** Fun Box  
**Manufacturer:** Not Identified  
**Surface Type:** Bitmac  
**Item Quantity:** 1  
**Equipment Compliance:** No  
**Surface Area Compliance:** No

The item has insufficient safety zone allowed as required by BS EN 14974; 6.4. This should equal at least 2.0 metres on this item - Monitor - No action given the risk assessment

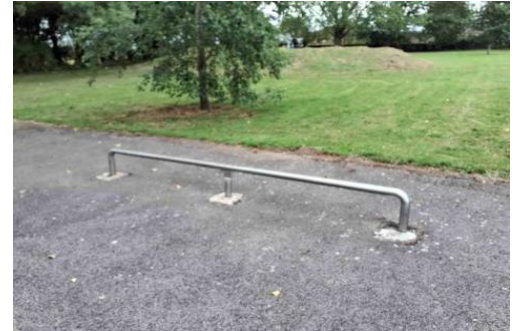
**Item:** Grind Rail  
**Manufacturer:** Not Identified  
**Surface Type:** Bitmac  
**Item Quantity:** 1  
**Equipment Compliance:** Yes  
**Surface Area Compliance:** Yes

The item has been damaged - Monitor for any further deterioration and replace as required

| Grind rail | 37 | Consider grind rail replacement – the concrete anchor also requires replacement/repair. |

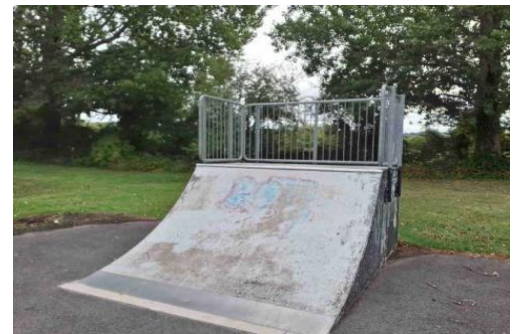
**Item:** Quarter Pipe  
**Manufacturer:** Not Identified  
**Surface Type:** Bitmac  
**Item Quantity:** 1  
**Equipment Compliance:** No  
**Surface Area Compliance:** Yes

The height of the barrier is less than 1200mm in contravention of BS EN 14974 - 6.2.6. This height must be achieved all around the platform and at a maximum distance of 300mm from the front of the platform. - Monitor - no reasonably practicable action given the risk assessment

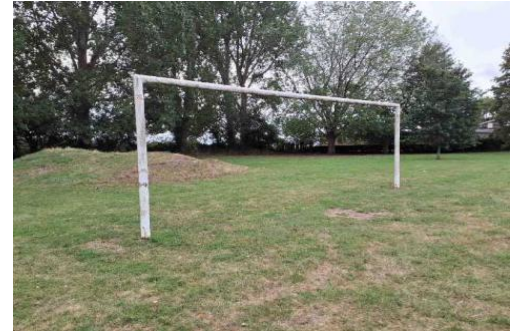
**Item:** Football Goal  
**Manufacturer:** Not Identified  
**Surface Type:** Grass  
**Item Quantity:** 1  
**Equipment Compliance:** N/A  
**Surface Area Compliance:** N/A

NB: We have undertaken a maintenance inspection only of the football goal(s); full load testing falls outside the scope of our inspection. - Implement load testing as required

The paintwork on this item has been damaged or worn exposing the metal underneath which is rusting / corroding - Treat affected areas and repaint

The surface has eroded in some areas and may be slippery in wet conditions - Reinstate the surface

**Finding:** NB: We have undertaken a maintenance inspection only of the football goal(s); full load testing falls outside the scope of our inspection.

**Action:** Implement load testing as required

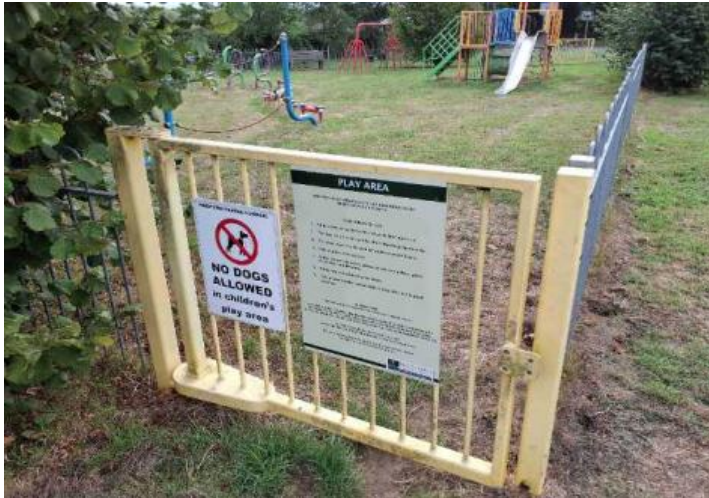
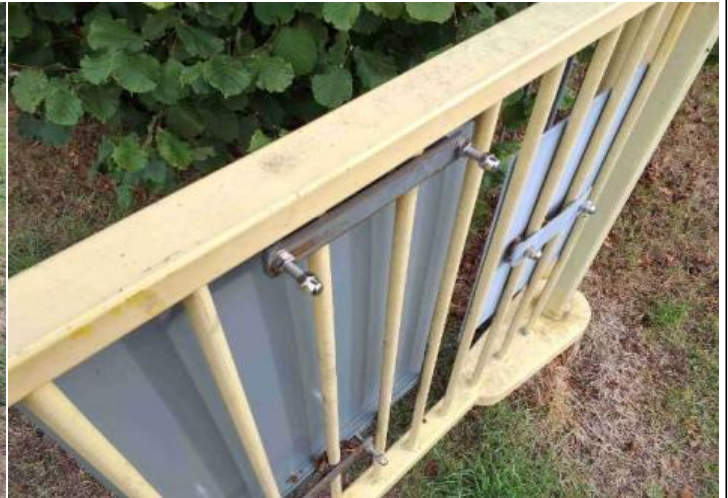
**Item:** Ancillary Items - Sign  
**Manufacturer:** Not Identified

**Finding:** There are projecting bolt thread(s) present

**Action:** Remove excess thread length and deburr or provide cap

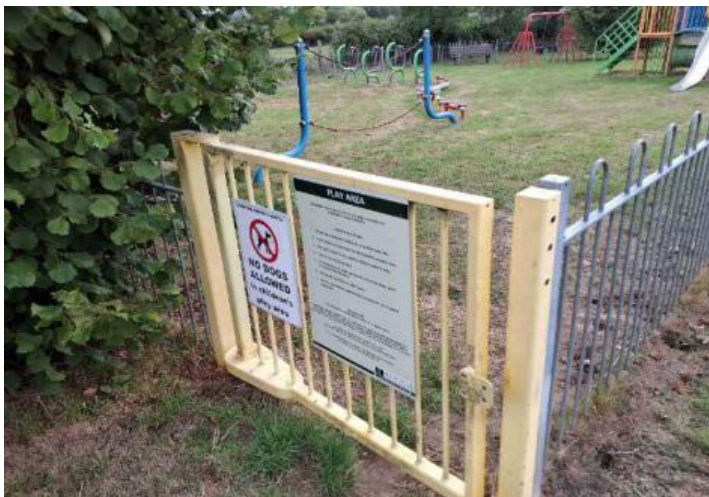
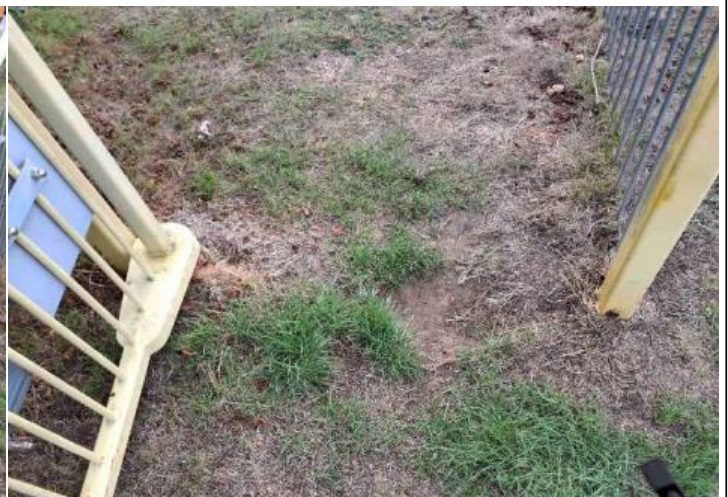
**Item:** Gates - Gate - Self Closing  
**Manufacturer:** I.A.E. Fencing

**Finding:** There are trip hazards present

**Action:** Remove trip hazard

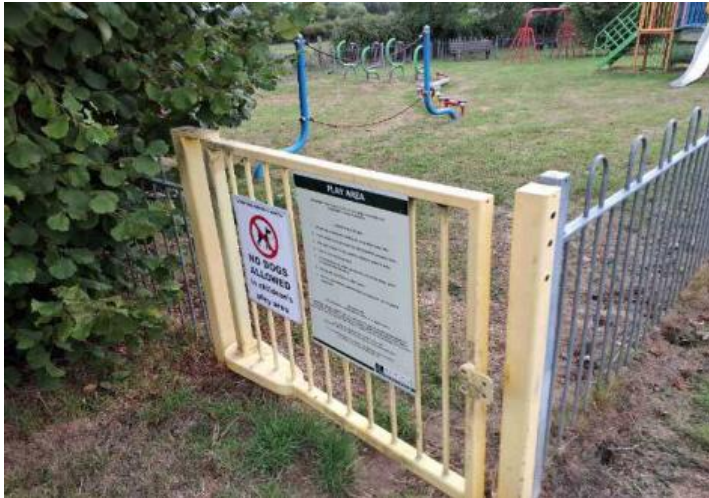
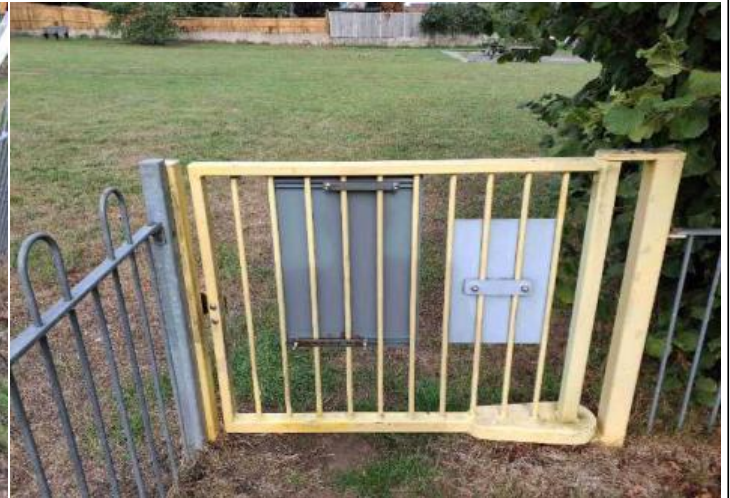
**Item:** Gates - Gate - Self Closing  
**Manufacturer:** I.A.E. Fencing

**Finding:** The gate is closing too quickly (less than 4 seconds)

**Action:** Take corrective action to ensure that the gate closes in 4-8 seconds from 90 degrees

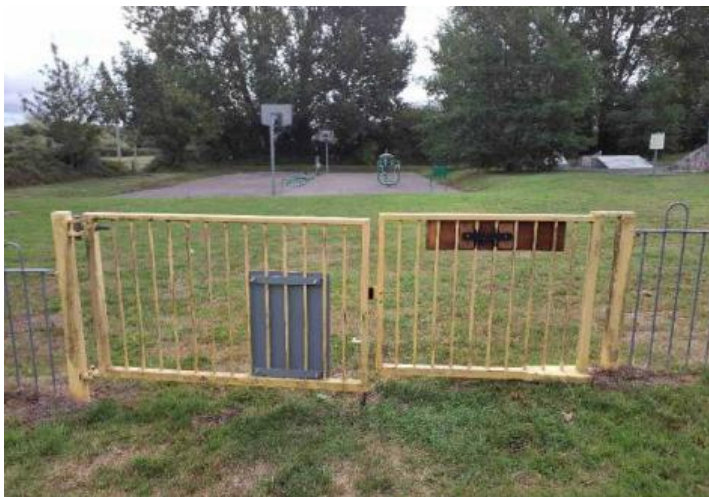
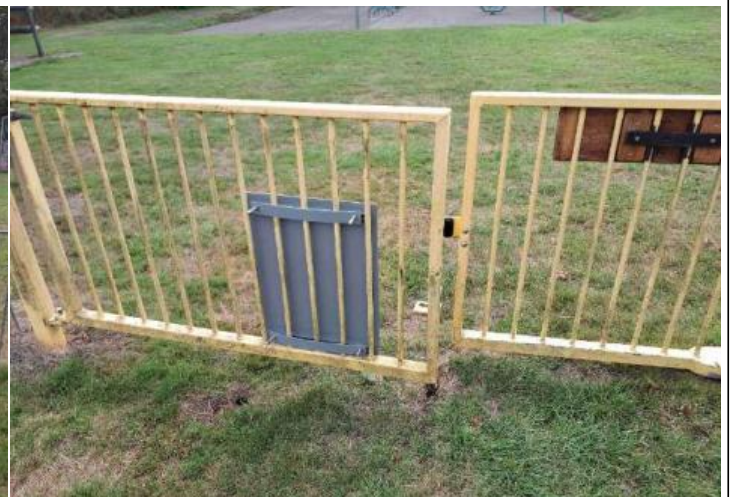
**Item:** Gates - Gate - Combination  
**Manufacturer:** I.A.E. Fencing

**Finding:** There is no padlock on the maintenance gate

**Action:** Provide a padlock to secure the gate

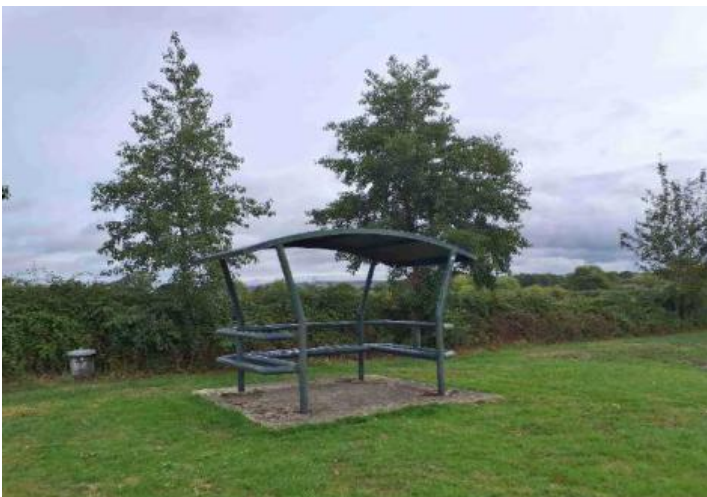
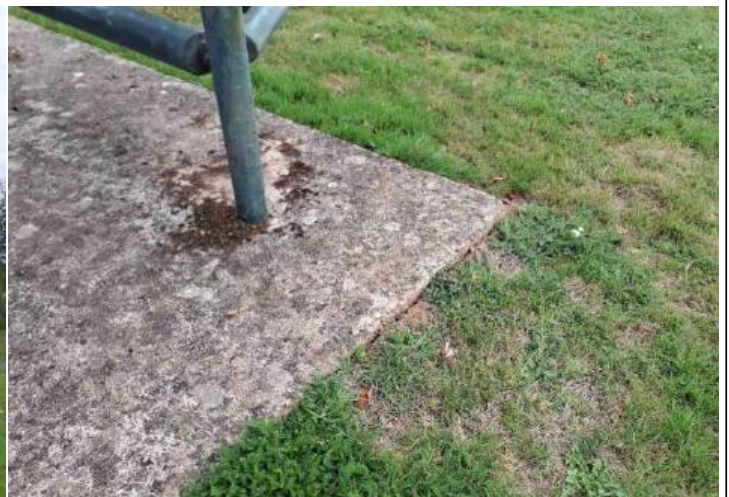
**Item:** Ancillary Items - Teenage Shelter  
**Manufacturer:** Not Identified

**Finding:** There are trip hazards at the edges of the surface

**Action:** Remove trip hazard

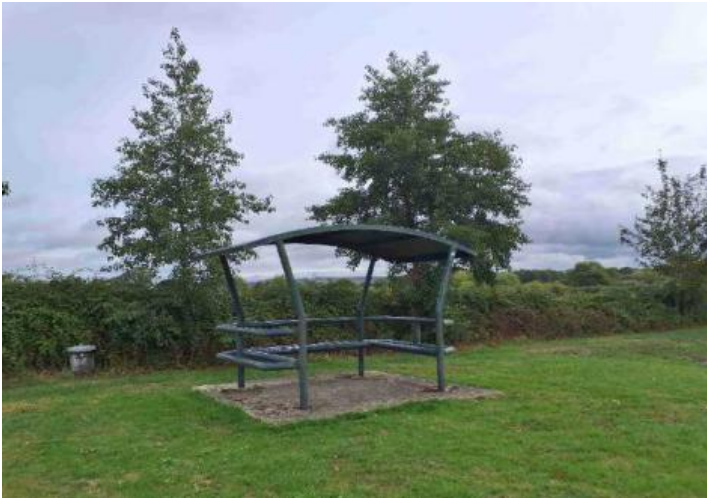
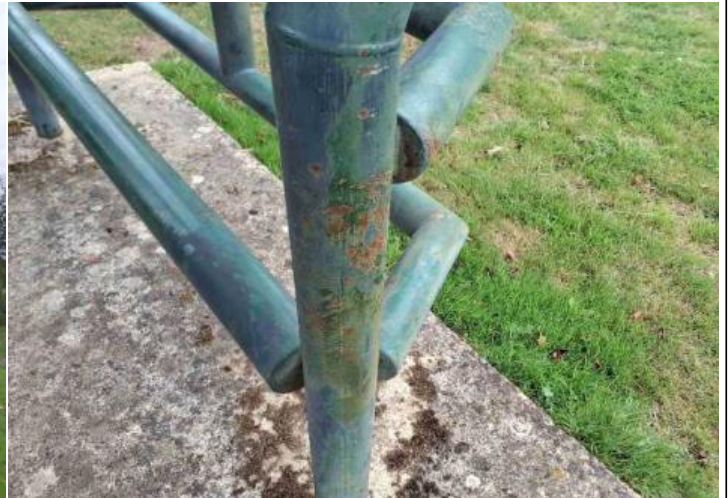
**Item:** Ancillary Items - Teenage Shelter  
**Manufacturer:** Not Identified

**Finding:** The paintwork on this item has been damaged or worn exposing the metal underneath which is rusting / corroding

**Action:** Treat affected areas and repaint

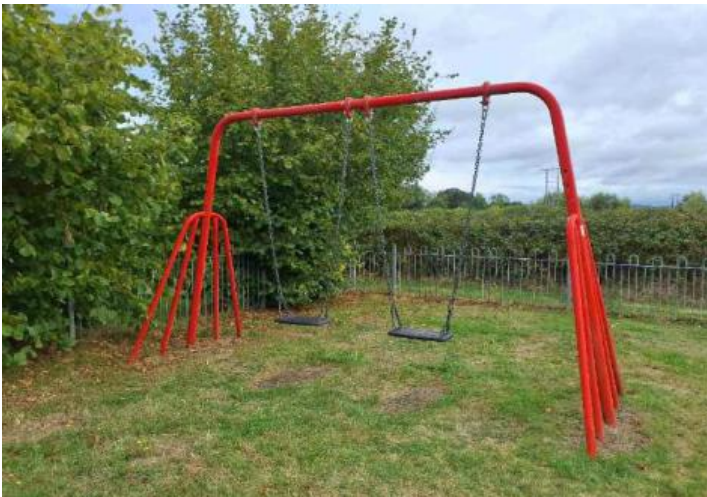
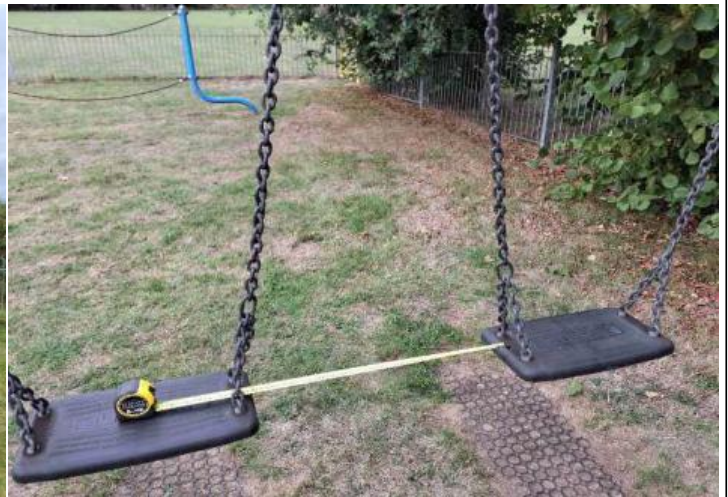
**Item:** Swings - 1 Bay 2 Seat (Flat)  
**Manufacturer:** Wicksteed Playgrounds

**Finding:** The seats are too close to each other as defined in BS EN 1176 Part 2; this is a low risk failure and no remedial action is required

**Action:** Monitor - No action given the risk assessment

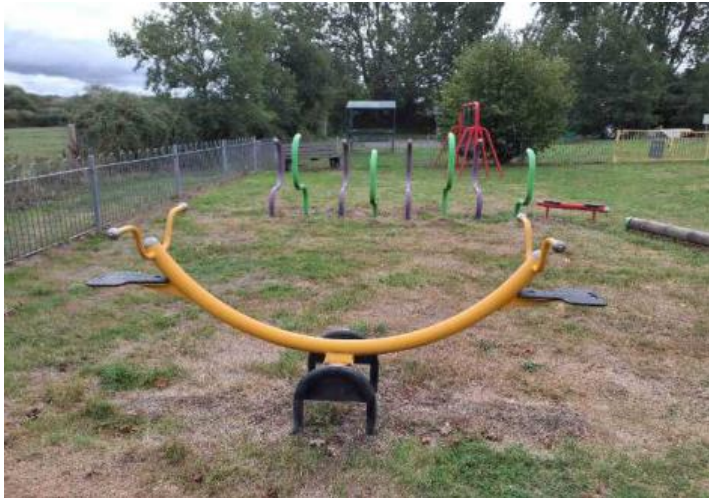
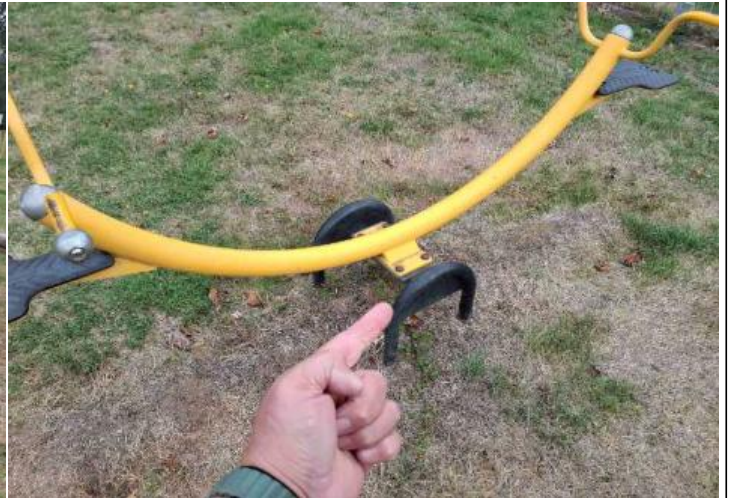
**Item:** Rocking Equipment - See Saw  
**Manufacturer:** Wicksteed Playgrounds

**Finding:** The torsion joint is very stiff and difficult to operate **Action:** Repair or replace

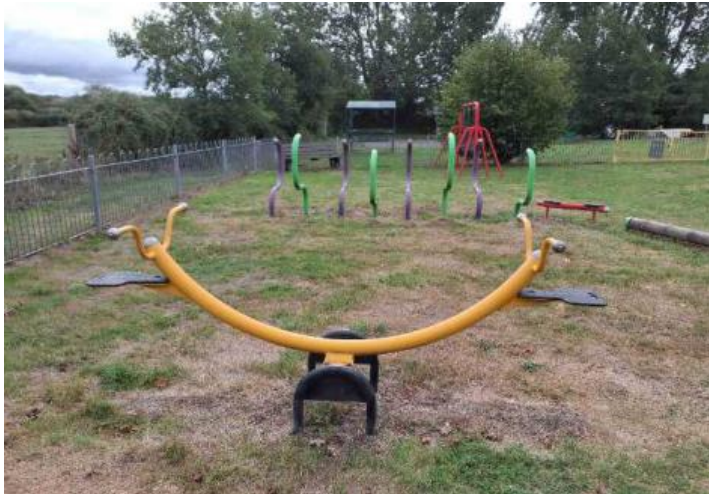
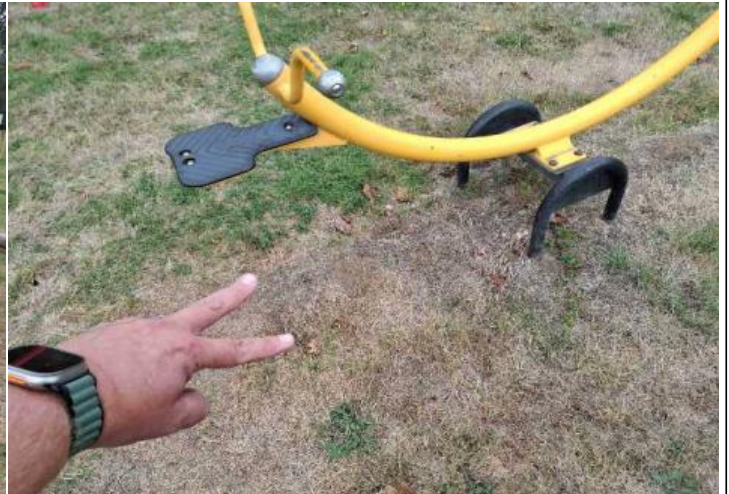
**Item:** Rocking Equipment - See Saw  
**Manufacturer:** Wicksteed Playgrounds

**Finding:** There are trip hazards present **Action:** Remove trip hazard

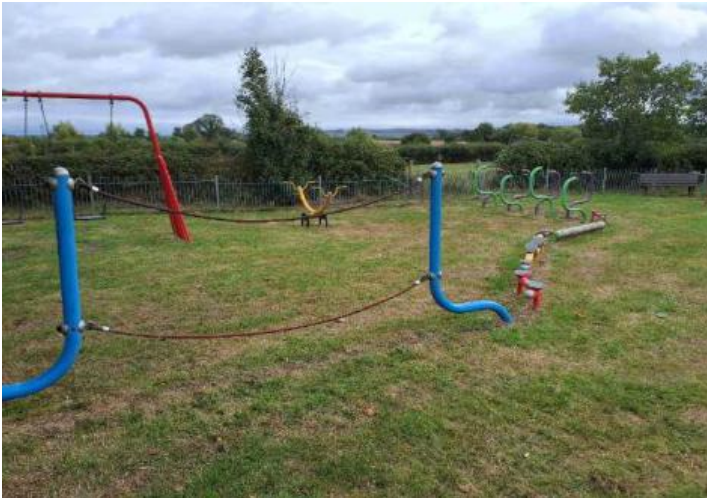
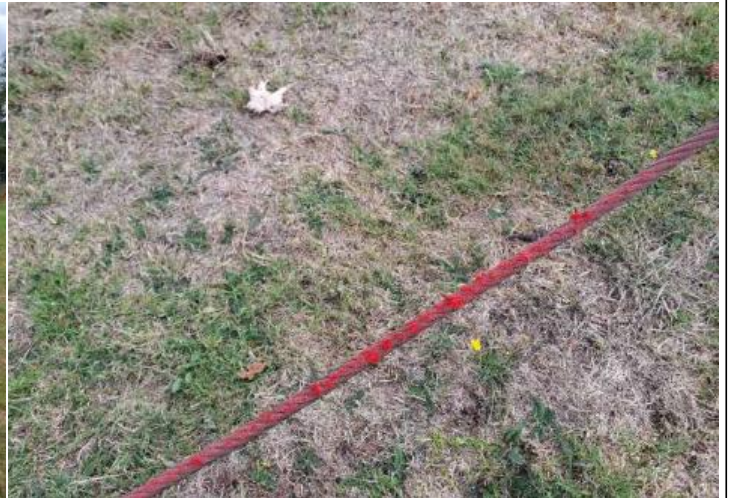
**Item:** Activity Equipment - Activity Trail  
**Manufacturer:** Wicksteed Playgrounds

**Finding:** The ropes/nets are worn/damaged in places

**Action:** Monitor for any further deterioration and repair or replace as required

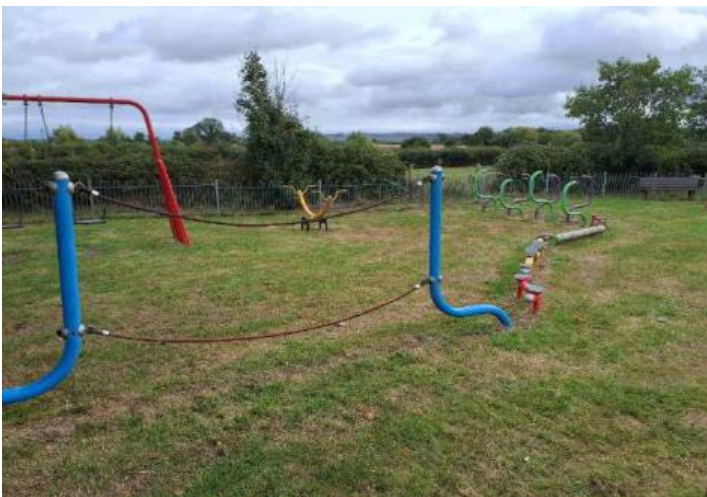
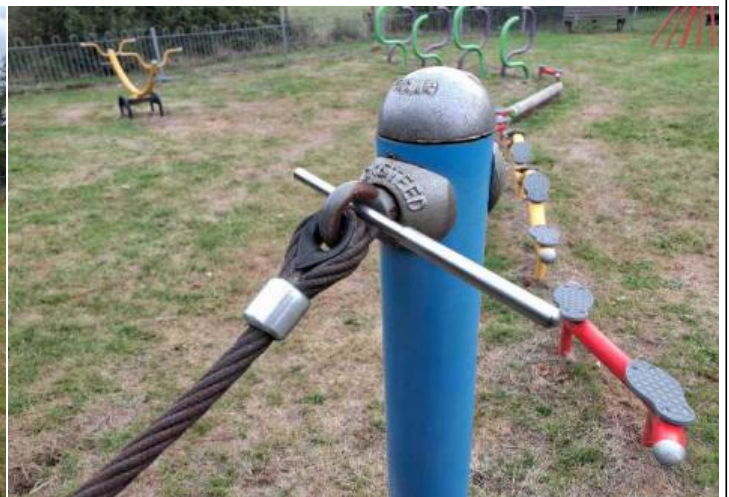
**Item:** Activity Equipment - Activity Trail  
**Manufacturer:** Wicksteed Playgrounds

**Finding:** The connecting links are in excess of 8.6mm and less than 12mm and fail the requirements of BS EN 1176 Part 1; clause 4.2.13, Chains

**Action:** Monitor - No action given the risk assessment

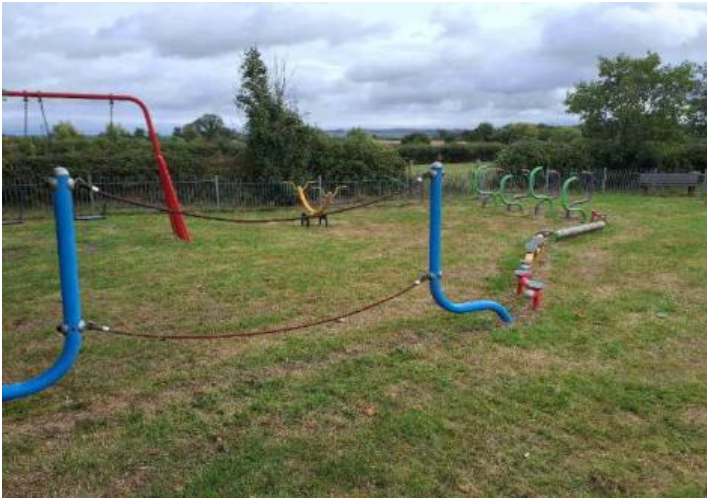
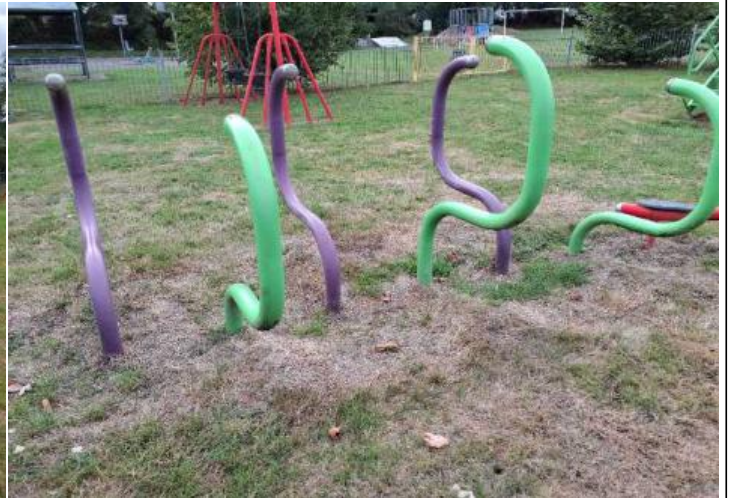
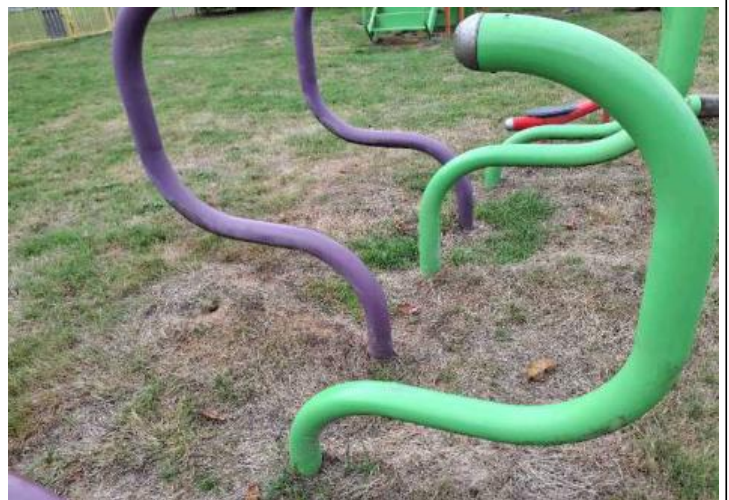
**Item:** Activity Equipment - Activity Trail  
**Manufacturer:** Wicksteed Playgrounds

**Finding:** The surface has subsided in some areas

**Action:** Monitor for any further deterioration and repair as required

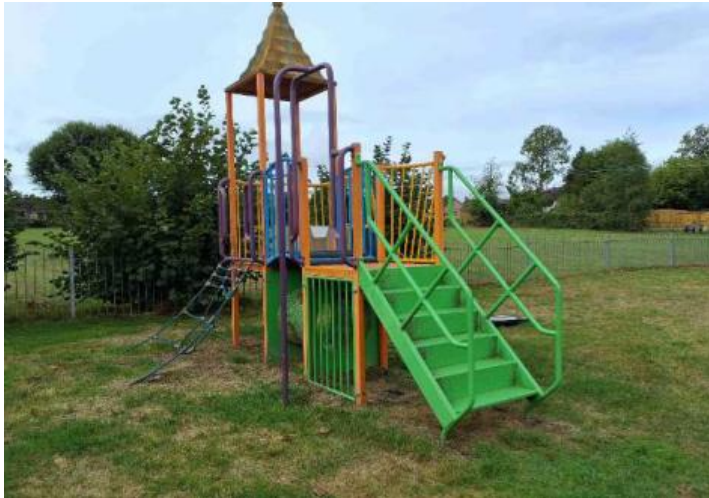
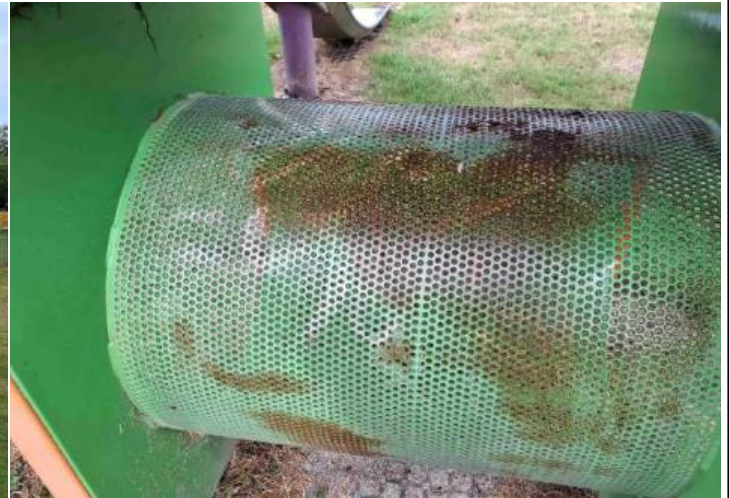
**Item:** Activity Equipment - Multi Play (Junior)  
**Manufacturer:** Wicksteed Playgrounds

**Finding:** The paintwork on this item has been damaged or worn exposing the metal underneath which is rusting / corroding

**Action:** Treat affected areas and repaint

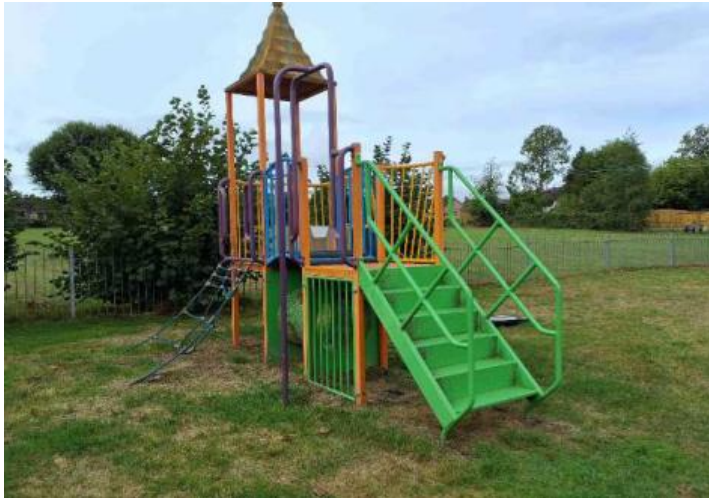
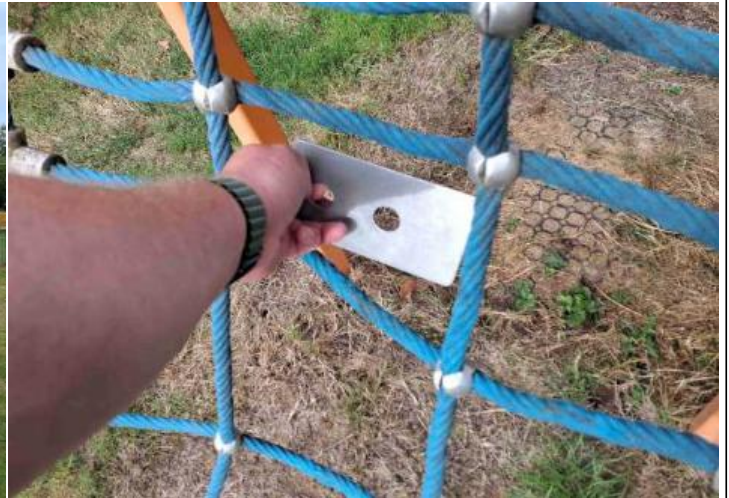
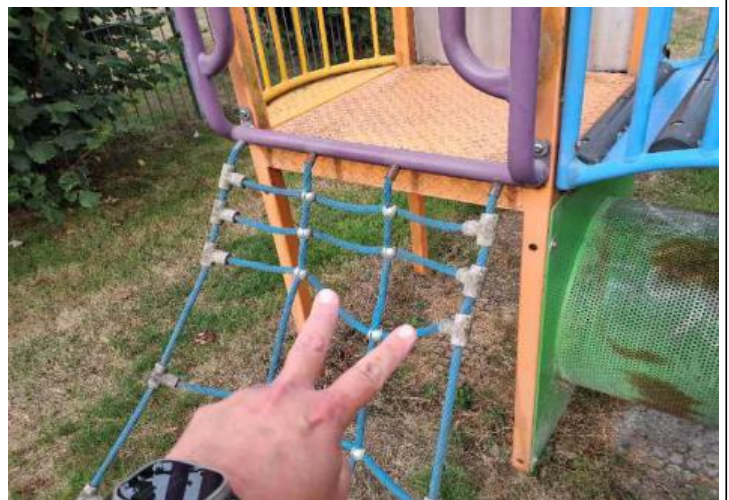
**Finding:** The item fails to meet the requirements of BS EN 1176 Part 1 4.2.7.2 for head and neck entrapment in the netting due to a loose rope connector

**Action:** Adjust and secure the rope connector to remove the entrapments

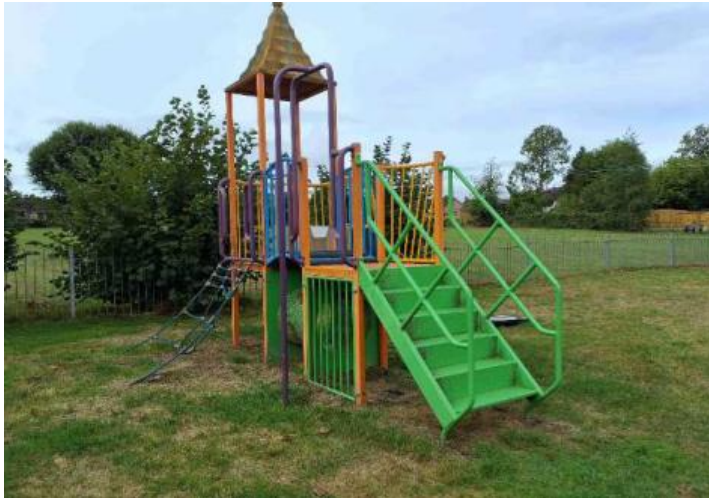
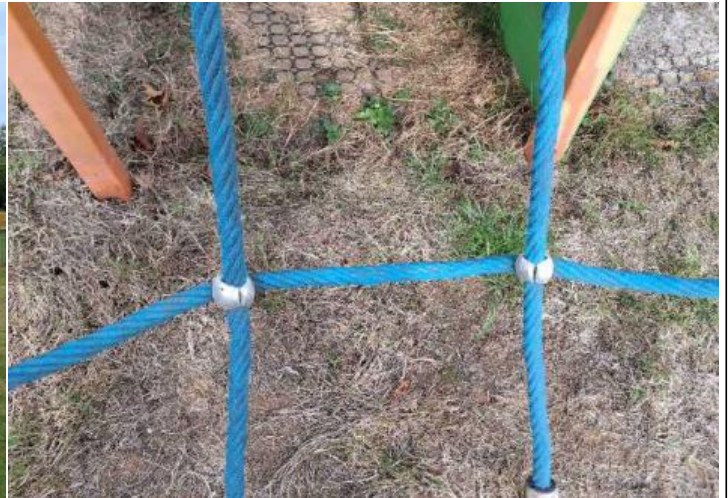
**Finding:** The ropes/nets are worn/damaged in places

**Action:** Monitor for any further deterioration and repair or replace as required

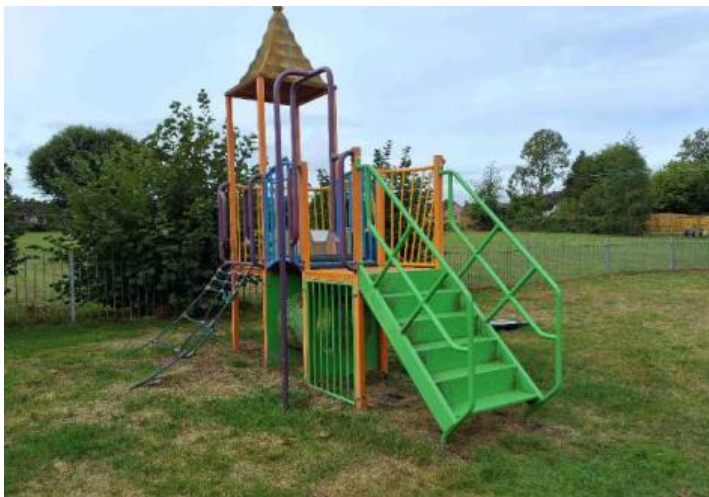
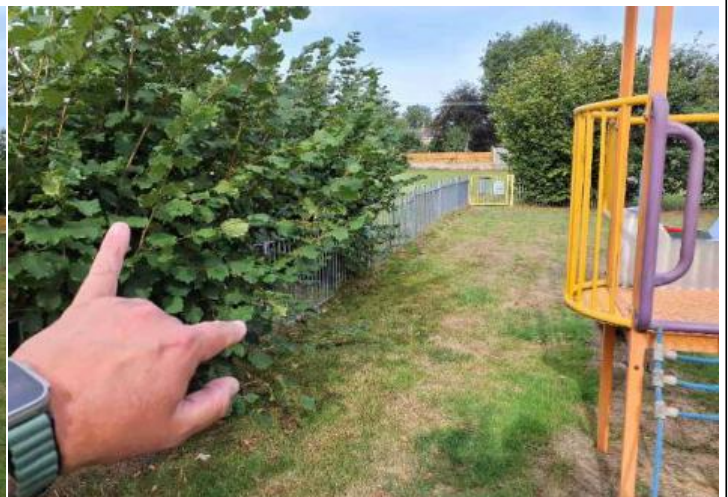
**Finding:** The adjacent foliage is overhanging the falling space

**Action:** Cut back and maintain a clear falling space

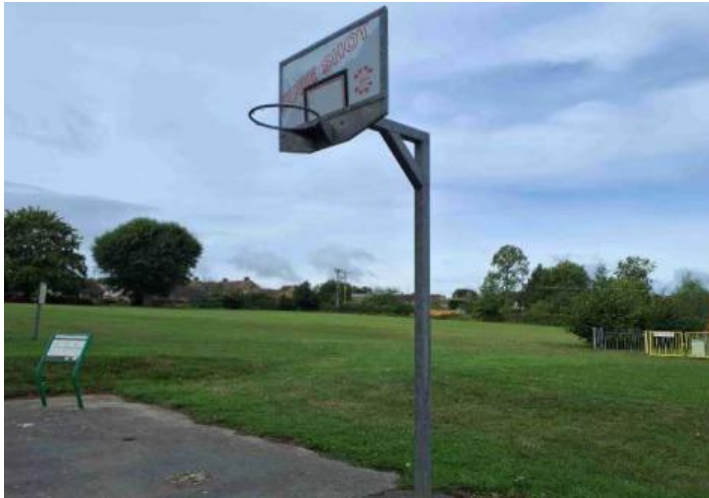
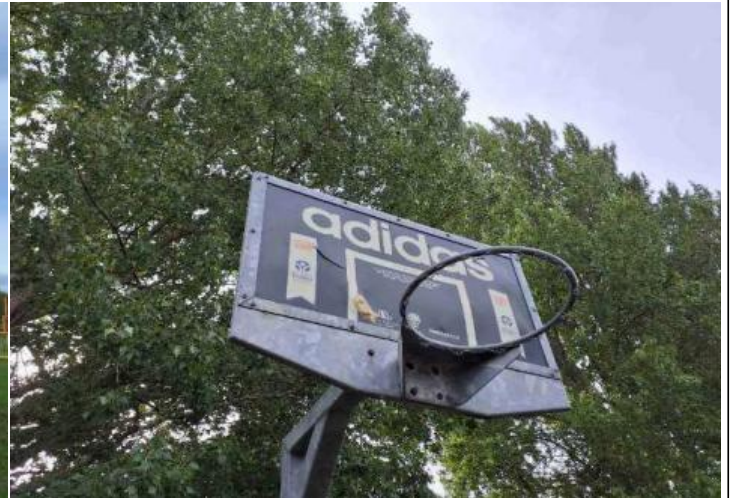
**Item:** Multi Use Games Area - Basketball Post  
**Manufacturer:** Adidas

**Finding:** The backboard graphics card is damaged

**Action:** Replace

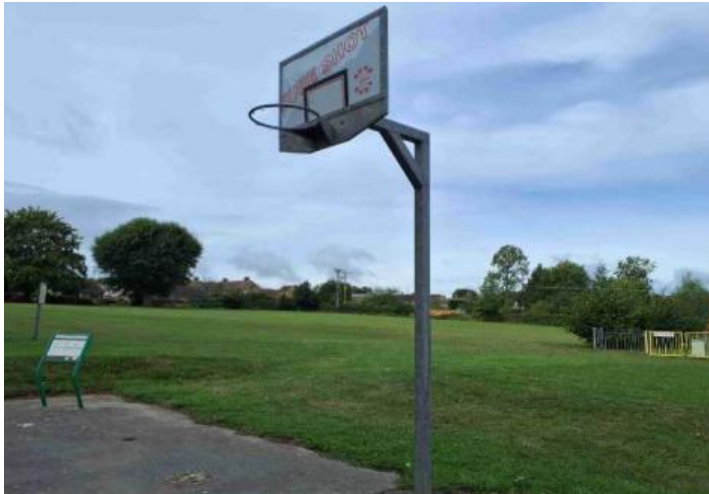
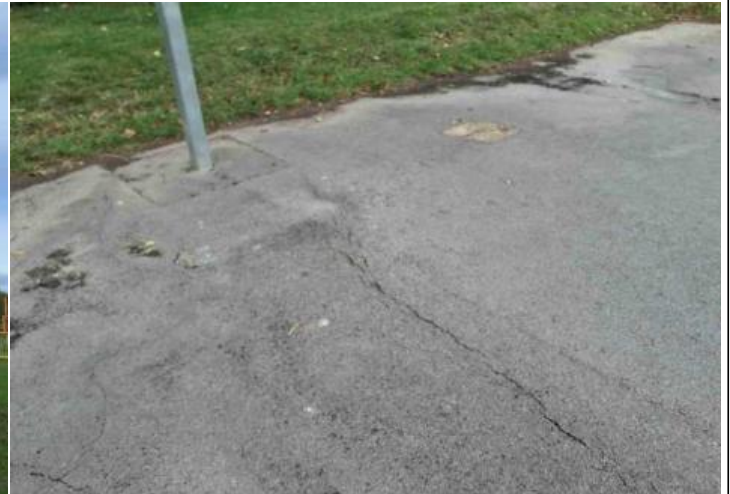
**Finding:** There is some minor damage to the surface

**Action:** Monitor for any further deterioration and repair as required

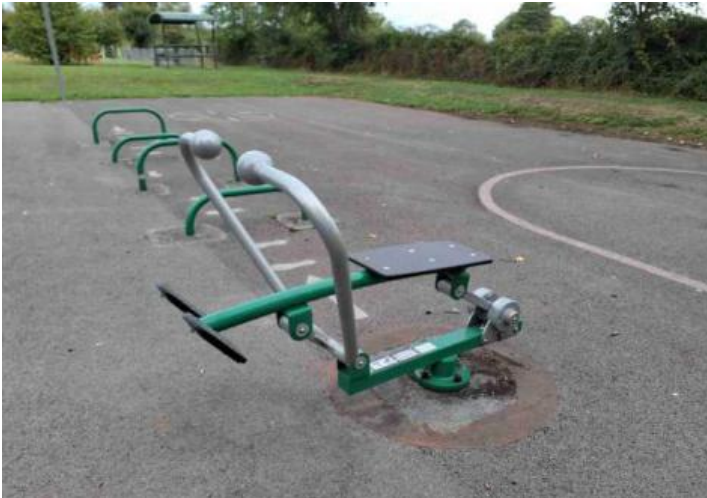
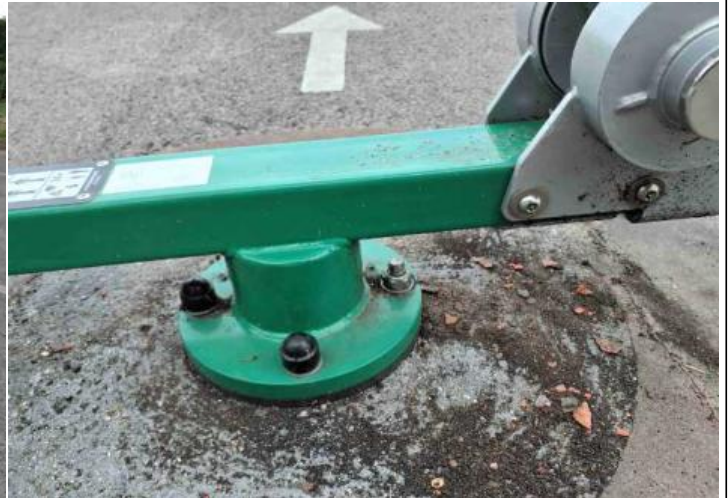
**Finding:** Bolt cap cover/s missing or damaged

**Action:** Replace
