# **Supporting Papers**

Mudford Parish Council meeting

24<sup>th</sup> September 2026

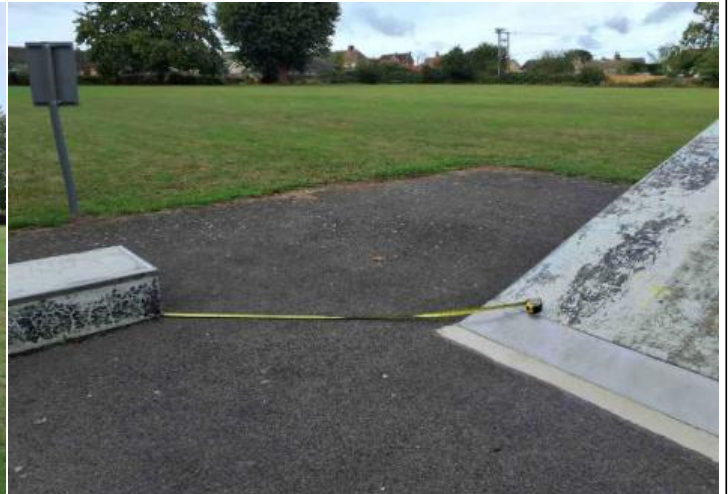
**Finding:** The item has insufficient safety zone allowed as required by BS EN 14974; 6.4. This should equal at least 2.0 metres on this item

**Action:** Monitor - No action given the risk assessment

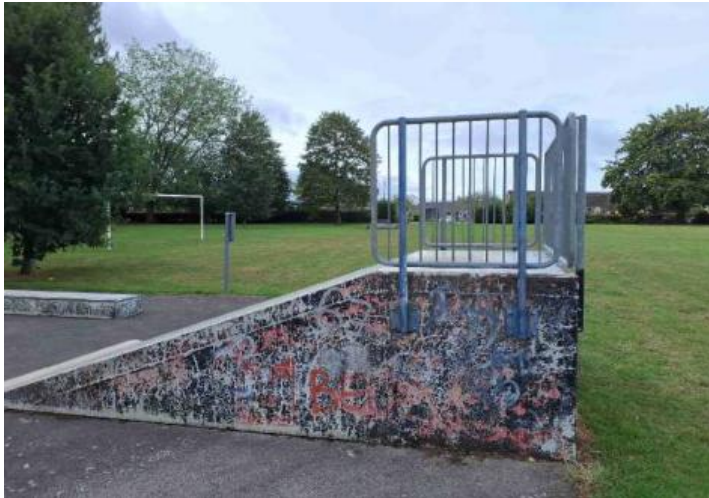
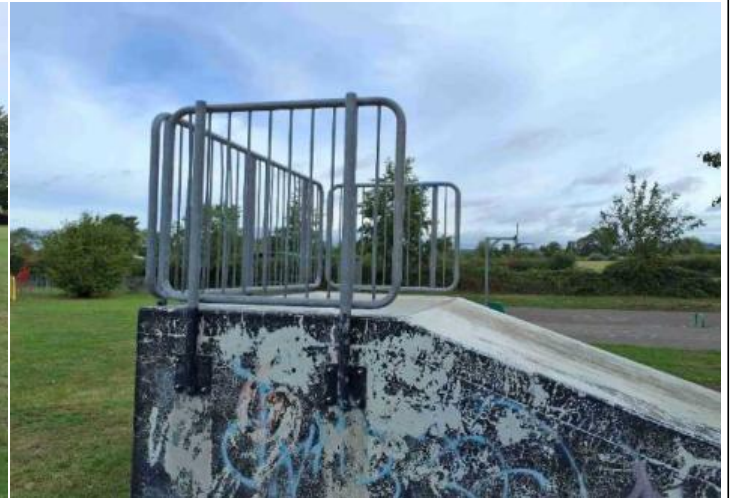
**Finding:** The height of the barrier is less than 1200mm in contravention of BS EN 14974 - 6.2.6. This height must be achieved all around the platform and at a maximum distance of 300mm from the front of the platform.

**Action:** Monitor - no reasonably practicable action given the risk assessment

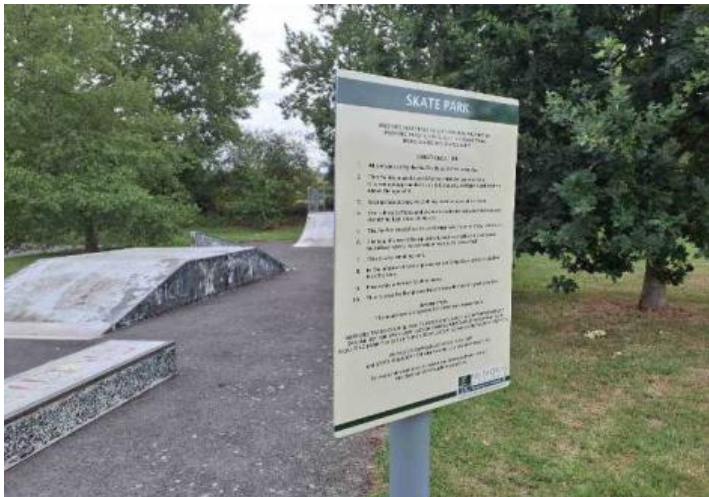
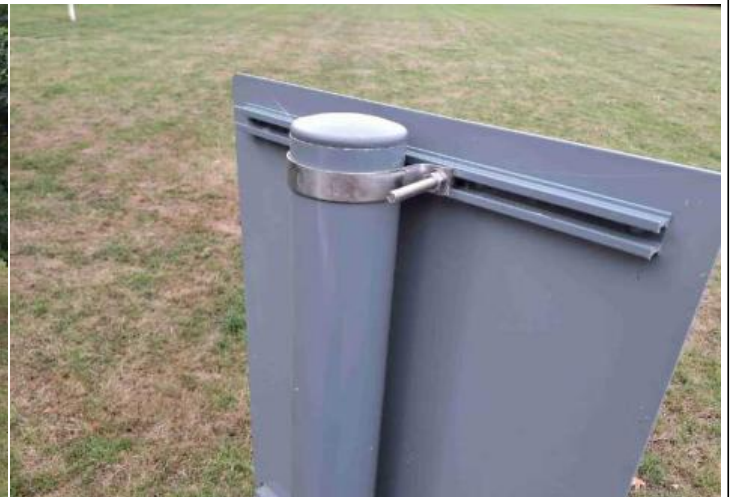
**Finding:** There are projecting bolt thread(s) present

**Action:** Remove excess thread length and deburr or provide cap

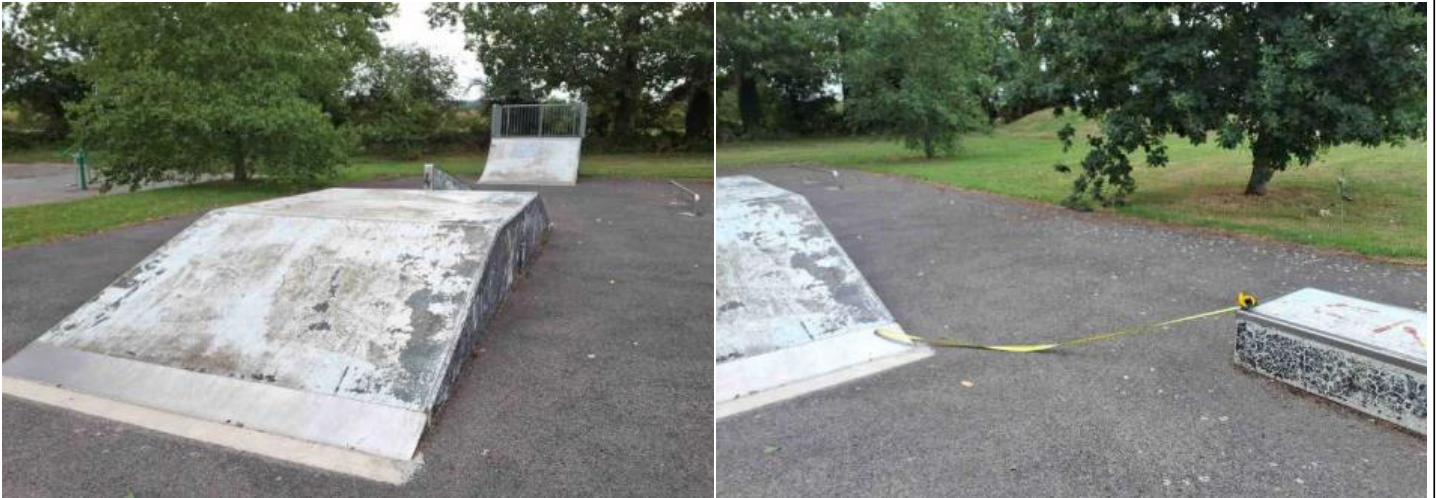
**Finding:** The item has insufficient safety zone allowed as required by BS EN 14974; 6.4. This should equal at least 2.0 metres on this item

**Action:** Monitor - No action given the risk assessment

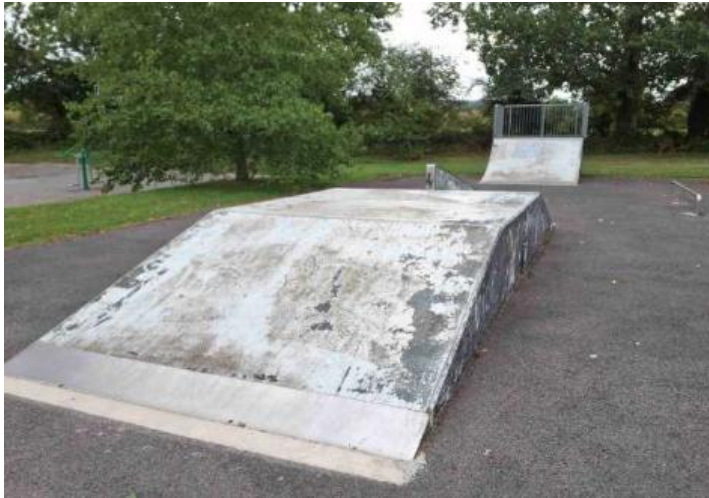
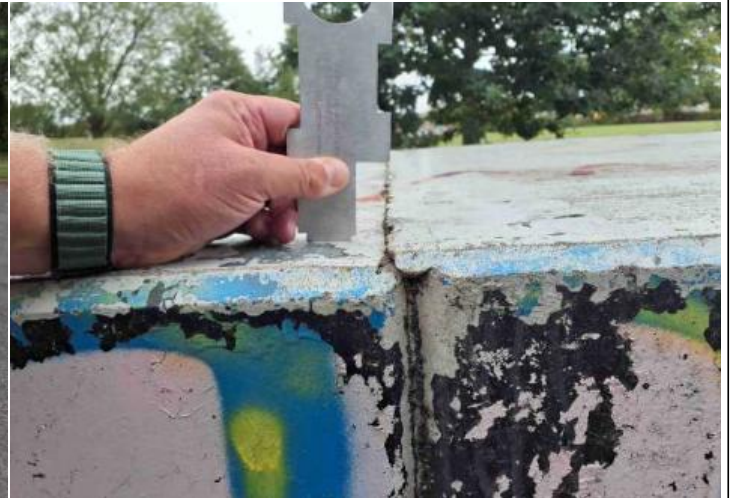
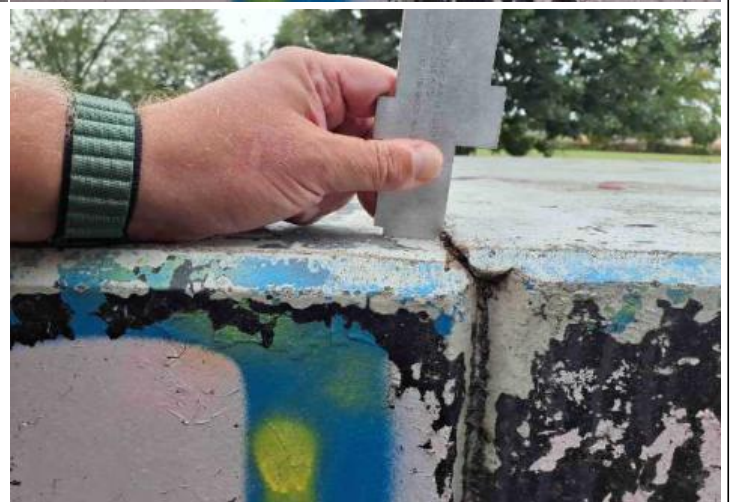
**Finding:** There are differences in height exceeding 3mm on the rolling / riding surfaces in contravention of the requirements of BS EN 14974; - 6.2.4

| <b>Item</b> | <b>Page(s)</b> | <b>Clerk's Recommendation</b> |
|---|---|---|
| Fun Box skate ramp | 18, 36 | Obtain quotations for repair of the gaps in the riding surface. |

**Action:** Take corrective action to ensure that the gaps between the joints do not exceed 3mm

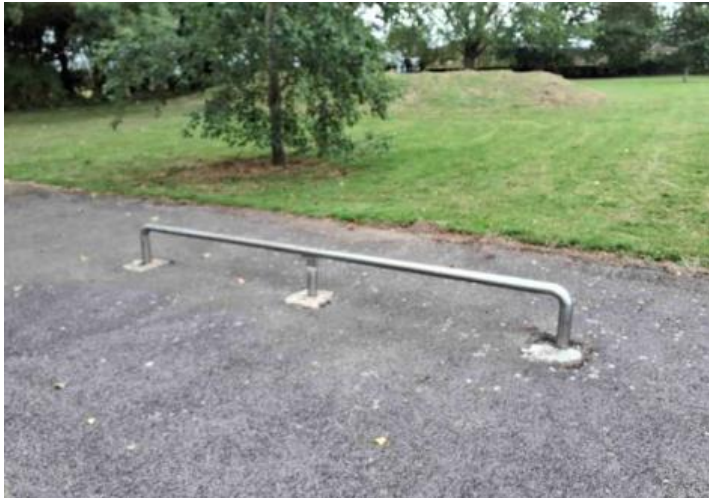
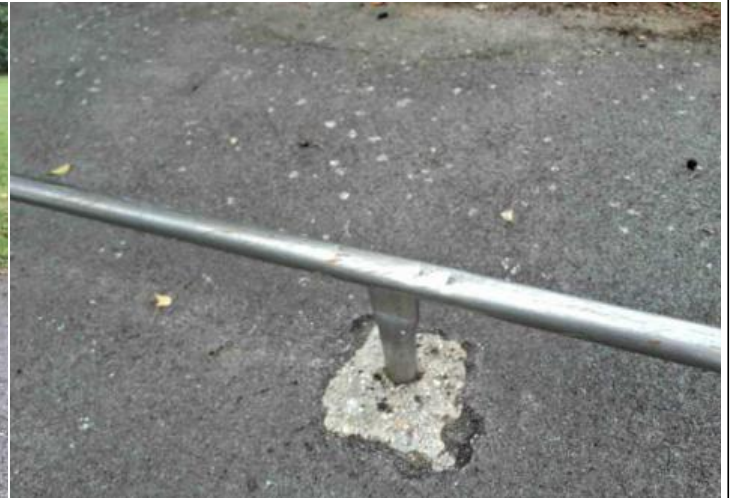
**Finding:** The item has been damaged

| Grind rail | 37 | Consider grind rail replacement – the concrete anchor also requires replacement/repair. |

**Action:** Monitor for any further deterioration and replace as required

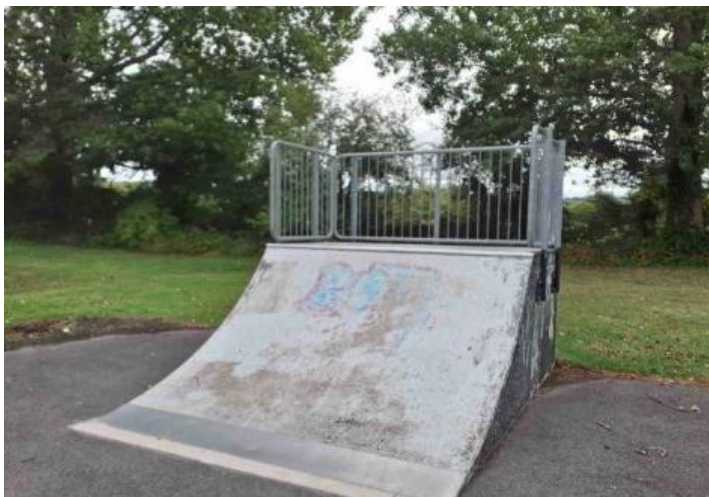
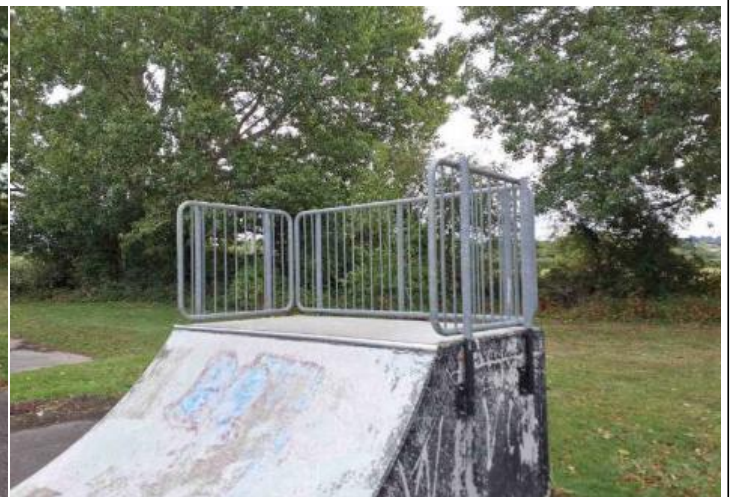
**Finding:** The height of the barrier is less than 1200mm in contravention of BS EN 14974 - 6.2.6. This height must be achieved all around the platform and at a maximum distance of 300mm from the front of the platform.

**Action:** Monitor - no reasonably practicable action given the risk assessment

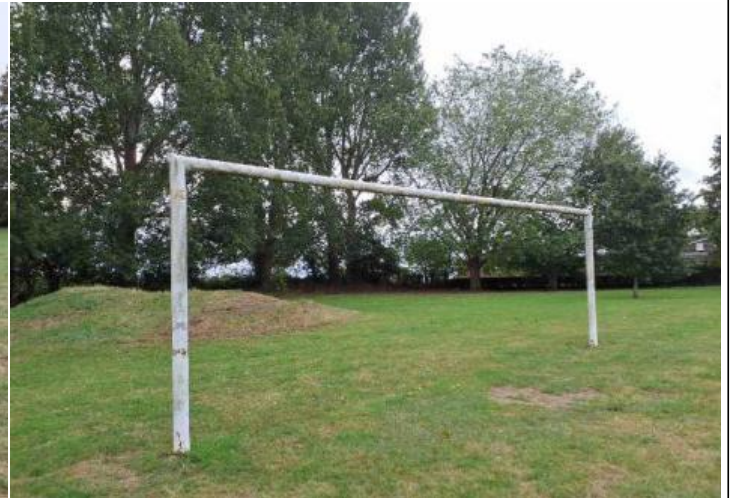
**Finding:** NB: We have undertaken a maintenance inspection only of the football goal(s); full load testing falls outside the scope of our inspection.

**Action:** Implement load testing as required

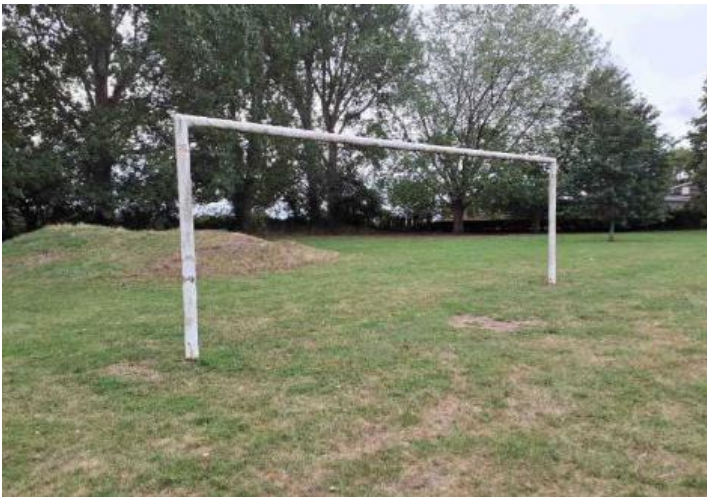
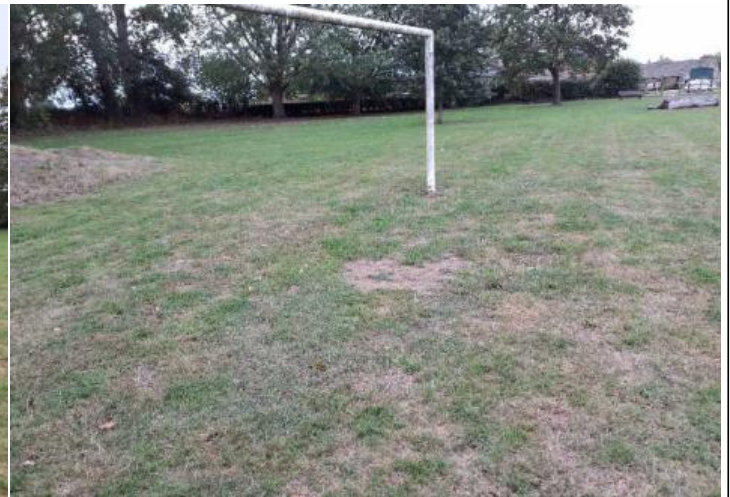
**Finding:** The surface has eroded in some areas and may be slippery in wet conditions

**Action:** Reinstate the surface

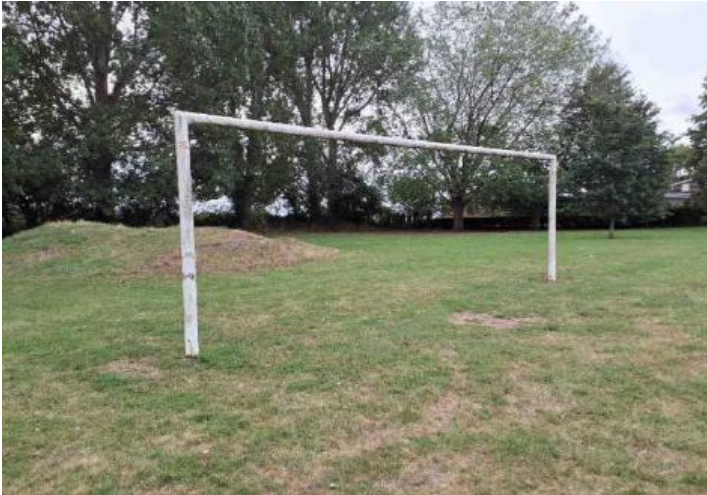
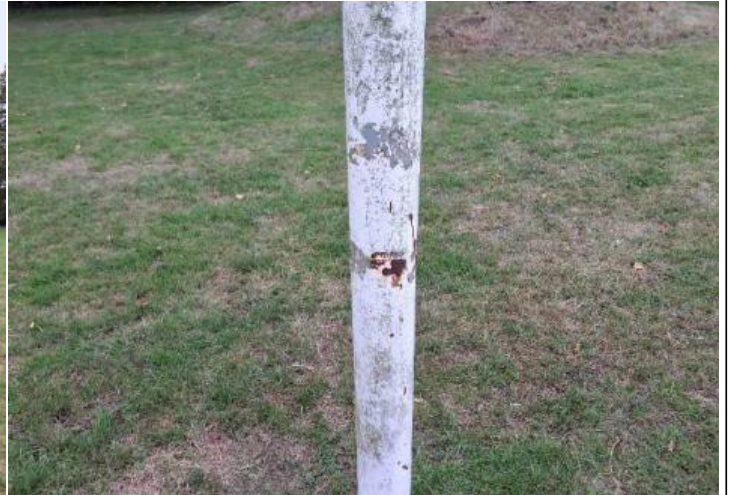
**Finding:** The paintwork on this item has been damaged or worn exposing the metal underneath which is rusting / corroding

| <b>Item</b> | <b>Page(s)</b> | <b>Clerk's Recommendation</b> |
|---|---|---|
| Football Goal rust/corrosion | 20, 39 | Consider treatment and repainting. |

**Action:** Treat affected areas and repaint
